SEA FISH INDUSTRY AUTHORITY

INVESTIGATION ON "MARANATHA II" (UL33)

Consultancy Report No.50

**H. R. English
January 1992**

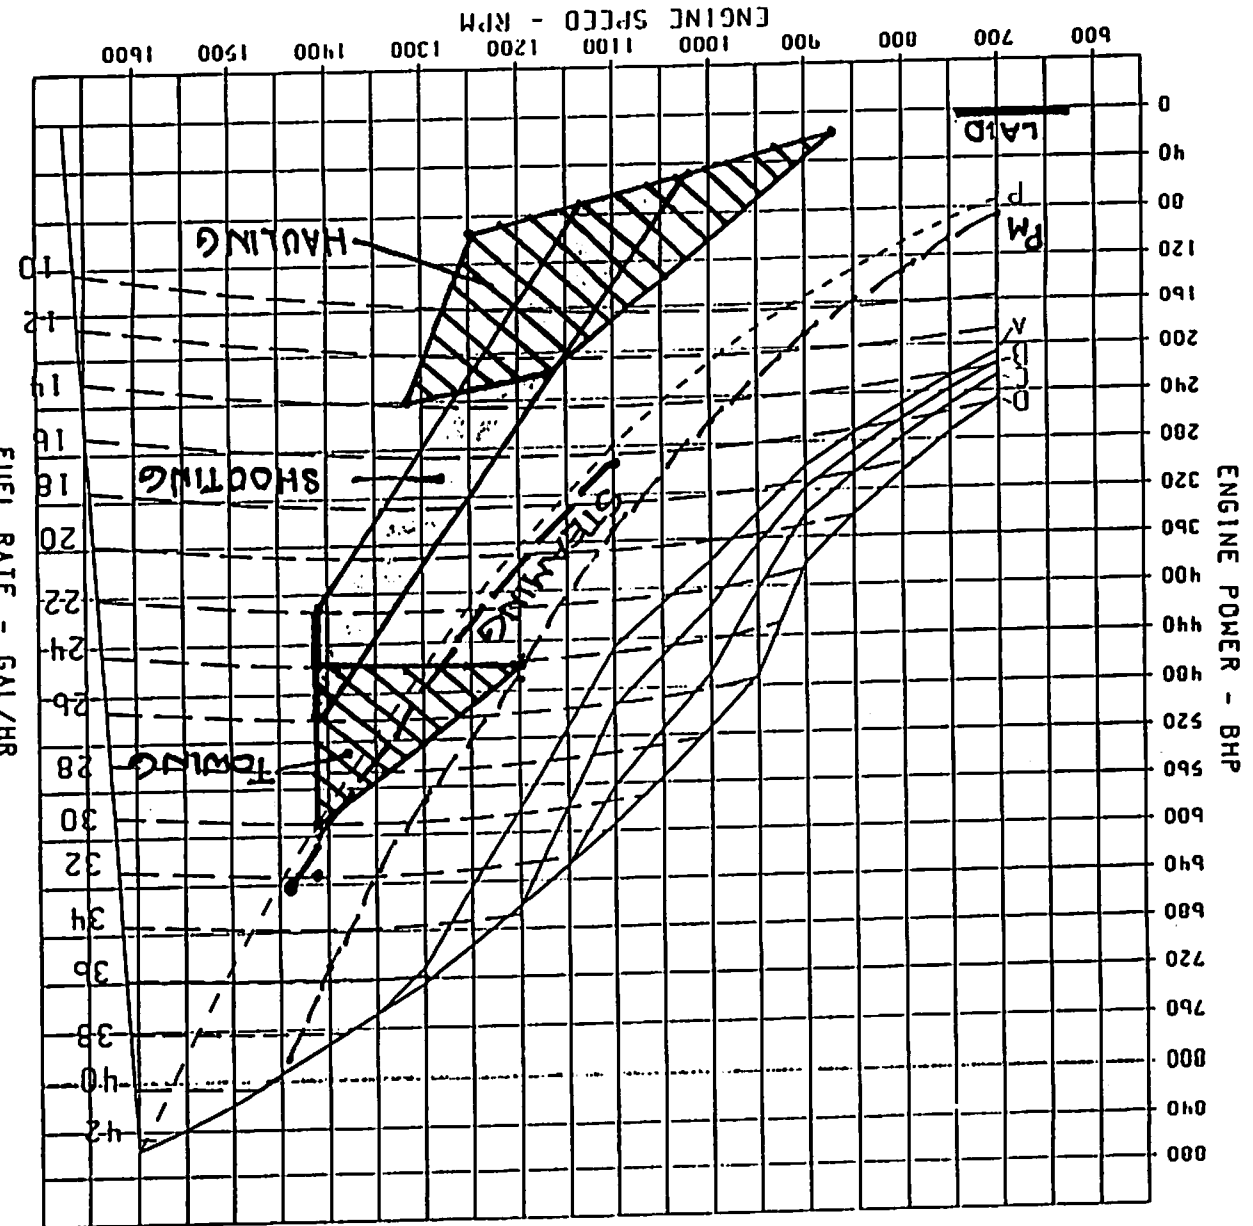
It should be noted that Figure 1 is overlaid on Caterpillar Performance Curve TE0017-00 and that this refers to the manufacturers quoted rating of 855 hp at 1800 revs/min. The rating of the engine installed on the "Maranatha II" is quoted at 775 hp at 1440 revs/min. This is about 2% below the performance curve value at full power (i.e. at 1440 revs/min) and may vary by more or less than this value at lower engine speeds. However it can be seen that actual powers recorded were much lower than the performance curve and that the matter is thus of little importance.

All powers recorded during steaming or any of the fishing operations are well within the performance curve of the engine as can be seen in Figure 1. The range of powers used during hauling is particularly low and reflects the skippers handling of winch and vessel during hauling. It is common practice to run the winch at its fastest hauling speed, reducing engine speed and propeller pitch in order to limit forward thrust and thus pull on the winches. This generally gives the minimum hauling time. Vessel speed falls to the range 0 to 1 knot during this sequence. The hauling sequence is shown in Parameter v. Time format in Figure 3. Changes in power shown are consistent with the movements of speed and pitch control and with the demands during a typical hauling sequence. However it should be noted that the water depth in the trials area was only some 40 fathoms; the vessel has fished in waters some 10 times as deep as this and the hauling period would then be extended by about the same ratio. Engine operational parameters (Lub Oil Pressure, Boost Pressure and Exhaust Temp) all appear normal as does the Cooling Water Outlet Temp (not plotted on the graph) which falls by about 2°C during the hauling sequence.

This is by no means an uncommon situation but may be of some significance in conjunction with (i) above. For a marine propulsion engine driving a fixed pitch propeller the power demand at different engine speeds would not fall below the propeller demand curve. Figure 1 shows the manufacturers curve for the engine at its higher power/speed rating (P), together with a calculated curve (P_M) to represent the circumstances of the engine at its current power/speed rating with a fixed pitch propeller. The use of a controllable pitch propeller on this vessel allows of power/speed combinations well below the P_M curve, as shown in Figure 1. Only the engine manufacturer could comment on whether this might cause effects such as undercooling in the air inlet passages, due to the possibility of excessive air supplies being provided from the turbocharger. The point is raised since operation of an engine in the low power/middle speed regimes noted on the vessel trials might not be an important part of the manufacturers test procedures on their own engines. There is no evidence of "abnormal" temperature changes to be detected from exhaust temperature readings for example.

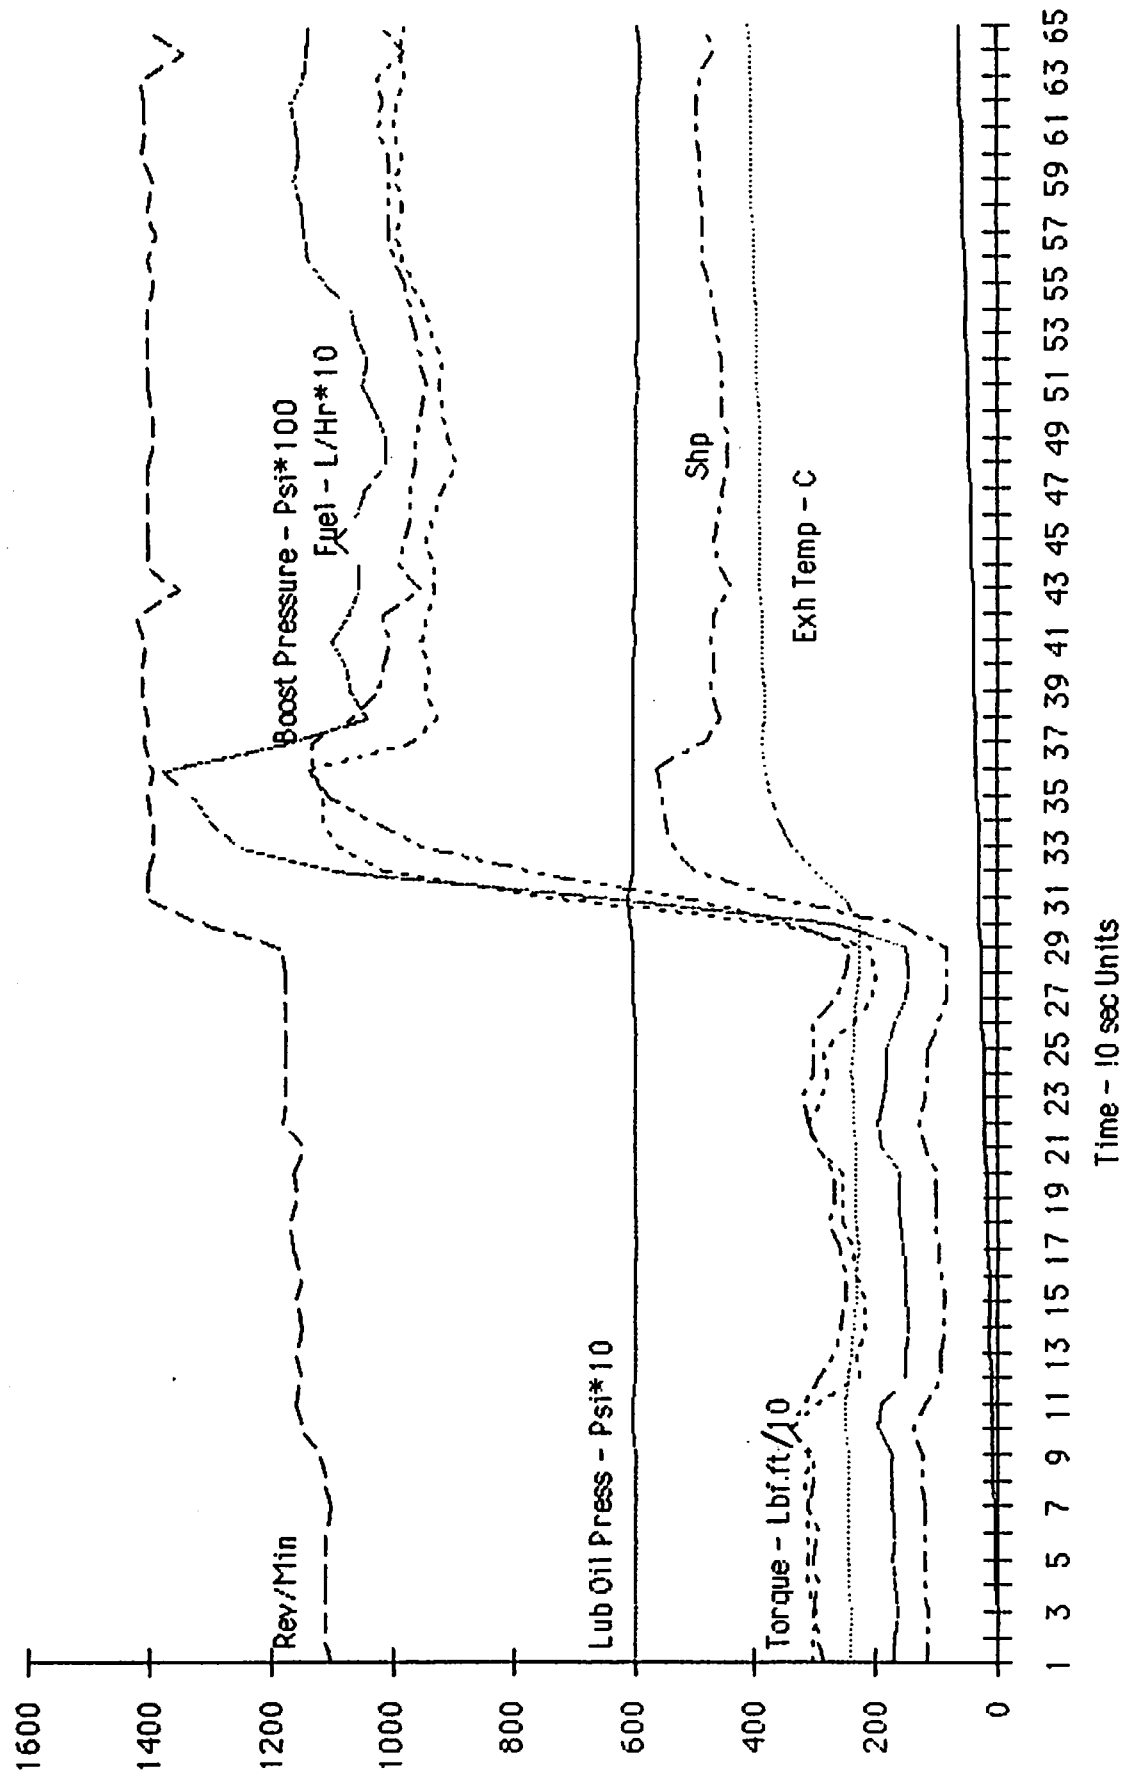
Fig 2

The shooting sequence (Figure 2) is as would be predicted for any stern trawler; a period of low power manoeuvring while the gear is shot away (with checks to ensure that it is not foul) followed by a high power boost to spread the gear, followed in turn by release of the warps and with a final reduction of power when the winch brakes have been applied. The final portion of Figure 2 shows power adjustments by the skipper in selecting the correct towing speed. In all this the engine operating parameters are well within manufacturers stated limits.

Maranatha II - Engine Parameters While Shooting

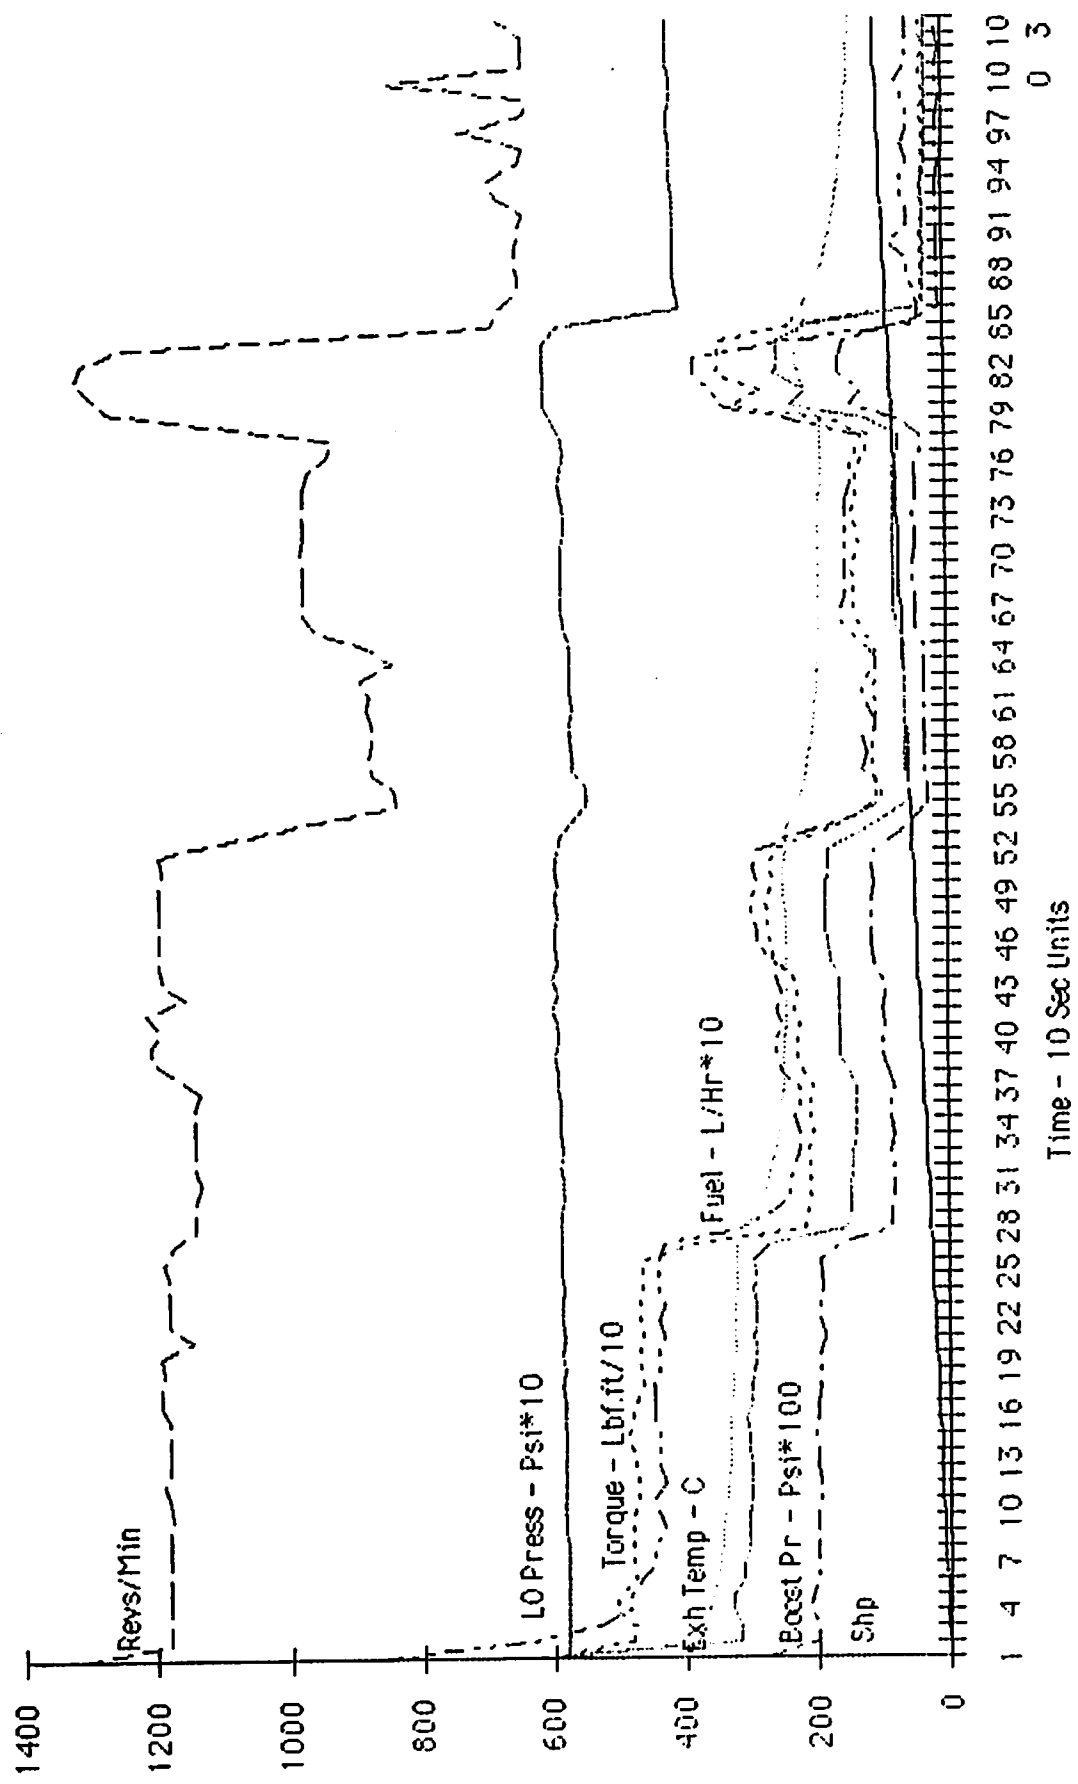
Fig3

Maranatha II - Engine Parameters while Hauling

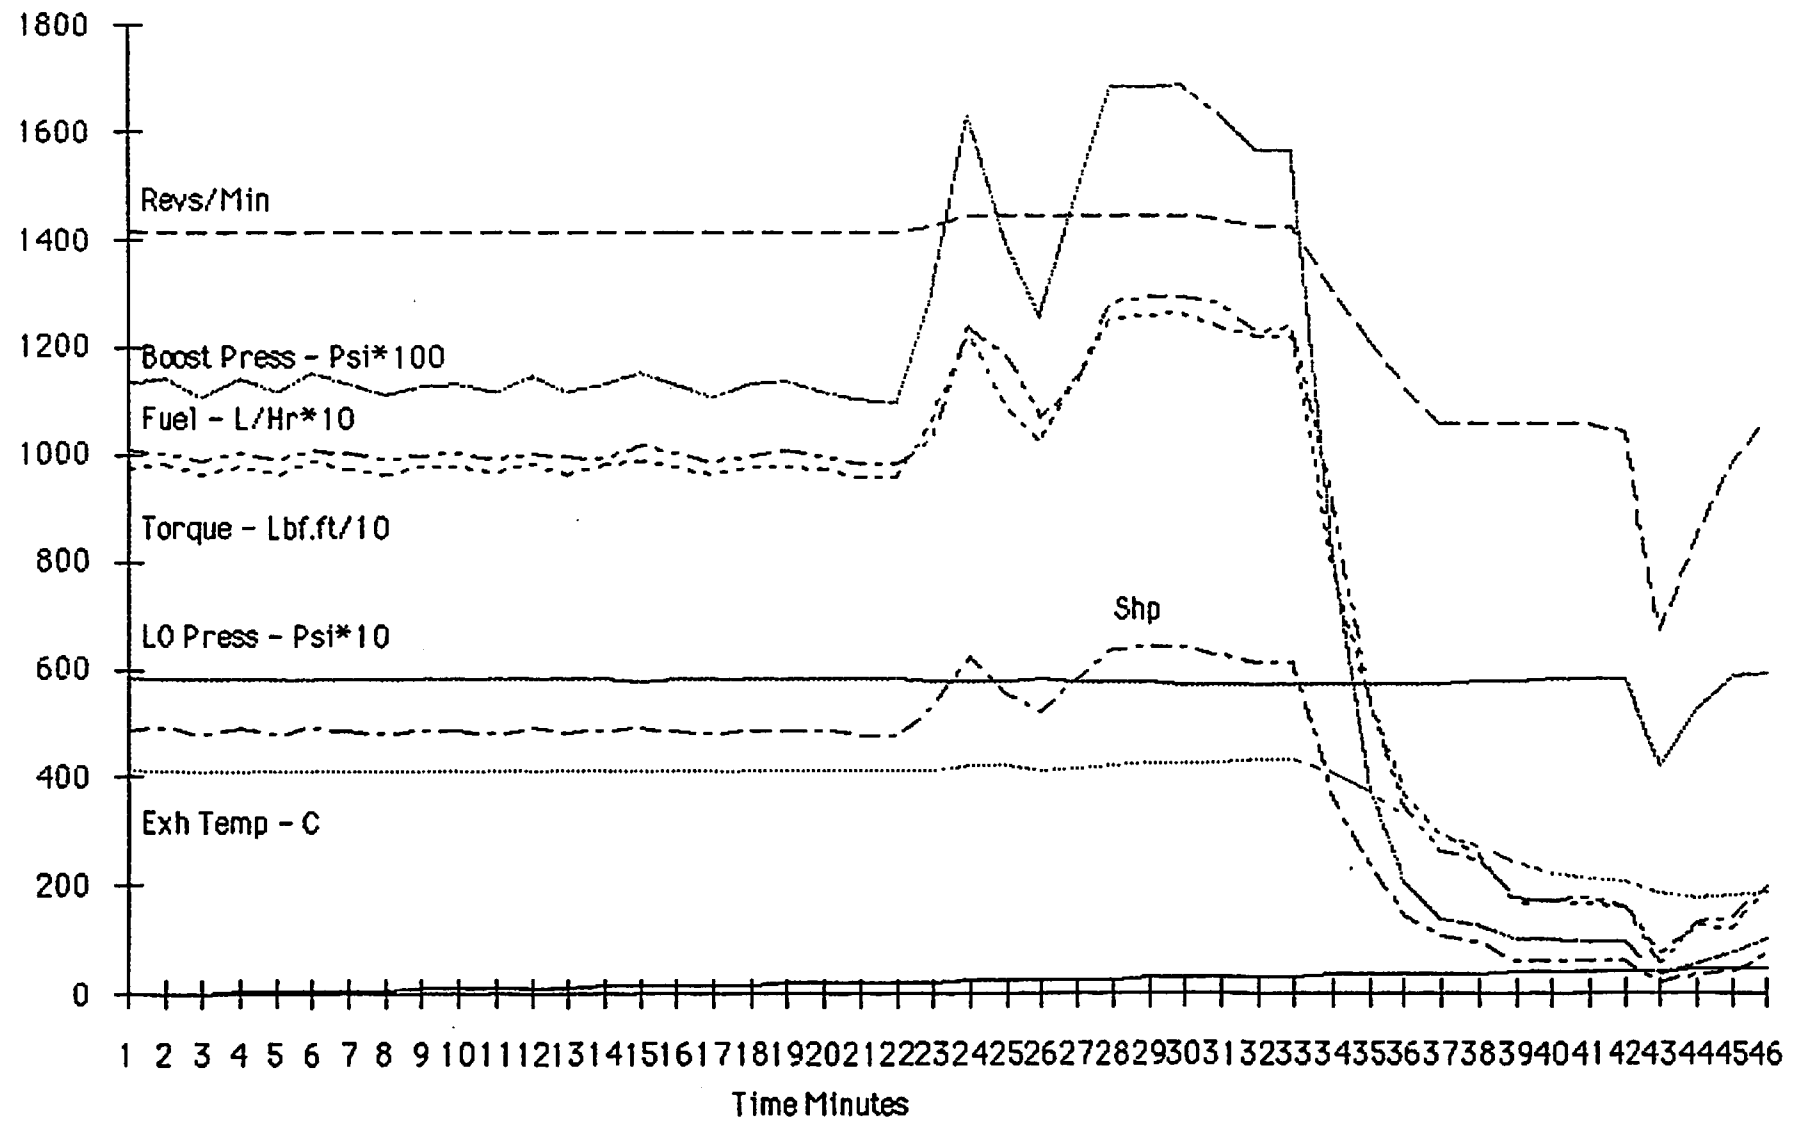
Fig 4

The steaming sequence (Figure 4) taken during the run into Peterhead again shows nothing untoward.

Maranatha II - Engine Parameters while Steaming.
