**Quality Audit of the
Port of Rye**

Consultancy Report No. CR127

September 1997

Seafish Technology

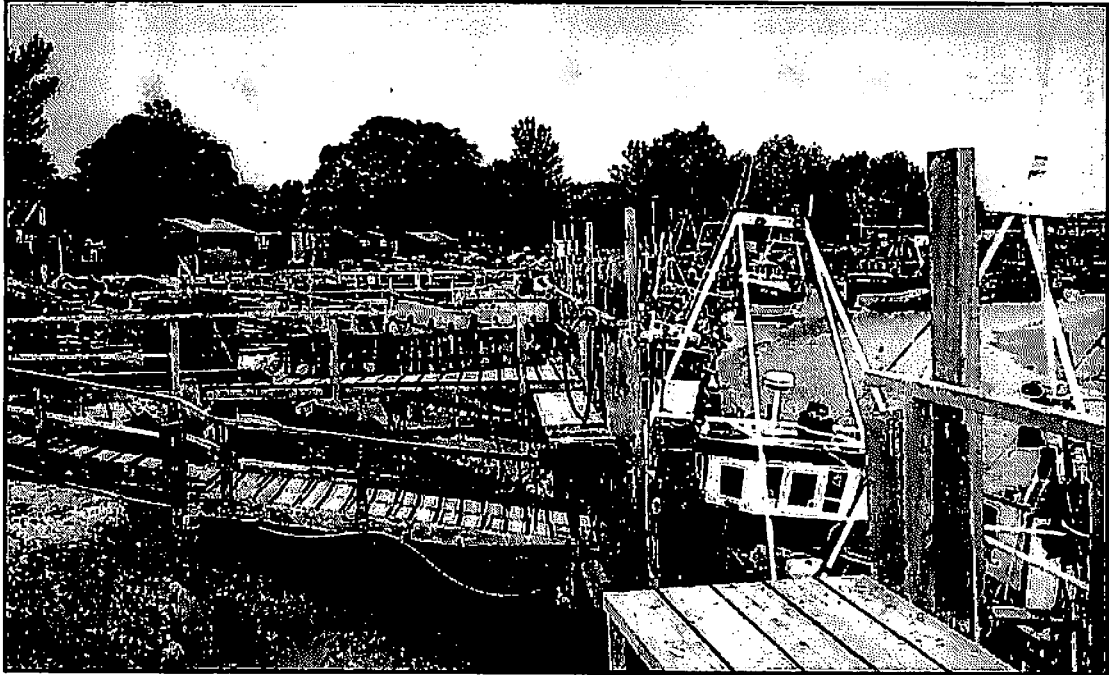
Figure 4 - Landing stages at low tide

Fish landings are made to 15 timber stages that can be accessed approximately 2 hours either side of high water. At low water the boats take the bottom (see Figure No. 4). With double berthing, the stages have capacity for 21 boats of maximum length 12 metres.

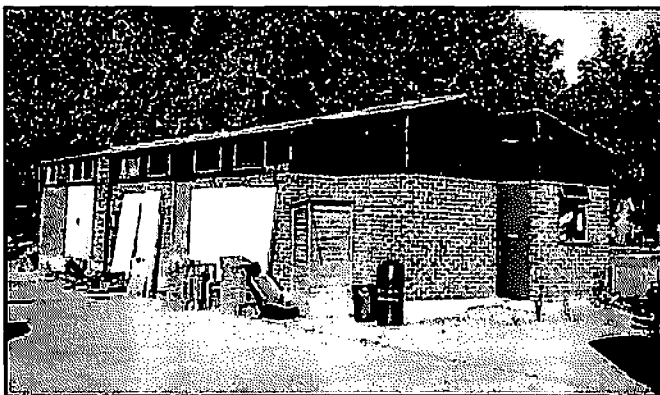
Figure 7 - Fish market

The fish market is of brick construction, part timber clad, with timber doors. It has a profiled sheet roof that is underdrawn internally. The market is show in Figure No. 7. It has a sales area of approximately 6 metres by 4.6 metres.

The market lacks any staff facilities, including toilets, and is generally in poor condition. The nearest toilets are public facilities on the Town Salts adjacent to the Bowling Green (Figure No. 3). It has no internal drainage and water from washing down is hosed/brushed towards a hole in the wall to an external gully that runs along the rear of the building. The market floor is raised approximately 0.3 m above the surrounding quay but is still subject to flooding. The market cannot be said to comply with the standards required by hygiene/food safety legislation. However, the owner and salesman, Mr. B. Drew, has plans to upgrade and extend it, and is seeking grant support.

- (a) the replacement of the landing stages with a sheet piled quay and surfaced access and working areas above flood levels;
- (b) a new or substantially upgraded fish market building and ice plant;
- (c) new facilities for the storage of nets and gear;
- (d) improved security fencing/wall.

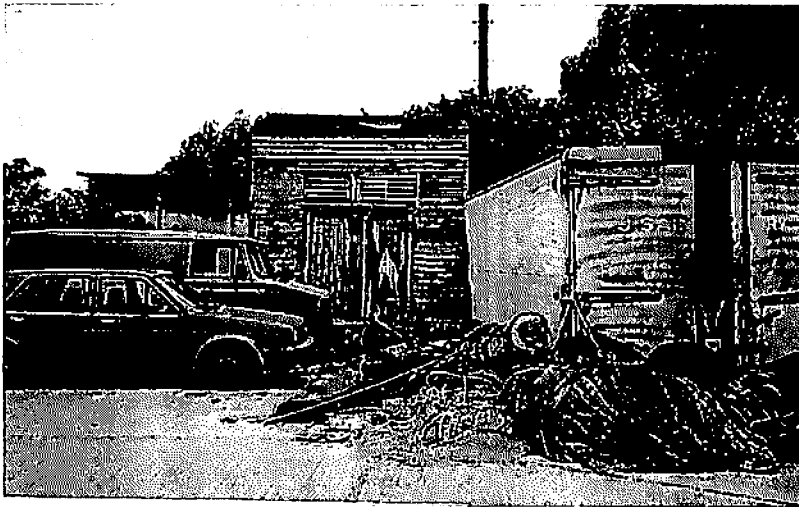
Road access to the landing stages and the fish market is by a narrow concrete surfaced road. There is no through route and all traffic is required to turn and exit the same way. Parking on site is limited and further restricted by the clutter of fishing gear and abandoned plant and equipment. See Figure 10. During high water floods, the fish market may be cut off from access by road vehicles.

Figure 10 - Abandoned plant and equipment

Ice is available on the market for icing fish on landing, etc. but is not used by the fleet at sea. The 'Scotsman' machine (Figure No. 12) can produce approximately $\frac{3}{4}$ tonne/24hr. A previous plant operated by the Fishermen's Co-operative (Figure No. 10) is defunct and derelict. D. Grant also has a machine capable of 5 tonnes/24 hr. but it is restricted to factory use.

- (a) the removal of rubbish, waste and abandoned plant and equipment, etc.;
- (b) the removal of fuel storage tanks;
- (c) demolition of the old ice plant and making good the paved surface;
- (d) repairs to road access;
- (e) repairs to hand rails and decking of landing stages;
- (f) improved security to restrict public access;
- (g) the removal of vegetation and weed growth on the site;
- (h) drainage from the fish market;
- (i) improved lighting of the landing stages.

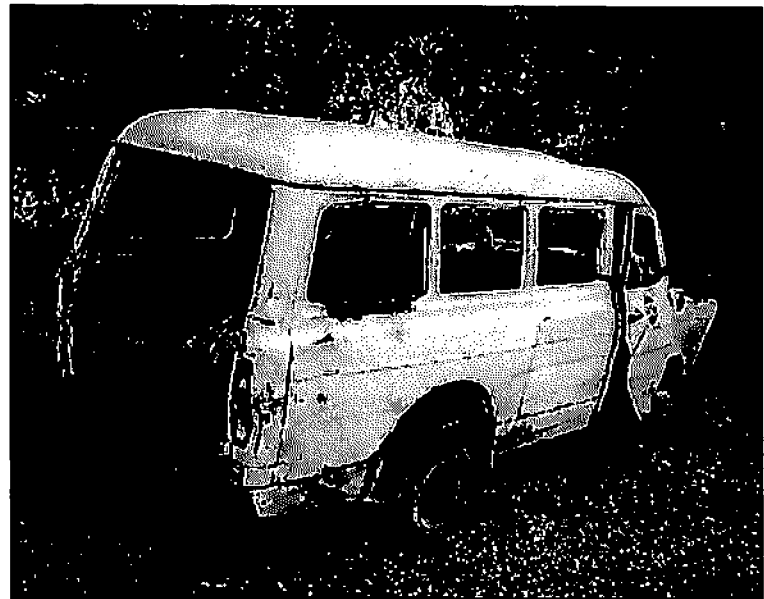
Vehicles used for dispatch of fish from the market were predominantly unrefrigerated panel vans owned by small merchants/retailers. B. Drew operates a refrigerated van for local deliveries and D. Grant operates a number of larger insulated and refrigerated wagons. Fish destined for export is usually collected from D. Grant's factory by contracted transport. The vehicle used to transport fish from the market and boats to D. Grant's premises (Figure No. 11)

Figure 11 - Transport used for delivery of landings to merchants premises

is in an appalling state of repair and cleanliness, having recently been vandalised.
