Kingfisher Fortnightly Bulletin

Subsea Cables

23rd December 2010

Issue 26 / 2010

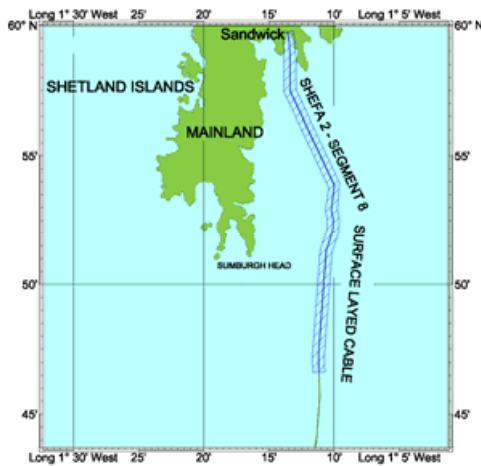
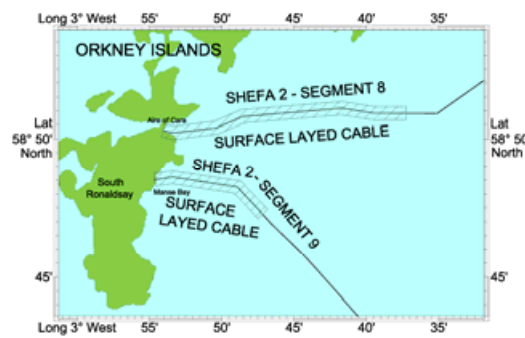
Exposed Cable Sections – SHEFA-2 Segments 8 & 9 (New Entry 08-01-2009)

Please be advised that the shore end sections of the SHEFA-2 Segment 8 cable have been surface laid for approximately 17 kilometres from the Orkney landing and 26 kilometres from the Shetland landing and therefore represents a hazard to fishing and should be avoided at all times. The Orkney landing of the SHEFA-2 Segment 9 cable has also been surface laid for a distance of approximately 9 kilometres from shore. A part buried section further south along the route also exists.

Please see the charts below for details of the exposed sections and for coordinates of these sections, please see Kingfisher Fortnightly Bulletin – 25 / 2009.

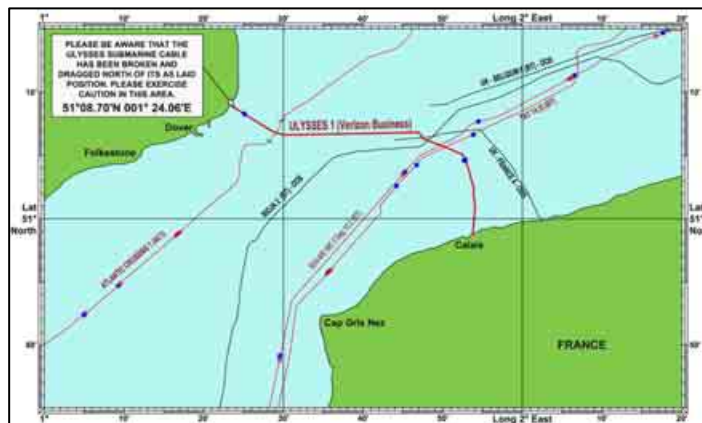
Hazardous Condition of Cable – Ulysses South landing - St Margaret's Bay

Further to earlier Notices, the Ulysses South submarine cable landing at St Margaret's Bay, near Dover, remains broken at a position:

51°08.70'N 01° 24.06'E

This position lies approximately 1.3km offshore in a water depth of 15 metres. As a result of this fault, the cable at the approaches to St Margaret's Bay has been dragged an indeterminate distance to the north of its as laid route on either side of the fault position. Caution should therefore be exercised in this area until the cable repair operation has been carried out.

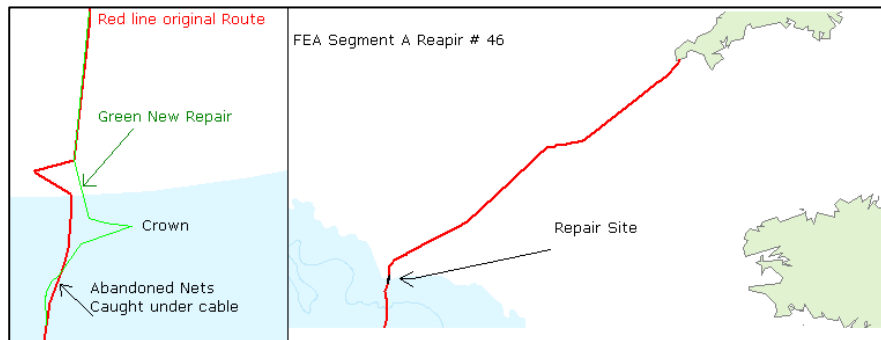
Cable Repair – Hazard to Fishermen (New Entry 30-09-2008)

Following a repair on the Reliance Globalcom FEA Segment A cable at 48°07.3216'N 009°29.7775'W, short lengths of cable within the final bight have not been fully reburied on the steep seabed slopes at this location. The final bight extends out to the East from the cable line from 48°07.3202'N 009°29.8122'W to the crown at 48°07.3202'N 009°29.8145'W - water depth 738.3m.

There are also abandoned fishing nets caught under the re-laid cable which are floating clear of the seabed between 48°06.8080'N 009°30.9012'W and 48°06.8078'N 009°30.9008'W - water depth 977.1m. As these two items could constitute a hazard to fishing vessels bottom trawling we would request that all fishing vessels give this area a wide berth.

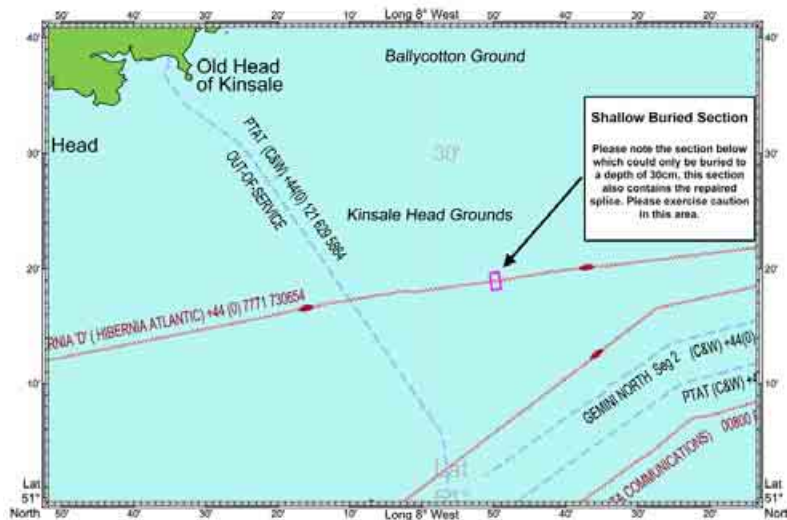
Shallow Buried Section

Shallow Burial of Submarine Cable Section – Hibernia ‘D’ (New Entry 25-11-2010)

Following a recent repair to the Hibernia ‘D’ cable, there was difficulty in reburying the cable to the required depth of 1 metre. Please note the section below which could only be buried to a depth of 30cm, this section also contains the repaired splice. Please exercise caution in this area.

1. 51°18.893'N 007°50.289'W
2. 51°18.903'N 007°50.229'W
3. 51°18.997'N 007°50.127'W
4. 51°18.998'N 007°50.120'W
5. 51°18.927'N 007°50.011'W
6. 51°18.951'N 007°49.641'W
7. 51°18.974'N 007°49.336'W

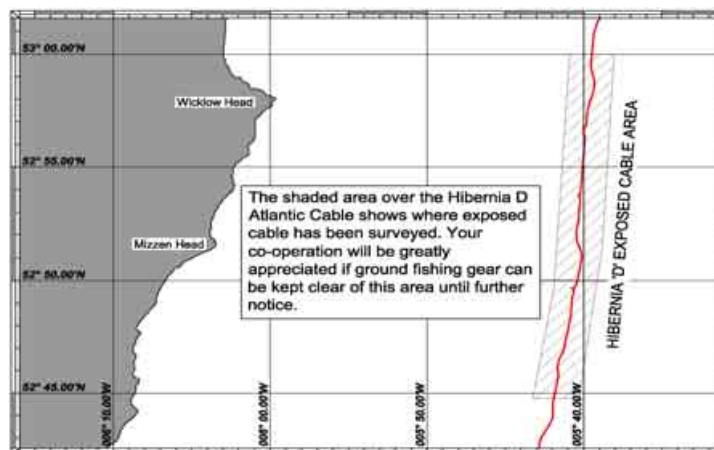
Exposed Submarine Cable Section – Hibernia ‘D’

Please note that the Hibernia ‘D’ cable has been surveyed and has an exposed section. This is indicated in the map below.

The exposed section runs from 52° 59.433' N 05° 39.540' W to 52° 45.118' N 05° 41.797' W. For full details of the exposed cable route, please refer to Kingfisher Fortnightly Bulletin Issue 24 / 2006.

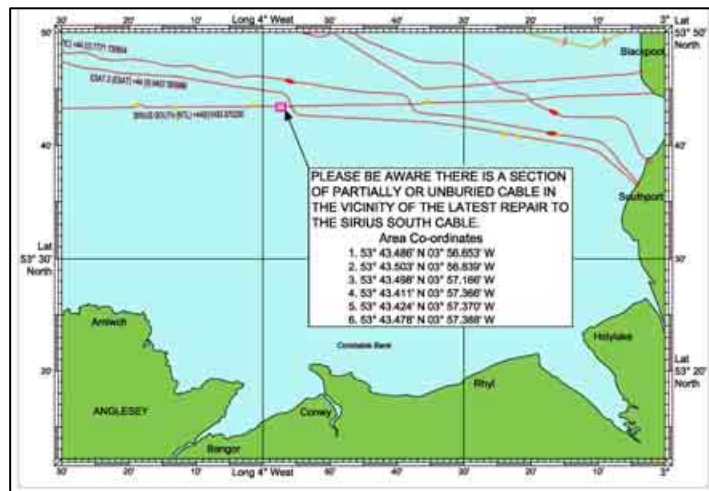
Exposed Submarine Cable Section – Sirius South

Please note that the Sirius South' cable has been repaired and it was found that there is a section of exposed cable in the vicinity of the repair. Please see the map below showing the location of the repair.
