# Kingfisher Fortnightly Bulletin

## Subsea Cables Subsea Cables Subsea Cables

11<sup>th</sup> November 2010

Issue 23 / 2010

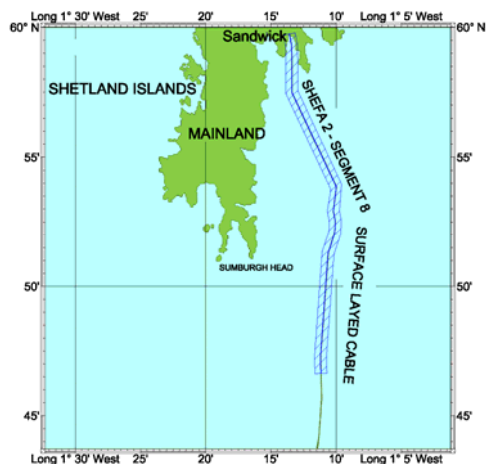
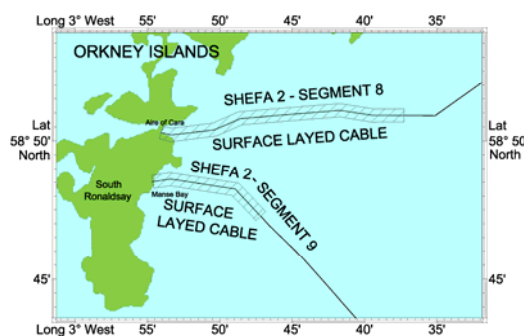
### Exposed Cable Sections – SHEFA-2 Segments 8 & 9 (New Entry 08-01-2009)

Please be advised that the shore end sections of the SHEFA-2 Segment 8 cable have been surface laid for approximately 17 kilometres from the Orkney landing and 26 kilometres from the Shetland landing and therefore represents a hazard to fishing and should be avoided at all times. The Orkney landing of the SHEFA-2 Segment 9 cable has also been surface laid for a distance of approximately 9 kilometres from shore. A part buried section further south along the route also exists.

Please see the charts below for details of the exposed sections and for coordinates of these sections, please see Kingfisher Fortnightly Bulletin – 25 / 2009.

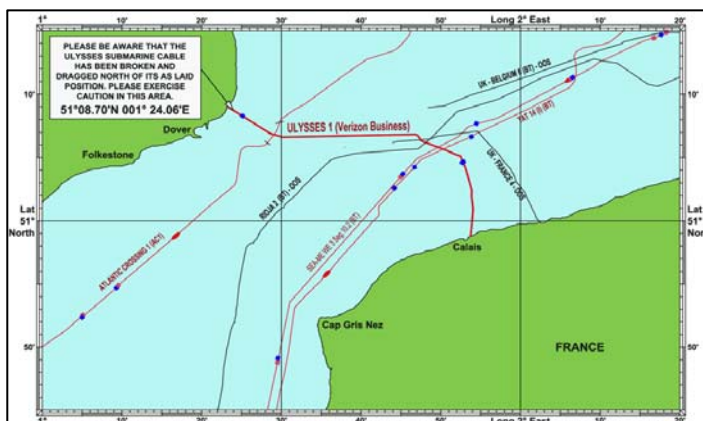
## Hazardous Condition of Cable – Ulysses South landing - St Margaret's Bay

Further to earlier Notices, the Ulysses South submarine cable landing at St Margaret's Bay, near Dover, remains broken at a position:

51°08.70'N 01° 24.06'E

This position lies approximately 1.3km offshore in a water depth of 15 metres. As a result of this fault, the cable at the approaches to St Margaret's Bay has been dragged an indeterminate distance to the north of its as laid route on either side of the fault position. Caution should therefore be exercised in this area until the cable repair operation has been carried out.

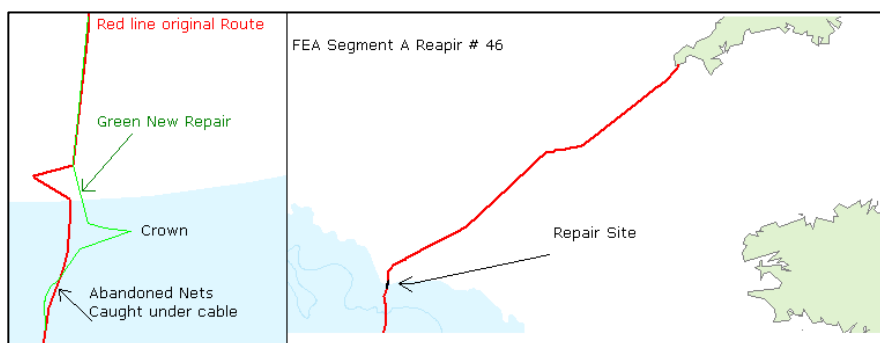
### Cable Repair – Hazard to Fishermen (New Entry 30-09-2008)

Following a repair on the Reliance Globalcom FEA Segment A cable at 48°07.3216'N 009°29.7775'W, short lengths of cable within the final bight have not been fully reburied on the steep seabed slopes at this location. The final bight extends out to the East from the cable line from 48°07.3202'N 009°29.8122'W to the crown at 48°07.3202'N 009°29.8145'W - water depth 738.3m.

There are also abandoned fishing nets caught under the re-laid cable which are floating clear of the seabed between 48°06.8080'N 009°30.9012'W and 48°06.8078'N 009°30.9008'W - water depth 977.1m. As these two items could constitute a hazard to fishing vessels bottom trawling we would request that all fishing vessels give this area a wide berth.

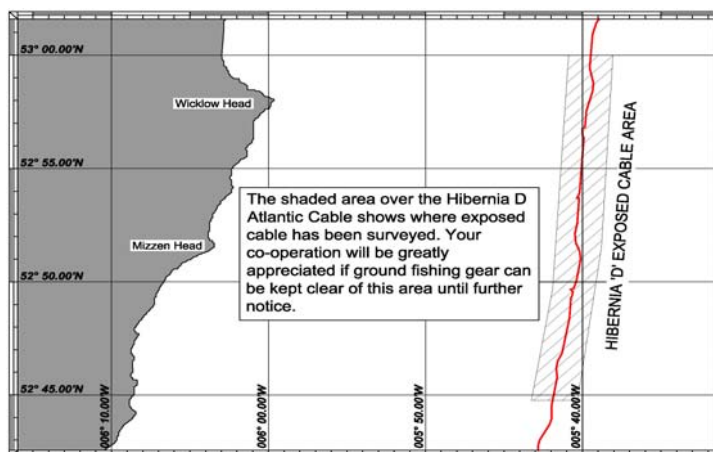
### Exposed Submarine Cable Section – Hibernia 'D'

Please note that the Hibernia 'D' cable has been surveyed and has an exposed section. This is indicated in the map below.

The exposed section runs from 52° 59.433' N 05° 39.540' W to 52° 45.118' N 05° 41.797' W. For full details of the exposed cable route, please refer to Kingfisher Fortnightly Bulletin Issue 24 / 2006.

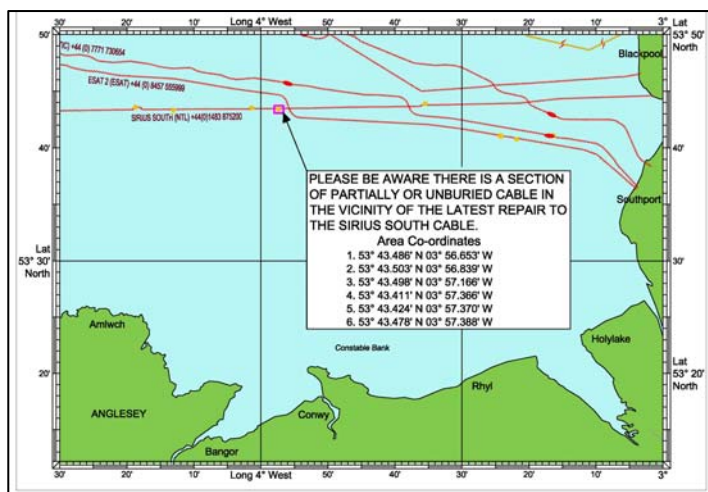
### Exposed Submarine Cable Section – Sirius South

Please note that the Sirius South' cable has been repaired and it was found that there is a section of exposed cable in the vicinity of the repair. Please see the map below showing the location of the repair.
