**Quality Audit
of the
Port of Brixham**

Seafish Report No. CR 176

February 2000

Confidential Report No. CR176

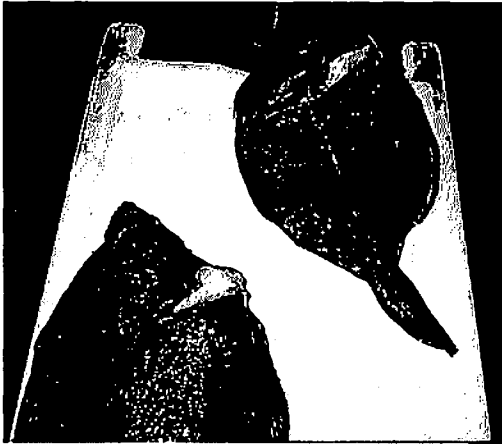
The results represent quite good standards of gutting with only 12% rated as poor. Many of these were so rated because the cut extended excessively into the fillet material of the flesh as shown in figure 1.

Figure 1 - Poor standard of gutting

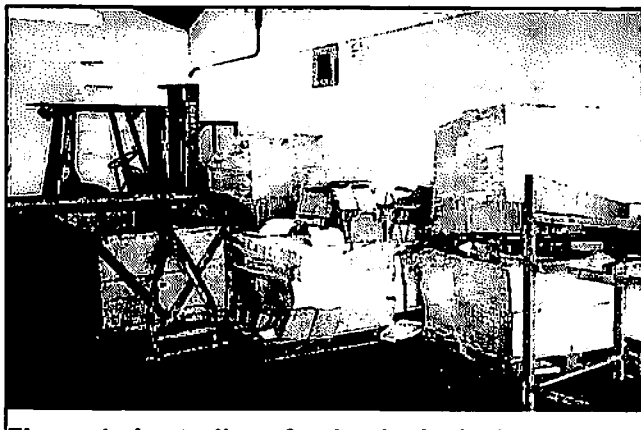
Figure 4 - Ice trolley of unhygienic design and the storage of packaging materials in the market

The two electronic grading lines in the market used for Dover soles and the mobile weigh scales are purpose designed and hygienically constructed in stainless steel and food grade materials, as are the working surfaces of the tables used for manual grading. The trolleys used for handling of ice however were of unhygienic design and construction and poorly maintained (figure 4).

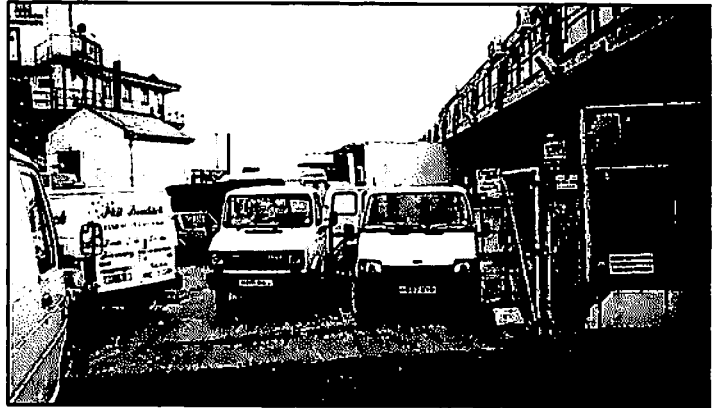
The market loading bay and manoeuvring area particularly are inadequate for the numbers and size of vehicles in use today (figure 6). Due to the deficiencies of the loading bay large fish-transport vehicles often have to park across the entrance to the harbour for loading by fork truck, blocking or restricting access and giving rise to concern for public safety.

Figure 6 - Inadequate loading area

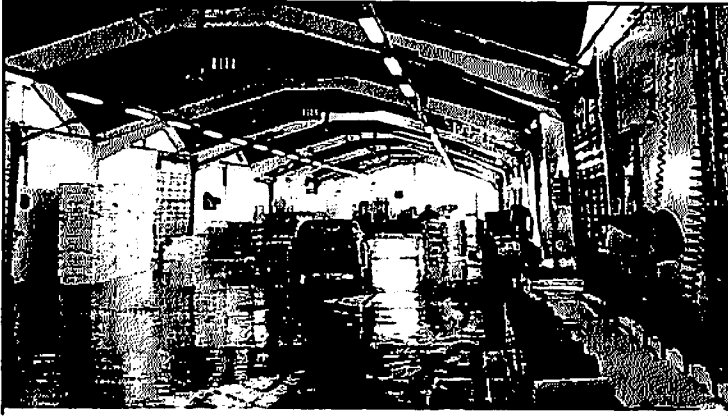
Figure 8 - Car driving through market

quay. Likewise landings of fish should not be made at the fueling berths for risk of contamination of product. The use of diesel fork trucks should be restricted to quayside operations. Fork trucks, vans and cars should not be permitted within the market (figure 8).
