# Kingfisher Fortnightly Bulletin

3<sup>rd</sup> February 2011

Issue 03 / 2011

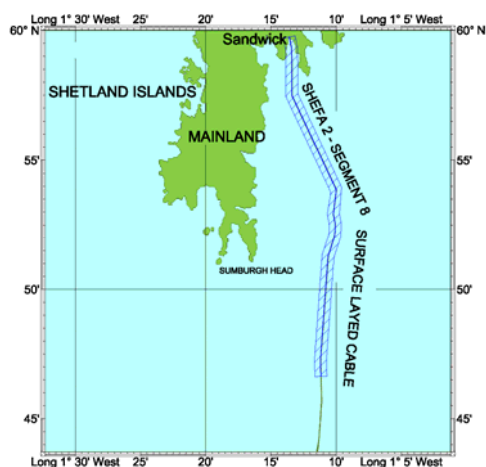
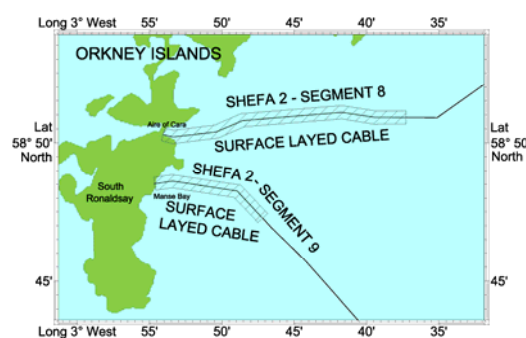
## Exposed Cable Sections – SHEFA-2 Segments 8 & 9 (New Entry 08-01-2009)

Please be advised that the shore end sections of the SHEFA-2 Segment 8 cable have been surface laid for approximately 17 kilometres from the Orkney landing and 26 kilometres from the Shetland landing and therefore represents a hazard to fishing and should be avoided at all times. The Orkney landing of the SHEFA-2 Segment 9 cable has also been surface laid for a distance of approximately 9 kilometres from shore. A part buried section further south along the route also exists.

Please see the charts below for details of the exposed sections and for coordinates of these sections, please see Kingfisher Fortnightly Bulletin – 25 / 2009.

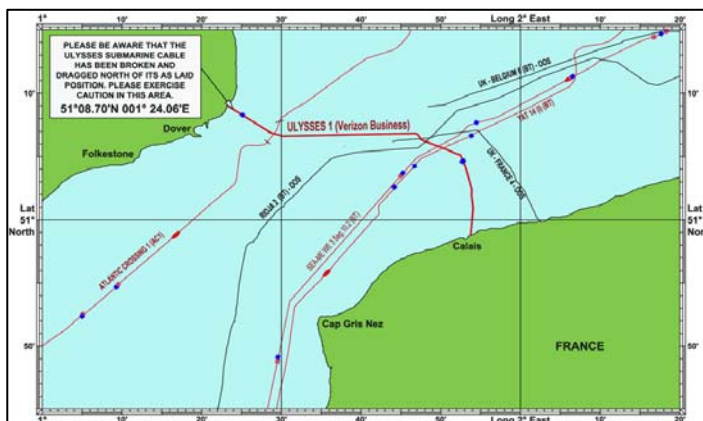
### Hazardous Condition of Cable – Ulysses South landing - St Margaret's Bay

Further to earlier Notices, the Ulysses South submarine cable landing at St Margaret's Bay, near Dover, remains broken at a position:

This position lies approximately 1.3km offshore in a water depth of 15 metres. As a result of this fault, the cable at the approaches to St Margaret's Bay has been dragged an indeterminate distance to the north of its as laid route on either side of the fault position. Caution should therefore be exercised in this area until the cable repair operation has been carried out.

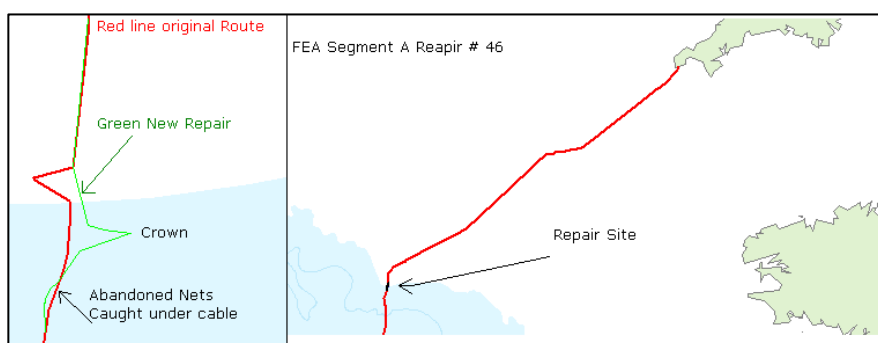
### Cable Repair – Hazard to Fishermen (New Entry 30-09-2008)

Following a repair on the Reliance Globalcom FEA Segment A cable at 48°07.3216'N 009°29.7775'W, short lengths of cable within the final bight have not been fully reburied on the steep seabed slopes at this location. The final bight extends out to the East from the cable line from 48°07.3202'N 009°29.8122'W to the crown at 48°07.3202'N 009°29.8145'W - water depth 738.3m.

There are also abandoned fishing nets caught under the re-laid cable which are floating clear of the seabed between 48°06.8080'N 009°30.9012'W and 48°06.8078'N 009°30.9008'W - water depth 977.1m. As these two items could constitute a hazard to fishing vessels bottom trawling we would request that all fishing vessels give this area a wide berth.

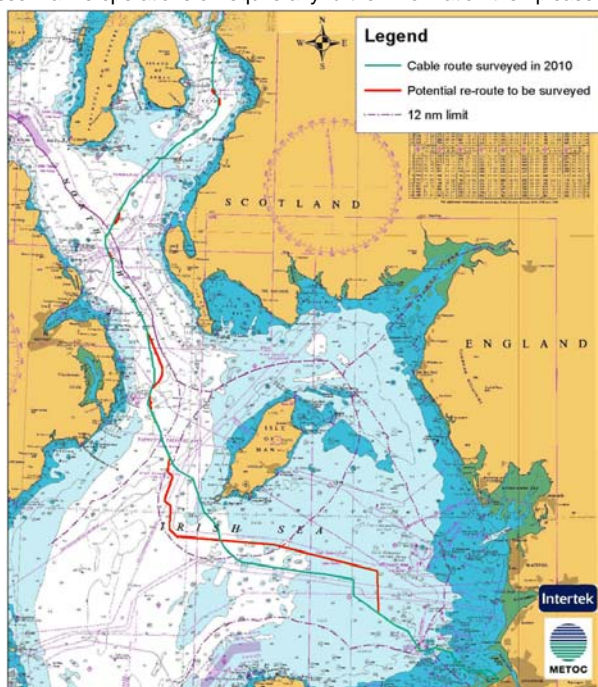
Red sections indicate potential re-route, and therefore, additional survey activity.

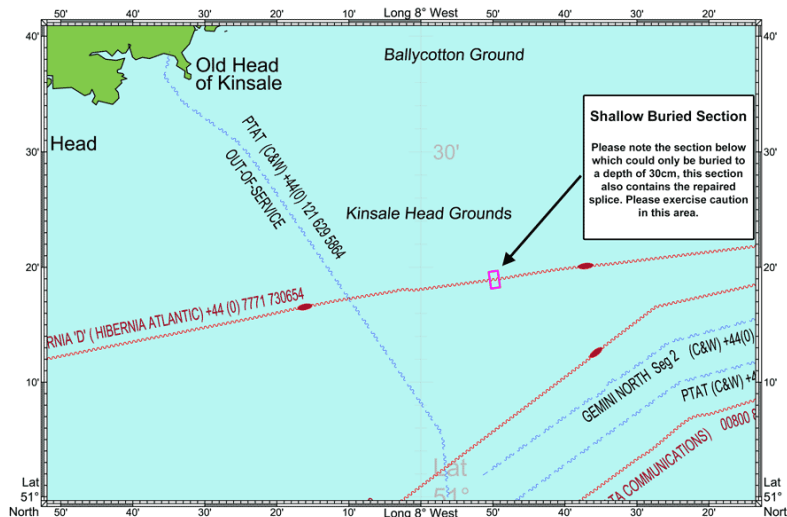
#### Shallow Buried Section

### Shallow Burial of Submarine Cable Section – Hibernia ‘D’ (New Entry 25-11-2010)

Following a recent repair to the Hibernia ‘D’ cable, there was difficulty in reburying the cable to the required depth of 1 metre. Please note the section below which could only be buried to a depth of 30cm, this section also contains the repaired splice. Please exercise caution in this area.

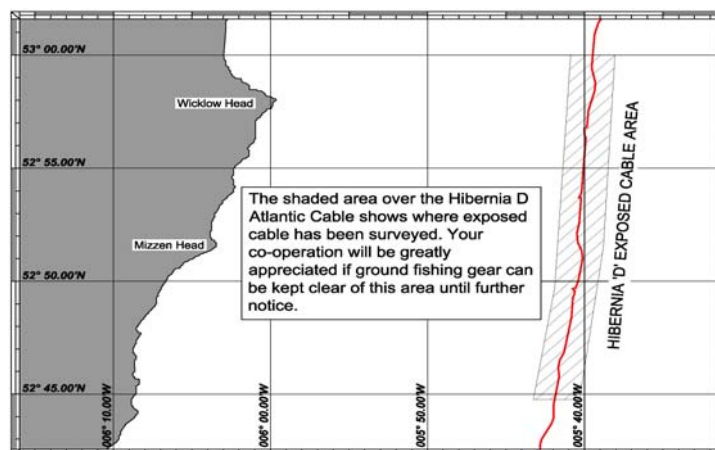
### Exposed Submarine Cable Section – Hibernia ‘D’

Please note that the Hibernia ‘D’ cable has been surveyed and has an exposed section. This is indicated in the map below.

The exposed section runs from 52° 59.433' N 05° 39.540' W to 52° 45.118' N 05° 41.797' W. For full details of the exposed cable route, please refer to Kingfisher Fortnightly Bulletin Issue 24 / 2006.

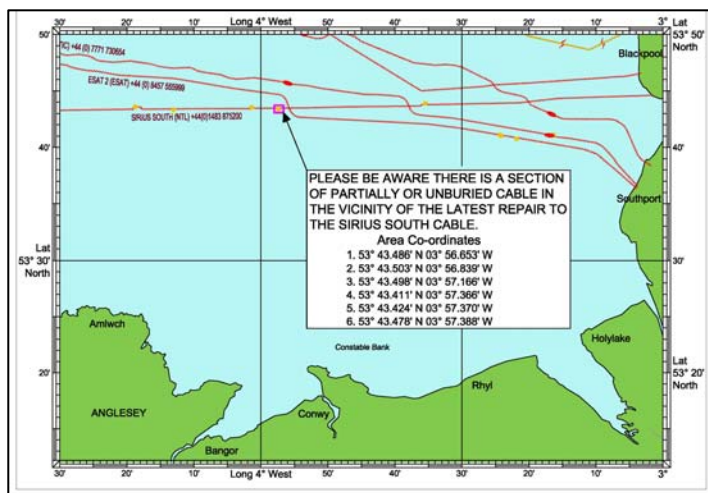
### Exposed Submarine Cable Section – Sirius South

Please note that the Sirius South' cable has been repaired and it was found that there is a section of exposed cable in the vicinity of the repair. Please see the map below showing the location of the repair.
