**Lochinver
Port Quality Audit**

Confidential Report No. CR157

February 1999

M. Myers
M. Emberton
February 1999

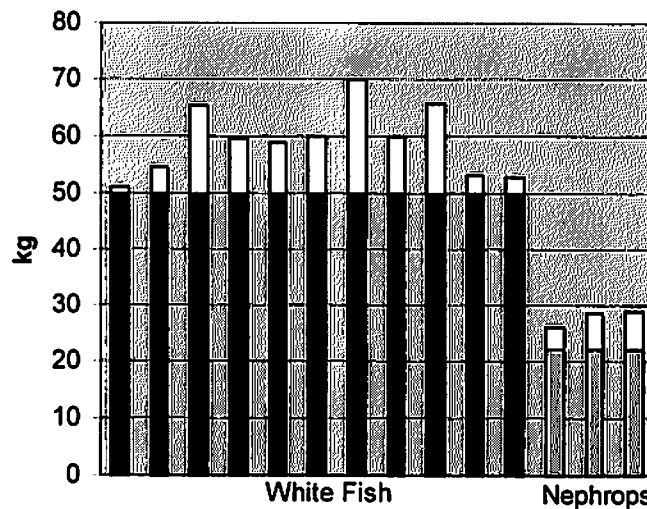
Figure 1 - Box overfilling

The overall average weight of fish found in a box was 57.9 kg; which is +1.6% over the accepted 57 kg port standard and well within the 5% legal tolerances of EU fish marketing regulations.

With regard to good boxing practice however the average weight of fish in a box is 15.8% over the recommended 50 kg above which there is danger of physical damage through crushing and loss of freshness caused by insufficient ice.

On average the boxes of Nephrops were overfilled by 47%.

Despite the levels of overfilling of boxes there was little sign of any physical damage either to fish or Nephrops but this may have been at the expense of freshness if insufficient ice was used.

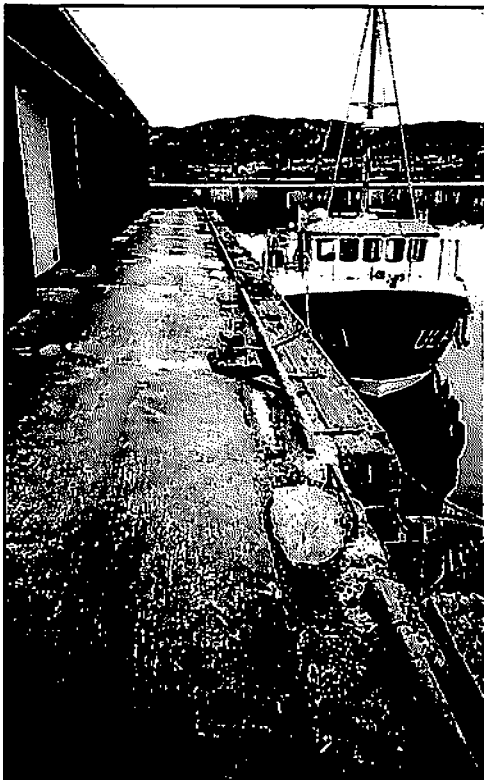
Figure 3 - The quaysides of the Culag Pier are in need of repair

The aprons of the pier are narrow and in poor condition (Figure No. 3). There is no drainage system. Ladders, rails and fenders have suffered serious damage and are in need of attention. (Figure No. 4). A survey commissioned by Highland Council has revealed that the piles supporting the pier are corroded in the inter-tidal zone and remedial work is planned to address these structural problems and repair of the aprons and fittings.

- 7.2.1 undertake various repairs to the fabric of the market, grading shed, quays and finger jetty.
- 7.2.2 improve the physical protection to doorways, wall pillars, canopies etc from damage by fork-lift truck or unloading operations.

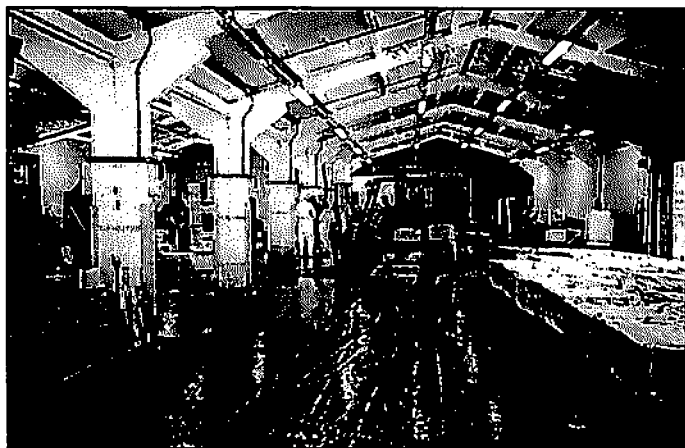
Forklift trucks and hand-pallet trucks are used for handling landings to and within the market and grading shed. The diesel-powered truck used in the grading shed is not suited for use in a food environment (Figure No. 6).

Figure 6 - Diesel truck used in the grading shed

- 7.2.7 replace wooden boxes used as support for the balances used to determine the 'count' of prawns with a more hygienic construction.
- 7.2.8 replace diesel trucks operating in the grading shed and market with electric or restrict their use to external operations.

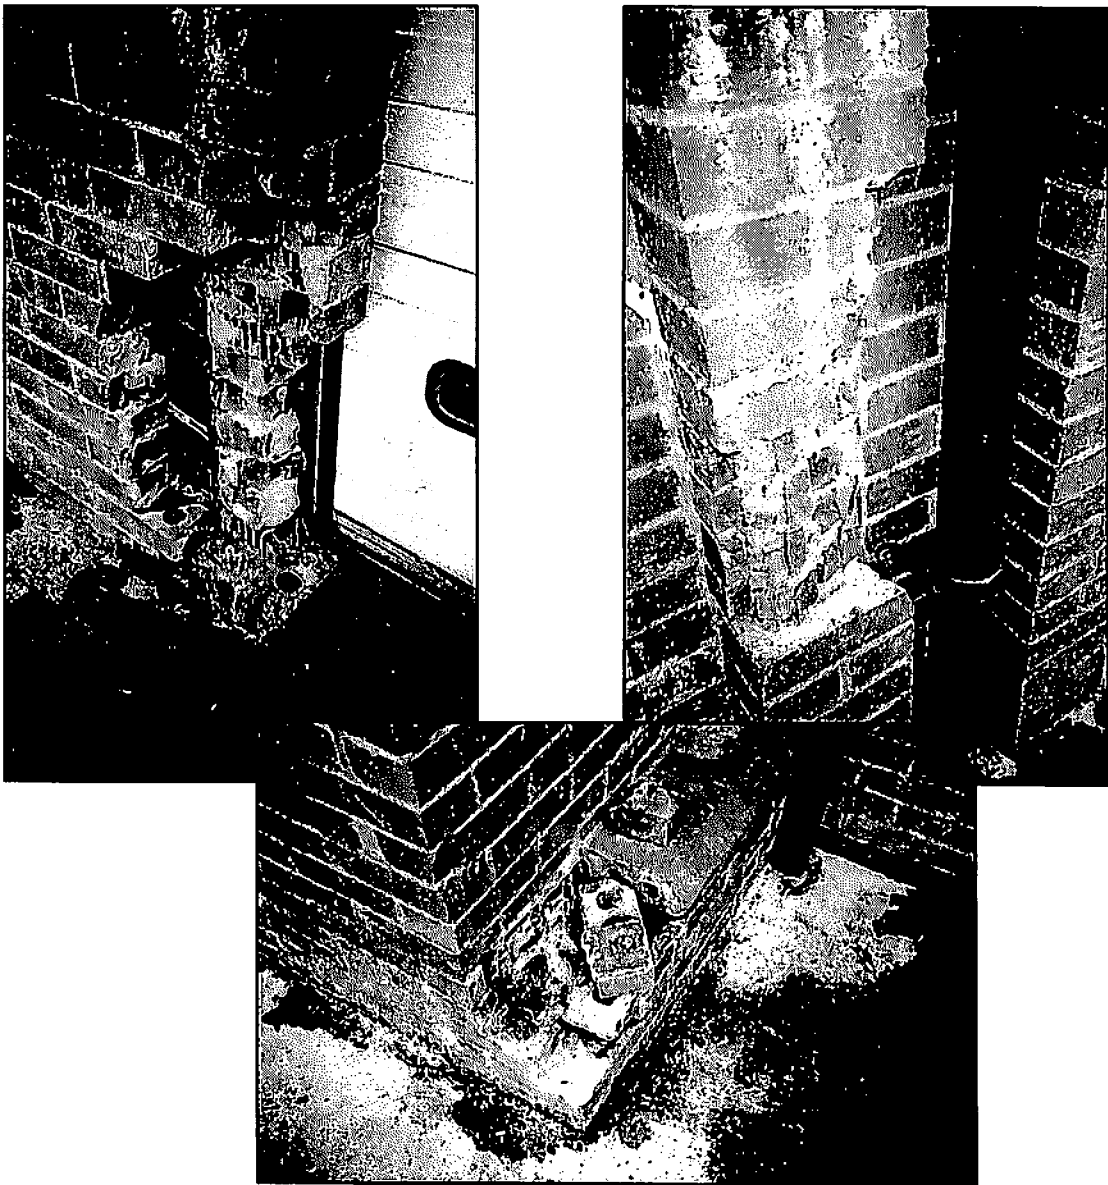
Although it is a relatively new structure it has suffered considerable damage both internally and externally by mechanised handling operations. Many of the doors, canopies, door architecture, and brick surrounds are damaged. (Figure Nos. 7,8 & 9).

Figures 7,8 and 9 - Damage to building structures

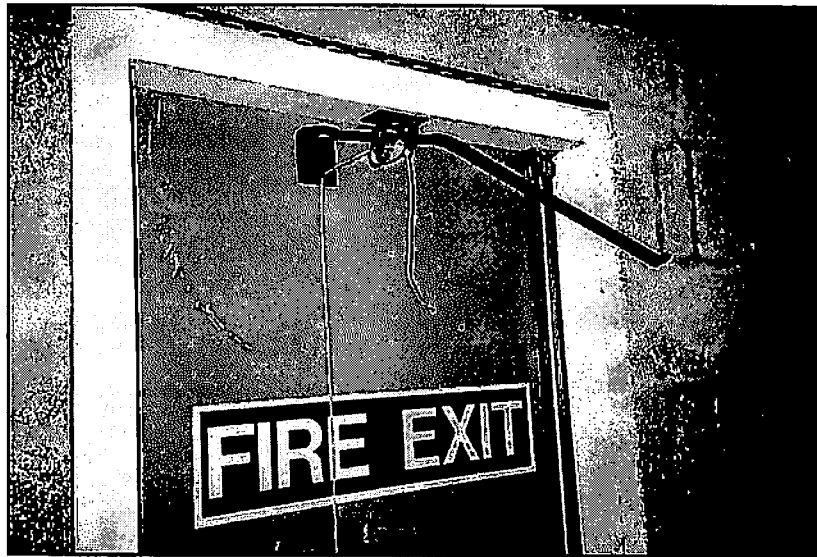
The market floor and the landing quay areas are not equipped with any mains drainage system but are graded to the dock (possibly in breach of environmental legislation?). The areas around the quayside doorways however were poorly drained, with standing water from meltwater or washdown. This has caused the wooden doors and frames of many of the fire-exits to swell making them difficult to open. In addition most of the doorway stays are bent and inoperative. (Figure 10).

Figure 10 - Damage to the doorway stays

- 7.2.3 undertake various repairs to fitments and fittings (fire-door stays, toilet sanitary ware, water hose-reels etc.)
- 7.2.4 consider a major refurbishment of the grading shed including; not only structural reinforcement but new drainage system, water supply, chilled holding and building structure. Alternatively consider the transfer of the operations to the fish market(?)

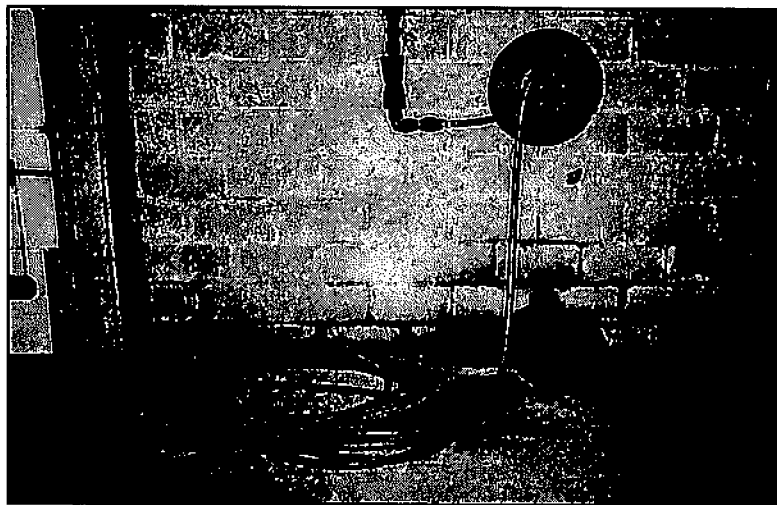
Many of the hose reels along the south side of the market have been damaged by misuse. (Figure No. 11).

Figure 11 - Damage to hose reels

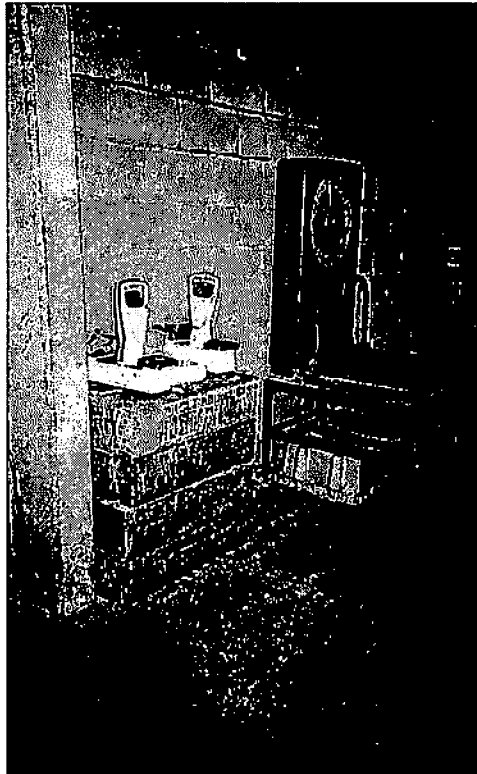
Most fish sold by auction is sorted and graded at sea and sold as standardised boxes, and other than forklift and pallet trucks, and platform scales for check-weighing, there is no requirement for sorting and weighing equipment. Balance scales are provided for determining the 'count' of Nephrops supported on unhygienic wooden boxes. (Figure 13).

Figure 13 - Wooden boxes used as a platform for weighing equipment

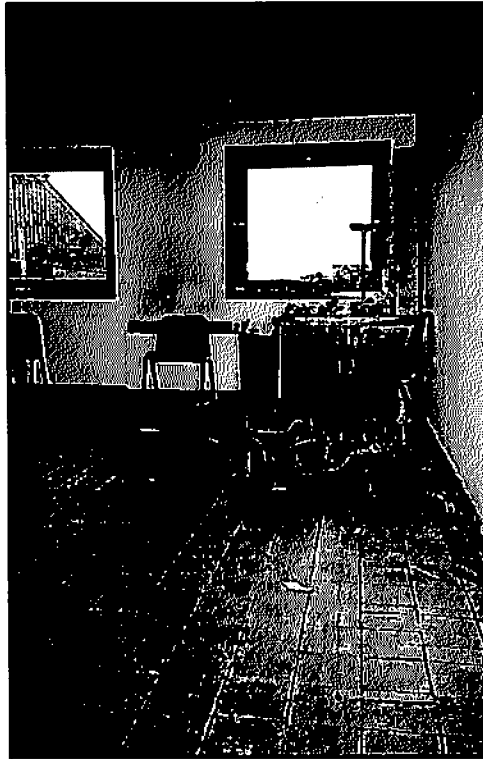
The standards of cleaning and hygiene in both the market and the grading shed could be considerably improved. The main sales area of the market was maintained clean and tidy but the toilet/washroom and the kitchen/canteen areas were not (Figure No. 15).

Figure 15 - Dirty and untidy staff facilities
