**Plymouth  
Port Quality Audit**

**Confidential Report No. CR 148**

September 1998

This report presents the findings of a Quality Audit of the new fishing complex at Sutton Harbour, Plymouth. The audit examined the quality of fish supplied to the market, standards of physical infrastructure, operating practices and management controls.

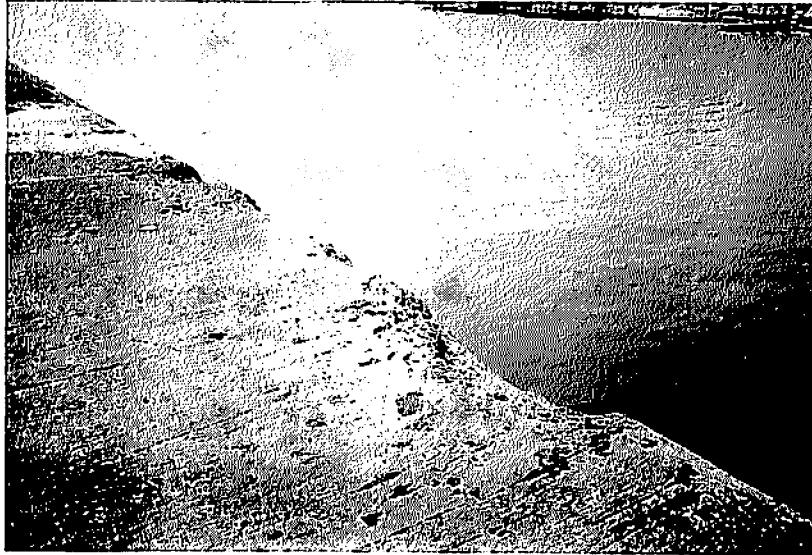
The new deep water landing quay is well situated allowing landings directly into the market building. The quay is spacious and well lit. If the main landing quay is busy, boats may also land round the corner by the ice berth on Baylys Wharf. However, the concrete margins on this quay have suffered from impact damage from vessels. The resulting defects are a potential hazard for pedestrians and vehicles (Fig. No. 3).

**Figure 3 - Damage to edges of quayside**

- Chill room floor
- Concrete margins of quays
- Electrical connections on crane
- Solve problem of slipping wires on cranes
- Clear gutters and consider fitting gutter guards
- Repair door opening on box washing shed
- Improve ramp into box washing shed
- Collapsed drain covers
- Damaged traffic bollards
- SHC to provide additional manpower for maintenance duties

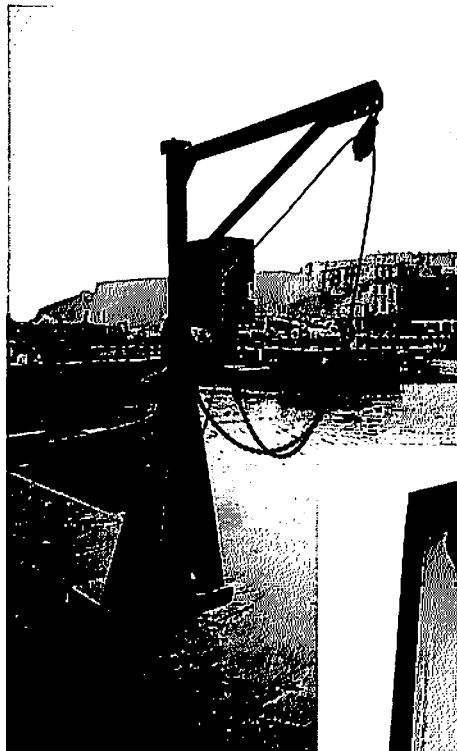
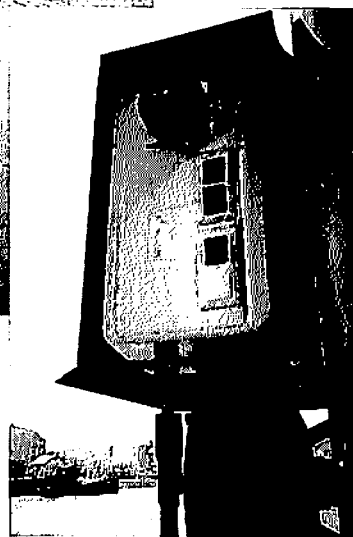
Three shore based static electric cranes were available to land smaller vessels. There was a persistent problem with the wire on the winch barrels slipping and causing boxes to fall off the lifting hooks. A poor electrical connection was observed on one of the crane motors (Fig. 4). Larger boats tended to use their own derricks.

**Figure 4 – Landing crane with inset showing poor electrical connection**

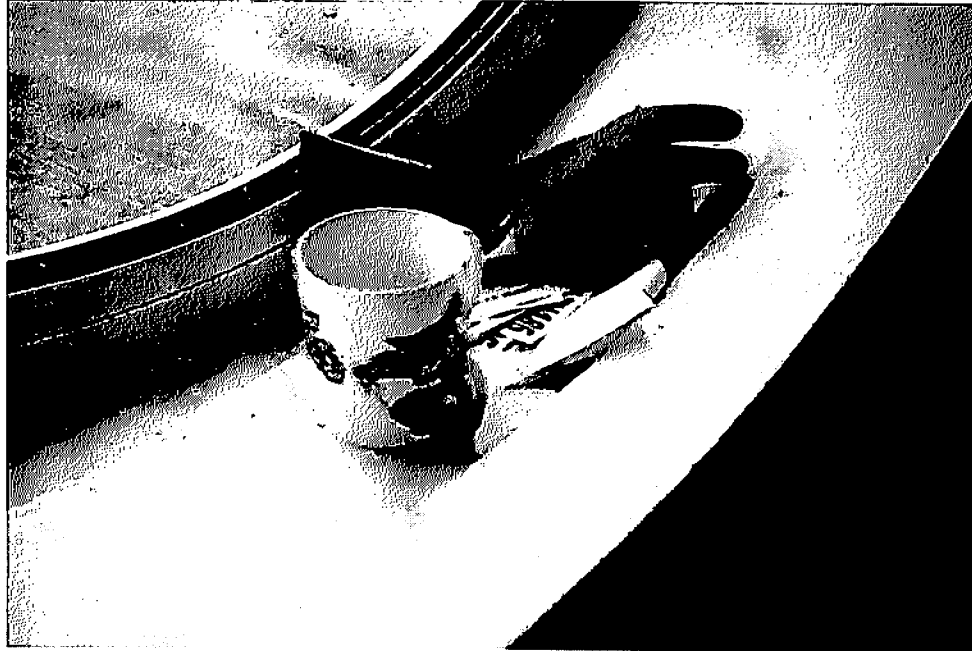
The circular window design has proved to be poor. The glazing is set almost flush with the outer skin of the building and as a result it has suffered from breakage. The internal sills are deep and have no drainage. Consequently, they attract litter and also hold water after washing. This latter problem is made worse due to the use of ungalvanised steel which is beginning to corrode (Fig No. 6)

**Figure 6 – Litter, personal items and water collect on market window sills**

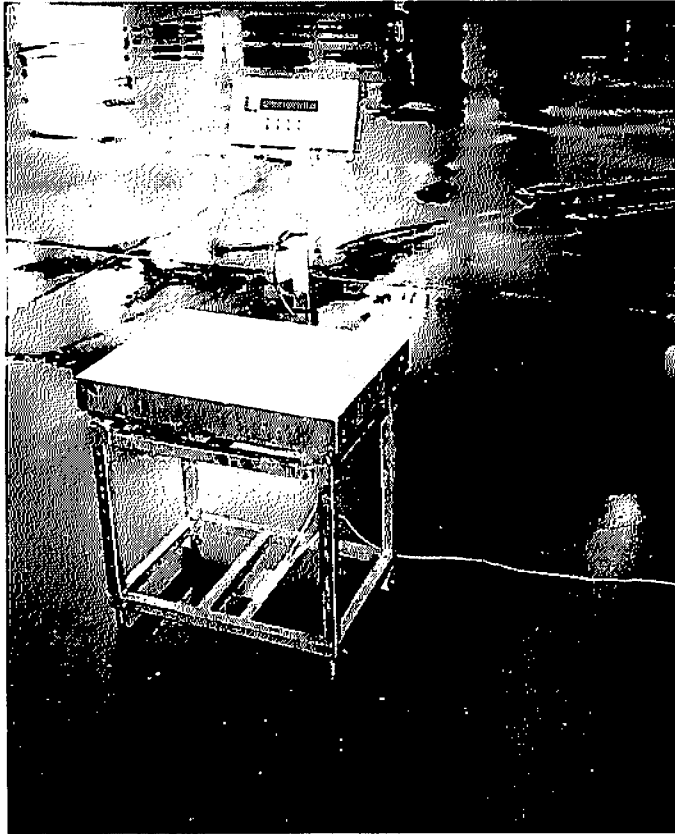
**Figure 8 – Cables which prevent passage of pallet trucks**

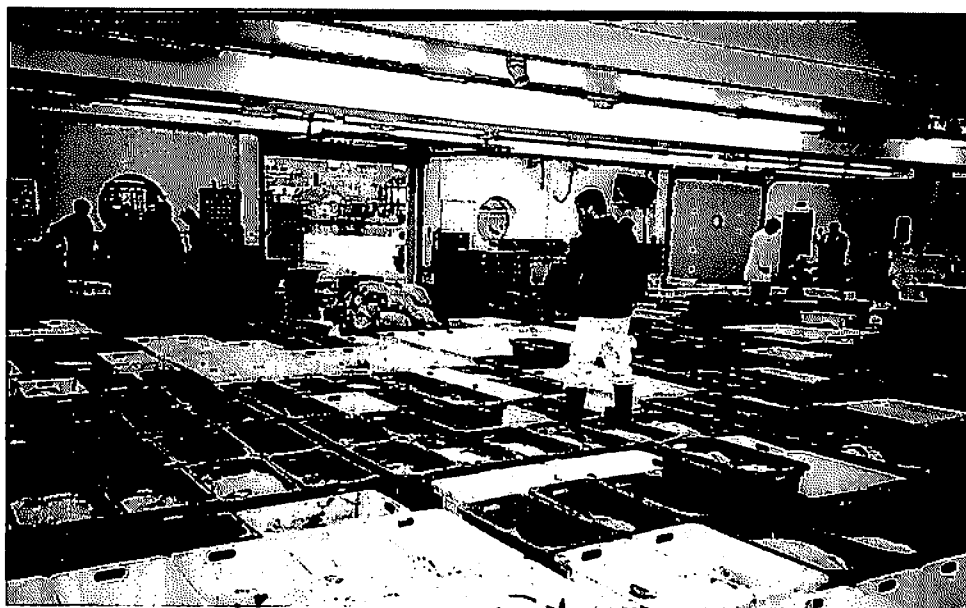
**Figure 9 – Floor space taken up by part-filled boxes**

Early viewing commenced at 0530hrs, one hour ahead of the auction. Because Plymouth fish is pre-sorted and weighed, we did not observe any of the box tipping problems so common in other ports. Clearly it was easier for buyers to see what they were buying. However, PTA staff failed to provide adequate walkways between boxes, and buyers were forced to cross boxes by walking on them (Fig 9).

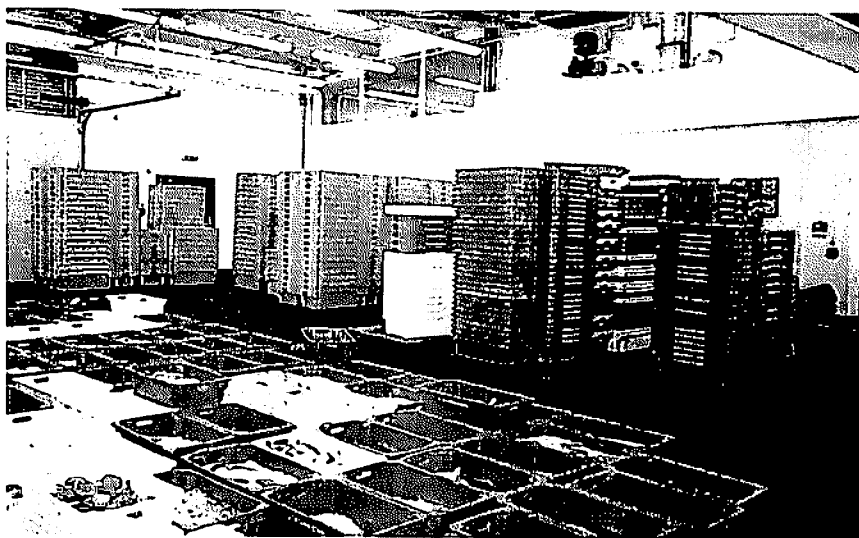
Laying out began at 0500hrs. The fish were removed from the chill and set out on the auction floor, grouped by vessel and species. Large single species lots such as Dover Soles from beamers were stacked in batches by size grade on plastic pallets. Small lots (predominantly day boat fish) were laid out unstacked. At the time of the audit most of the auction floor was occupied by unstacked boxes, which in turn were mostly only part filled (Fig. 9). Again, it was easy to envisage how the floor space, if used in this way, could become inadequate during large sales. The potential problem was made worse as some of the market floor was also being used to store unused boxes (Fig. 10) and vessel stores (see Section 4.8).

**Figure 10 – Spare boxes take up valuable market space**

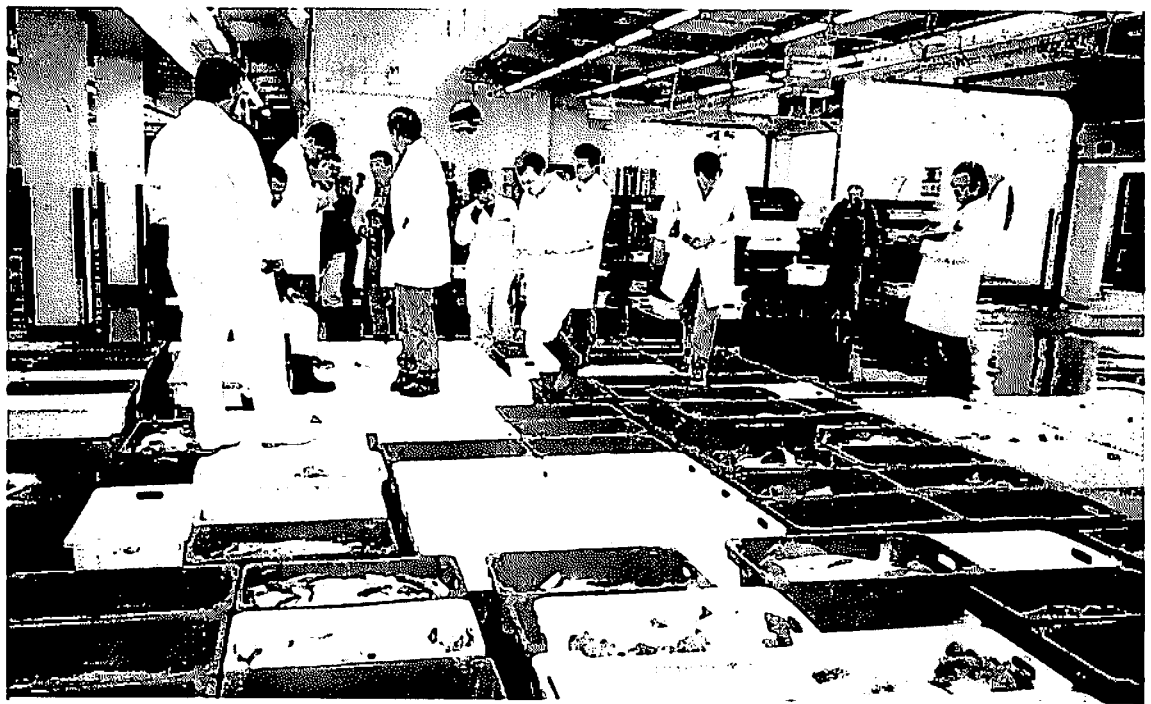
Dress was generally good but very few participants were wearing hats. Despite recent efforts to improve behaviour, some eating, drinking and smoking was observed. Many buyers were standing on boxes (Fig 11).

**Figure 11 – Buyers standing on boxes**

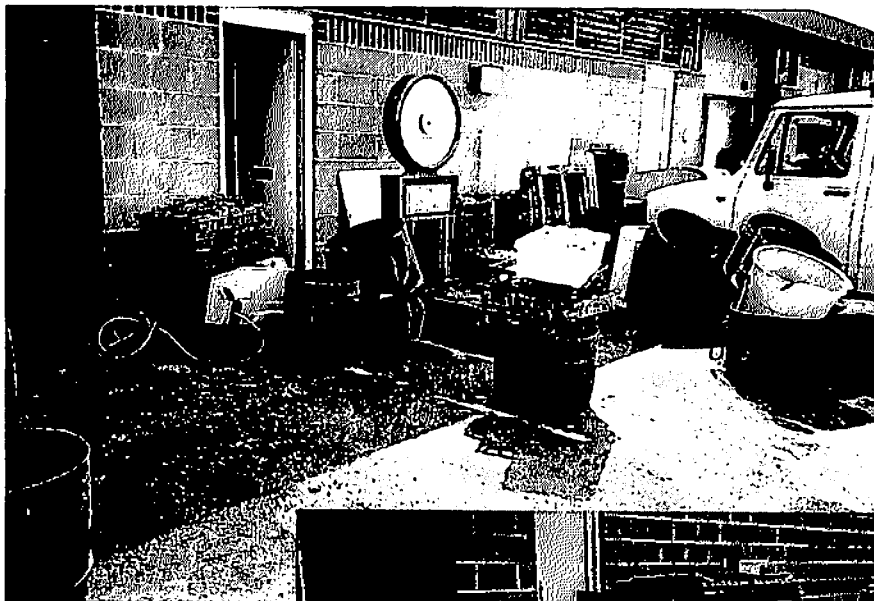
The cleaning of the roads is the responsibility of Plymouth Fisheries. A Bobcat tractor with brushes is used for this. Responsibility for the merchants' yards lies with the respective tenants. However, there is a persistent problem of smelly fish waste from some of the yards running onto the roads. The source of the problem is poor waste storage practice by some merchants' units (Fig 13). The containers used for waste are unsuitable as they allow liquid waste to leak onto the yards and roads. In addition, they are commonly overfilled so that the lids (if they have any) do not close. Odours have been so bad that a leisure business 100 m from the fishing complex reported a suspected gas leak! This is unacceptable from a hygiene point of view, is a public nuisance, and the bad odours project a very poor image to the public. In fairness, the tarmac surface is not ideal for fish industry premises. It is subject to attack from fish oils, and has a porous surface that is difficult to clean. In addition, the waste channel is located on the wrong side of the road for convenient use by the processing units. However the root of the problem lies in poor waste handling equipment and bad practice.

**Figure 13 – Bad practice and poor waste handling equipment outside some merchants' units**

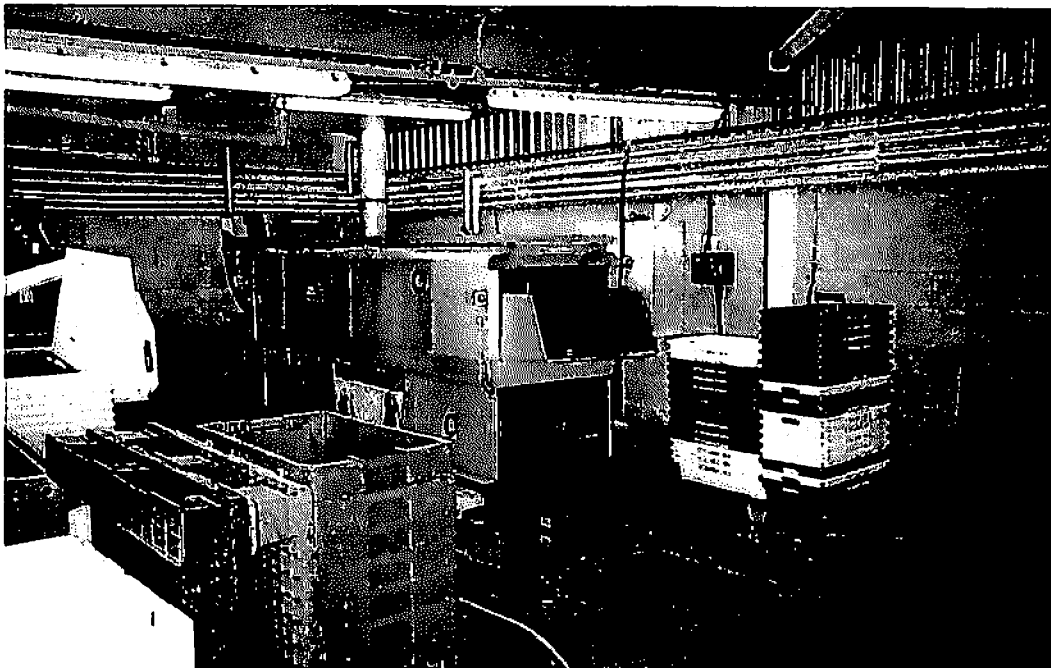
Cleaning of both sets of boxes is carried out by Plymouth Fisheries in a separate building across the yard from the fish market. Storage for dirty boxes within the box washing shed is very limited due to the space required for a Bobcat tractor and a row of bins used to soak heavily soiled boxes (Fig 14). The box washing machine is manually fed.

**Figure 14 – Space within the box washing shed is limited**

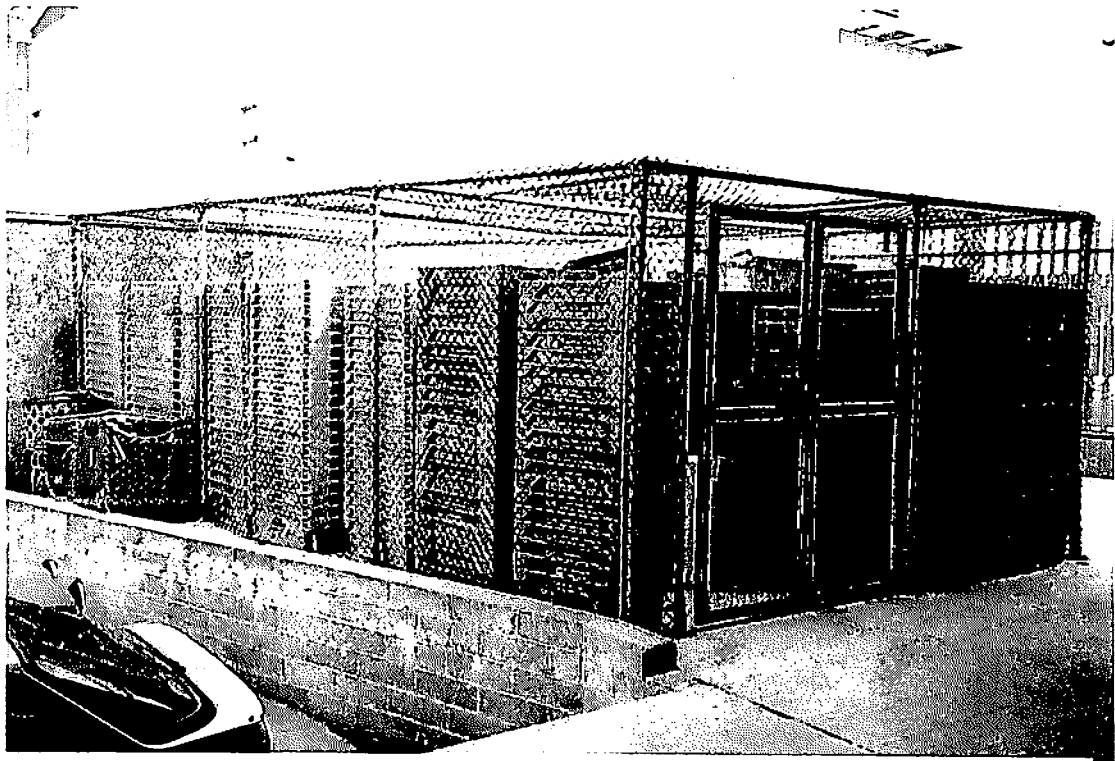
The only dedicated storage for clean boxes was within an outdoor cage between the box washer and the market (Fig 17). This space was far too small and the market and chill spaces were routinely used to store excess boxes.

**Figure 17 – The box store is too small**

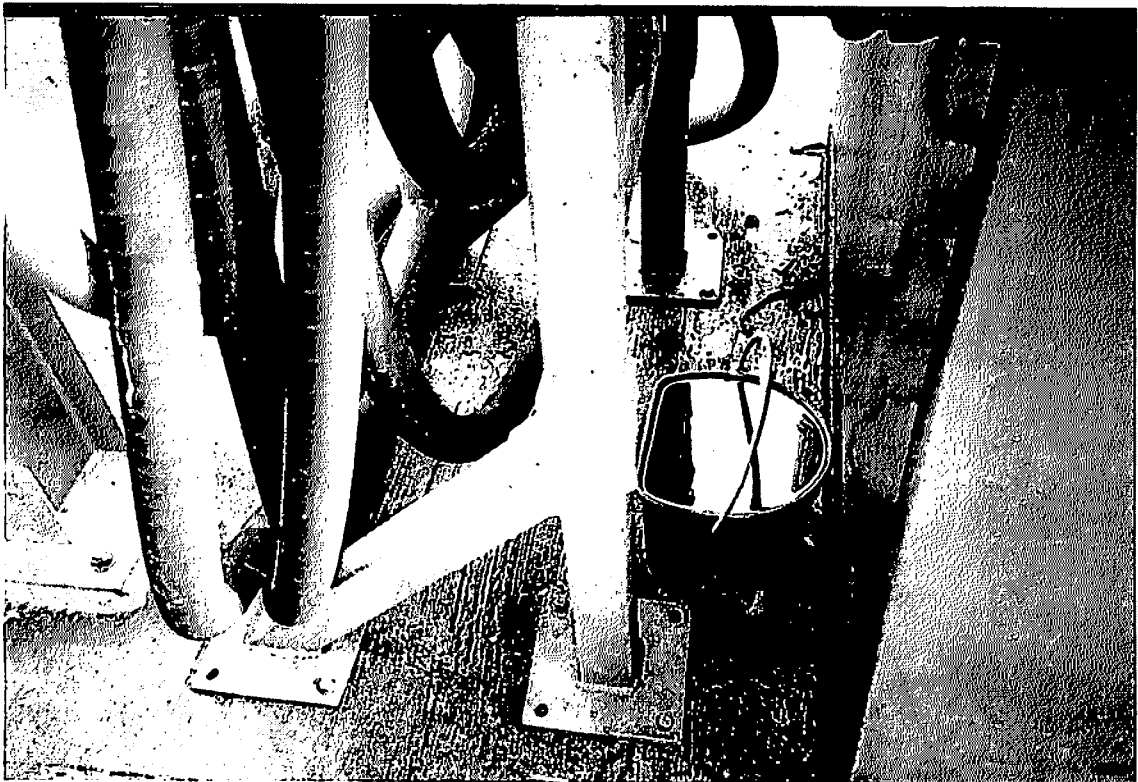
Combined, self-service water and fuel points are located at intervals along Baylys Wharf. Fuel is available using a convenient credit card system. It was noticed that diesel was leaking from the fuel point located by the ice plant (Fig. 19). The spilled diesel had made the quayside very slippery and hazardous to operators and passers-by. A fuel leak at an ice berth also poses a considerable contamination threat. The lack of main's water pressure means that it can take a long time to service vessels with large tanks (as confirmed by visiting beamer skippers). The delivery points are situated along the major berthing quay and this could lead to access problems when the port is busy.

**Figure 19 – A bucket is used to catch fuel from a leaking pipe**

- Consider the installation of a pump to speed water delivery
- Repair leaking fuel pipe at ice berth delivery point
- Keep at least one self-service point free of berthed vessels and available at all times

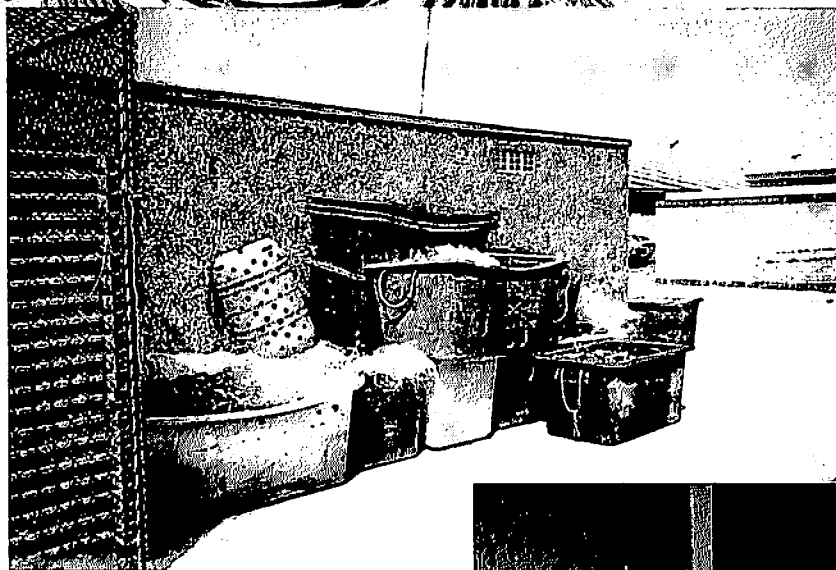
**Figure 22 – Bins of nets clutter the site**

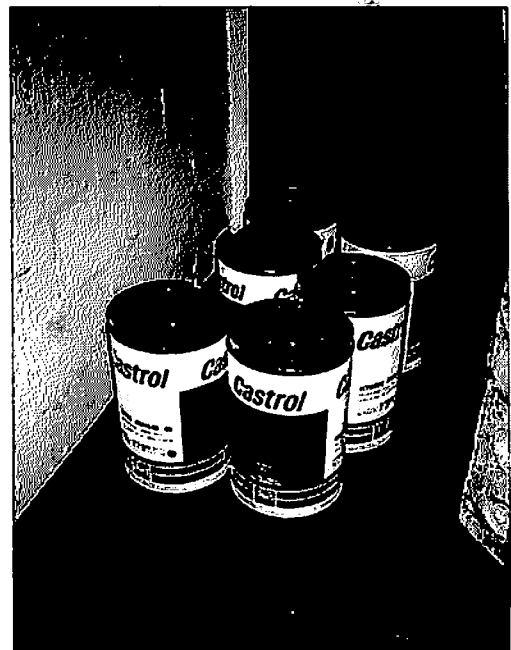
The expanding fleet has brought increased demand for gear storage and mending facilities. Unfortunately the dedicated gear stores originally planned were never built, and there is no longer room on site to provide them. At present there is a communal gear cage at the entrance to the complex, but this is inadequate. The increased beamer trade has brought a corresponding increase in heavy gear left on quays (Fig 21). This obstructs quayside access by vessels and service vehicles and has become a major problem. There are bins of static nets cluttering the site (Fig. 22). The fishmarket itself is currently being used as a depot for gear and supplies awaiting collection by vessels (Fig 23).

**Figure 23 – The market floor is used as a depot for vessel stores**

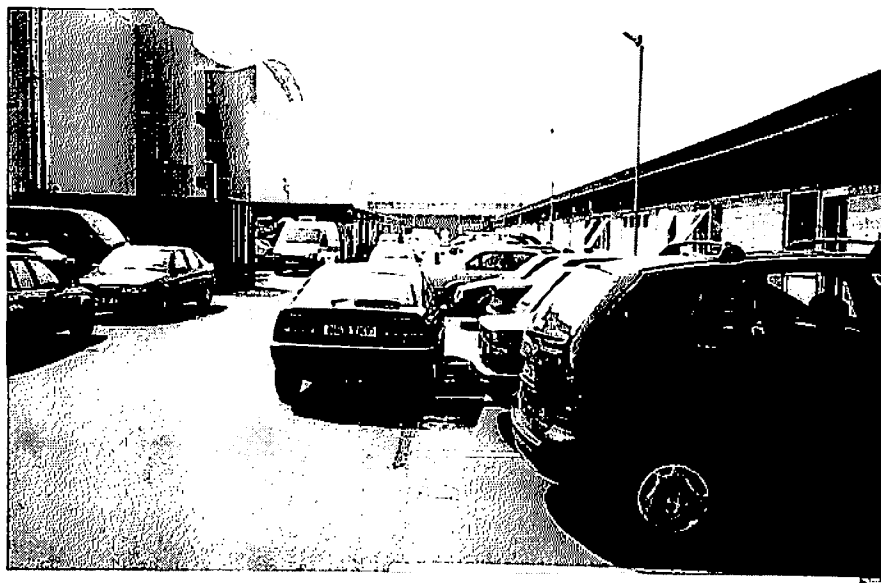
Whilst there is unrestricted access by commercial vehicles, private cars are limited to passholders and retail customers of fish merchants. There are 140 permits allocated for private cars, and these then compete with commercial vehicles and retail fish customers for the 90 available parking spaces. A survey conducted during the audit showed that there were 106 private cars, 39 commercial vehicles and 4 lorries competing for the spaces (Fig 24). There has been some accidental damage to cars parked (illegally) too close to vessels. Congestion and parking problems have both become a chronic daily nuisance and a major source of discontent for all site users.

**Figure 24 – Private vehicles predominate**

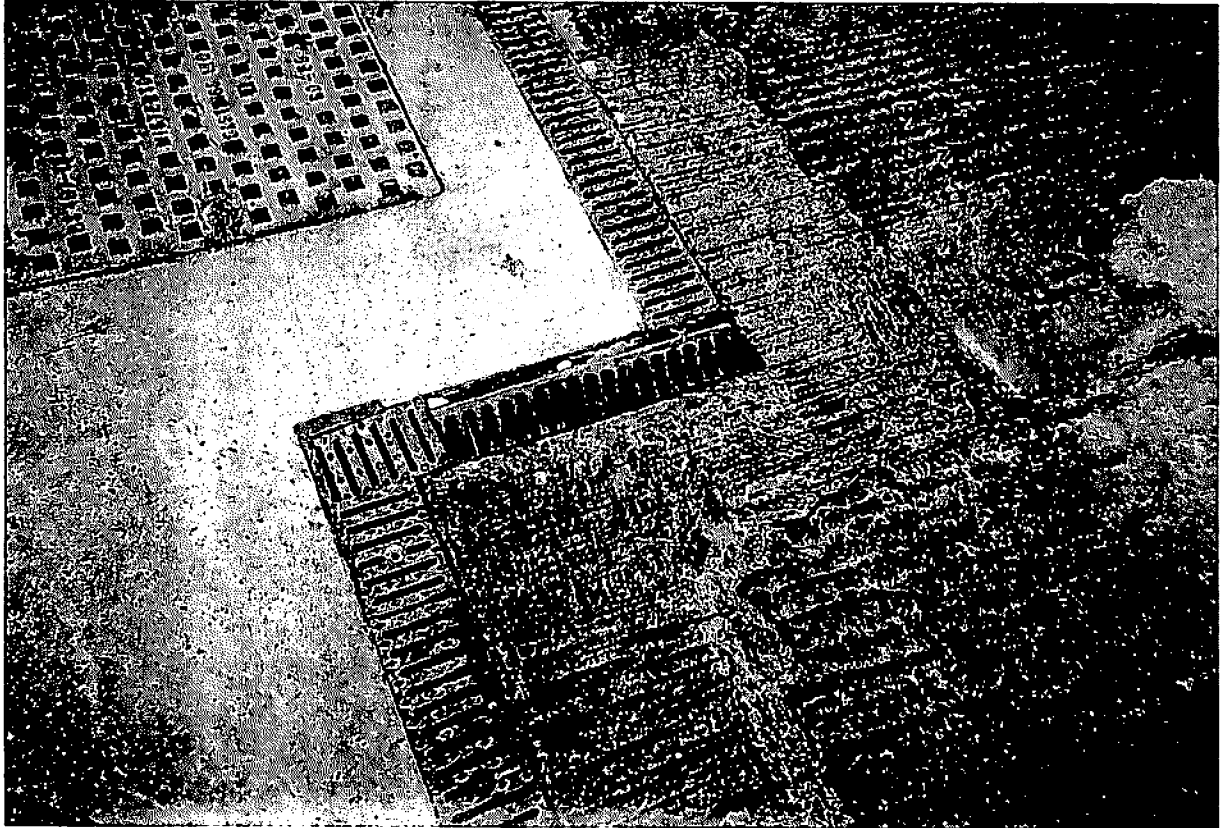
The roads and yards are generally in good condition. Some repairs are necessary to damaged bollards and a collapsed drain (Fig 25).

**Figure 25 – Collapsed drain cover**
