**INVESTIGATION INTO ELECTROMAGNETIC**  
**PROBLEMS ON MFV GRADLEY**

**Internal Report No. 1311**

**April 1987**  
**K. Hairsine**

## ELECTROMAGNETIC EMISSION SURVEY OF MFV GRADELEY, HAYLE, CORNWALL

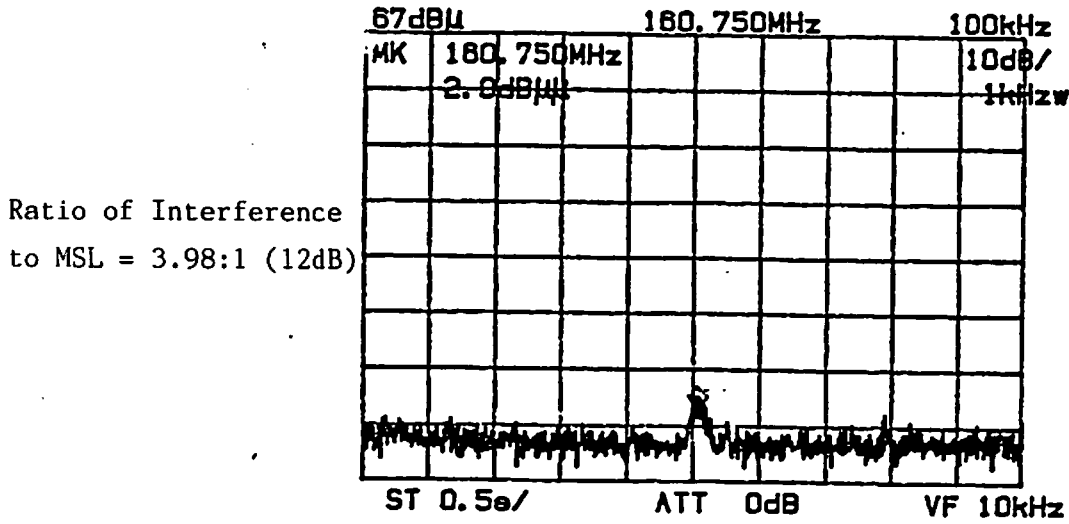
Figure 1

The receiver specifications state that the minimum input level to the receiver is 0.3 uV (-10dBuV). Figures 1 - 3 in Appendix 2 show the signals presented to the receiver from the two main VHF antennae on the vessel, with the plotter in its operating position. The main VHF antenna is situated on the gantry at the stern of the vessel approximately 6m from the plotter, while the Scanner VHF antenna is situated on the wheelhouse roof approximately 1m from the plotter. It can be

observed. The results are plotted in figures 1 - 3, and clearly indicate levels far in excess of the receiver's sensitivity of 0.3uv for 20dB's of quieting. A similar test was made with the Autopilot and the results are shown in figures 8 and 9.

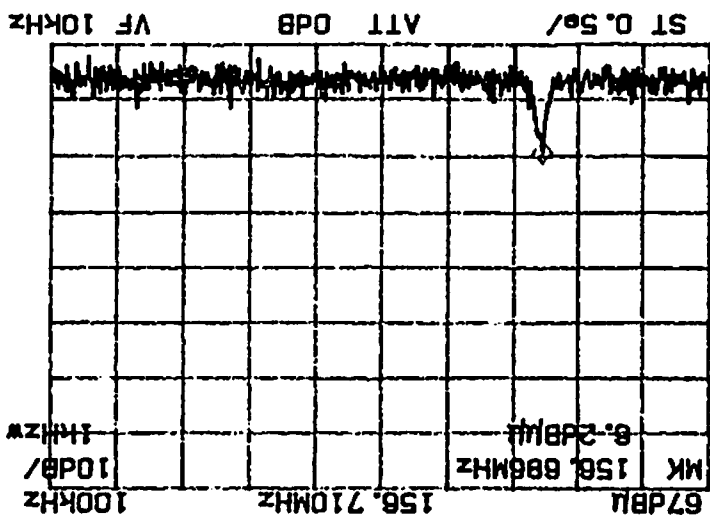
Figure 7

The particular carrier which blocked channel 74 was observed on the analyser. Plots of this were taken for the 10cm electric dipole inside the ballast and against parts of the cabling loom. These are shown in figures 4 - 7.

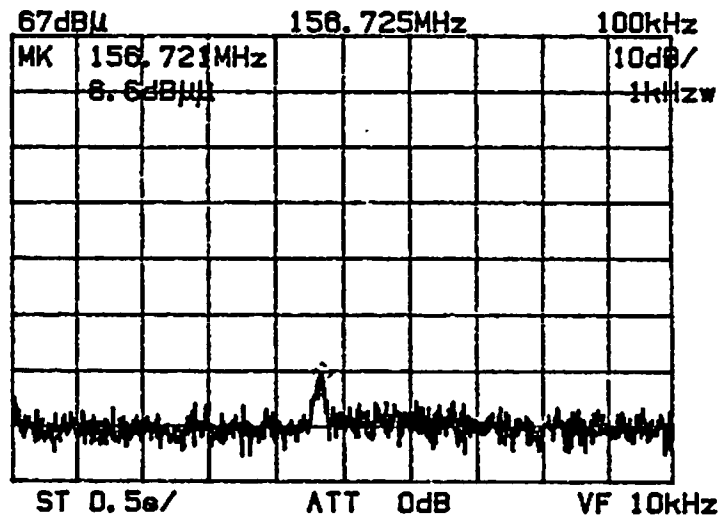
- Figure 9            As Figure 8 for main VHF antenna
- Figure 10           Signal level at the scanning VHF antenna input with the ballast removed, as a result of Autopilot radiation
