# Kingfisher Fortnightly Bulletin

Subsea Cables

9<sup>th</sup> December 2010

Issue 25 / 2010

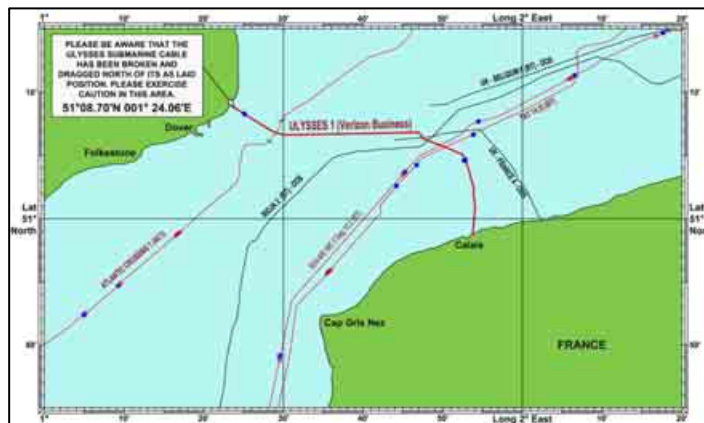
## Hazardous Condition of Cable – Ulysses South landing - St Margaret's Bay

Further to earlier Notices, the Ulysses South submarine cable landing at St Margaret's Bay, near Dover, remains broken at a position:

51°08.70'N 01° 24.06'E

This position lies approximately 1.3km offshore in a water depth of 15 metres. As a result of this fault, the cable at the approaches to St Margaret's Bay has been dragged an indeterminate distance to the north of its as laid route on either side of the fault position. Caution should therefore be exercised in this area until the cable repair operation has been carried out.

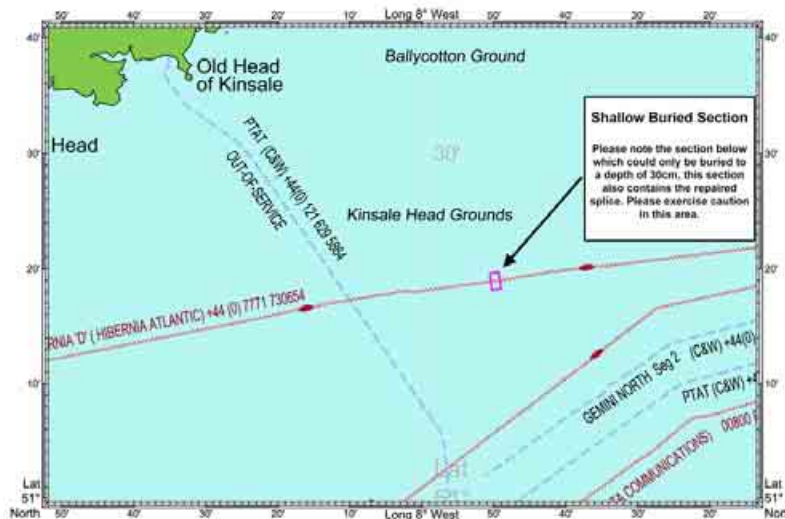
#### Shallow Buried Section

### Shallow Burial of Submarine Cable Section – Hibernia ‘D’ (New Entry 25-11-2010)

Following a recent repair to the Hibernia ‘D’ cable, there was difficulty in reburying the cable to the required depth of 1 metre. Please note the section below which could only be buried to a depth of 30cm, this section also contains the repaired splice. Please exercise caution in this area.

1. 51°18.893'N 007°50.289'W
2. 51°18.903'N 007°50.229'W
3. 51°18.997'N 007°50.127'W
4. 51°18.998'N 007°50.120'W
5. 51°18.927'N 007°50.011'W
6. 51°18.951'N 007°49.641'W
7. 51°18.974'N 007°49.336'W

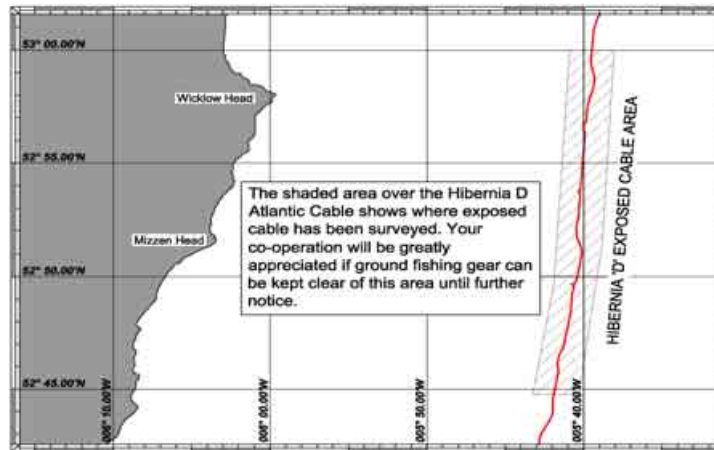
### Exposed Submarine Cable Section – Hibernia ‘D’

Please note that the Hibernia ‘D’ cable has been surveyed and has an exposed section. This is indicated in the map below.

The exposed section runs from 52° 59.433' N 05° 39.540' W to 52° 45.118' N 05° 41.797' W. **For full details of the exposed cable route, please refer to Kingfisher Fortnightly Bulletin Issue 24 / 2006.**

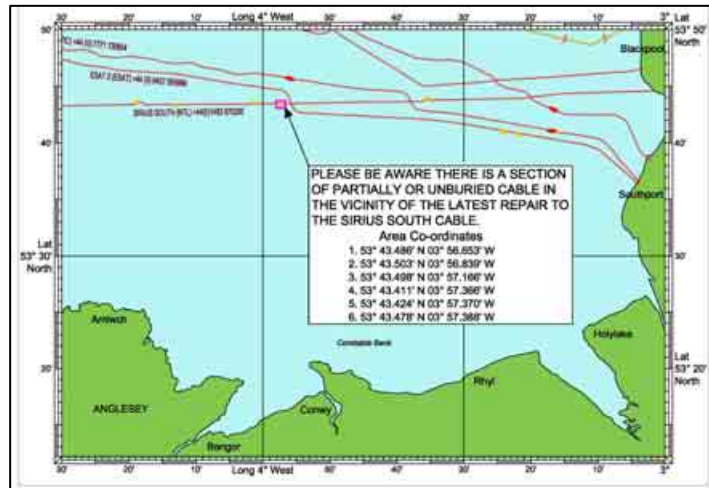
### Exposed Submarine Cable Section – Sirius South

Please note that the Sirius South' cable has been repaired and it was found that there is a section of exposed cable in the vicinity of the repair. Please see the map below showing the location of the repair.
