Bio-fuel engine test cell facility

An abstracted report from the Biofuels for the Fishing Industry project

February 2008

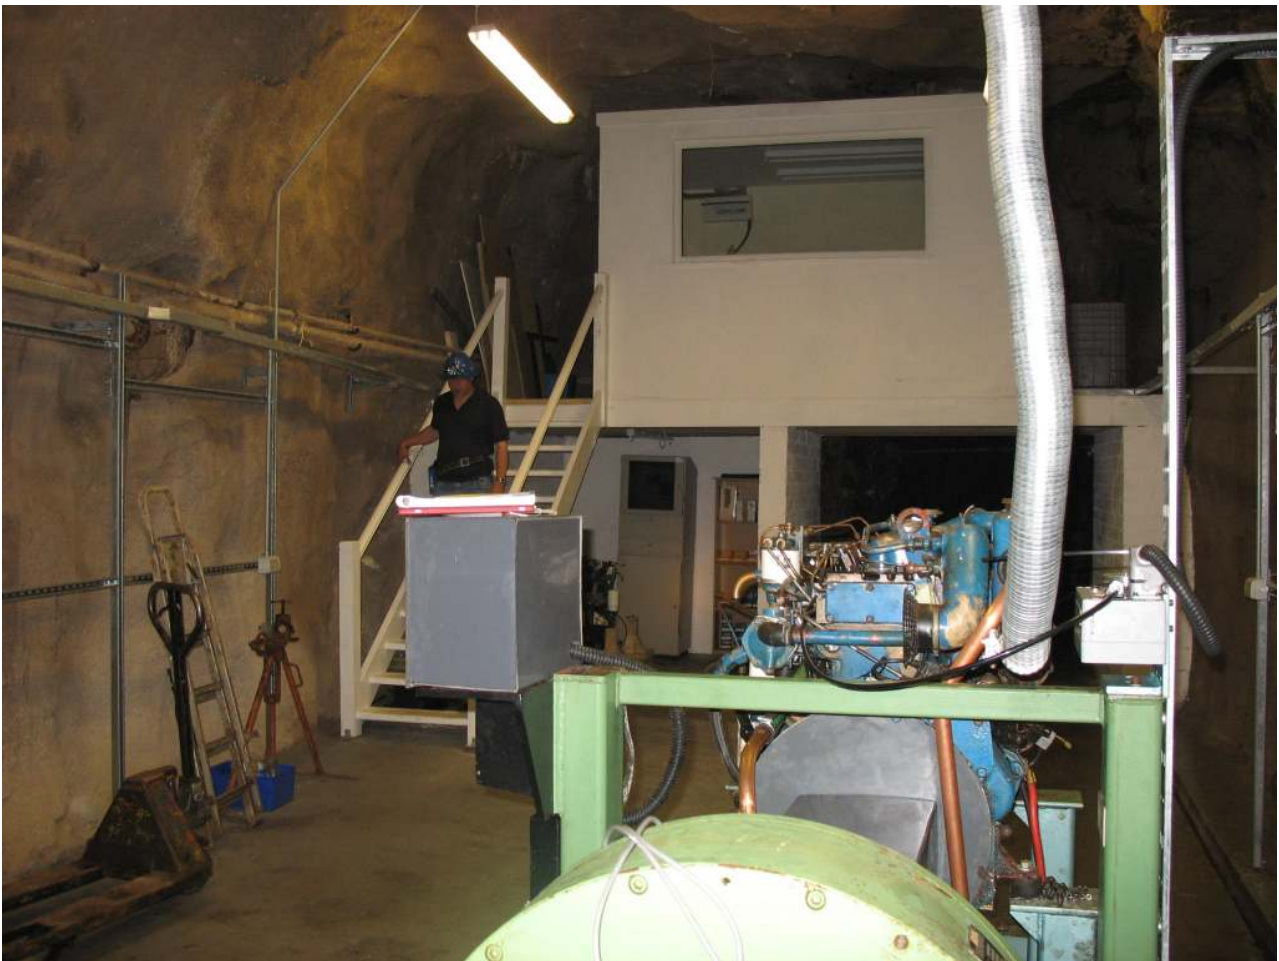
Figure 1: Photograph of the bio-fuel engine test cell facility underground at the CSM Holman's Test Mine. The top of the photograph shows the test cell control cabin. The dynamometer is in the foreground in green, the test cell engine is in blue.

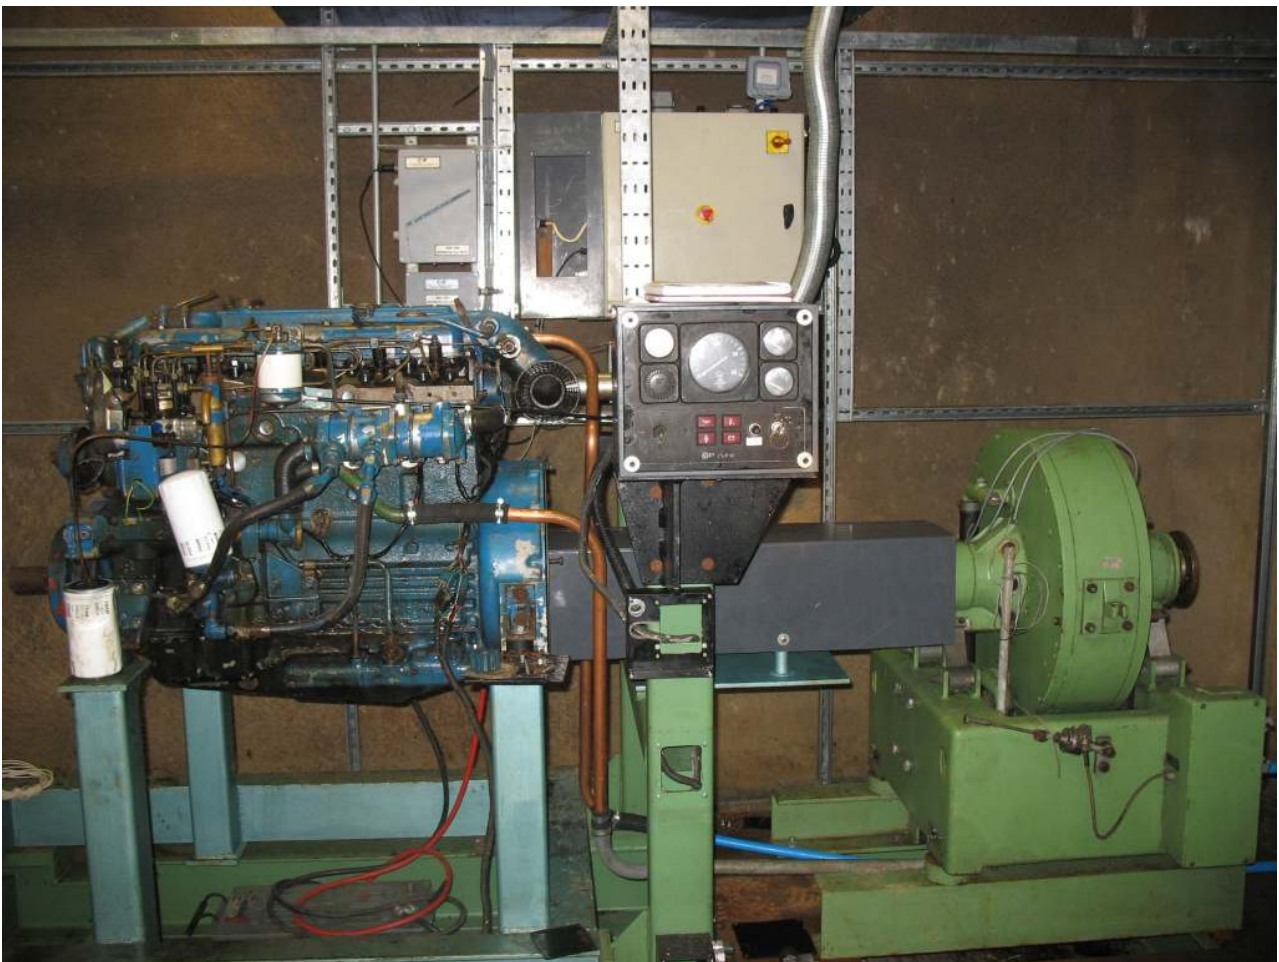
Figure 2: Foreground – Test engine (blue) and dynamometer (green). Background – data acquisition housing (RHS) and fuel measurement system housing (LHS).

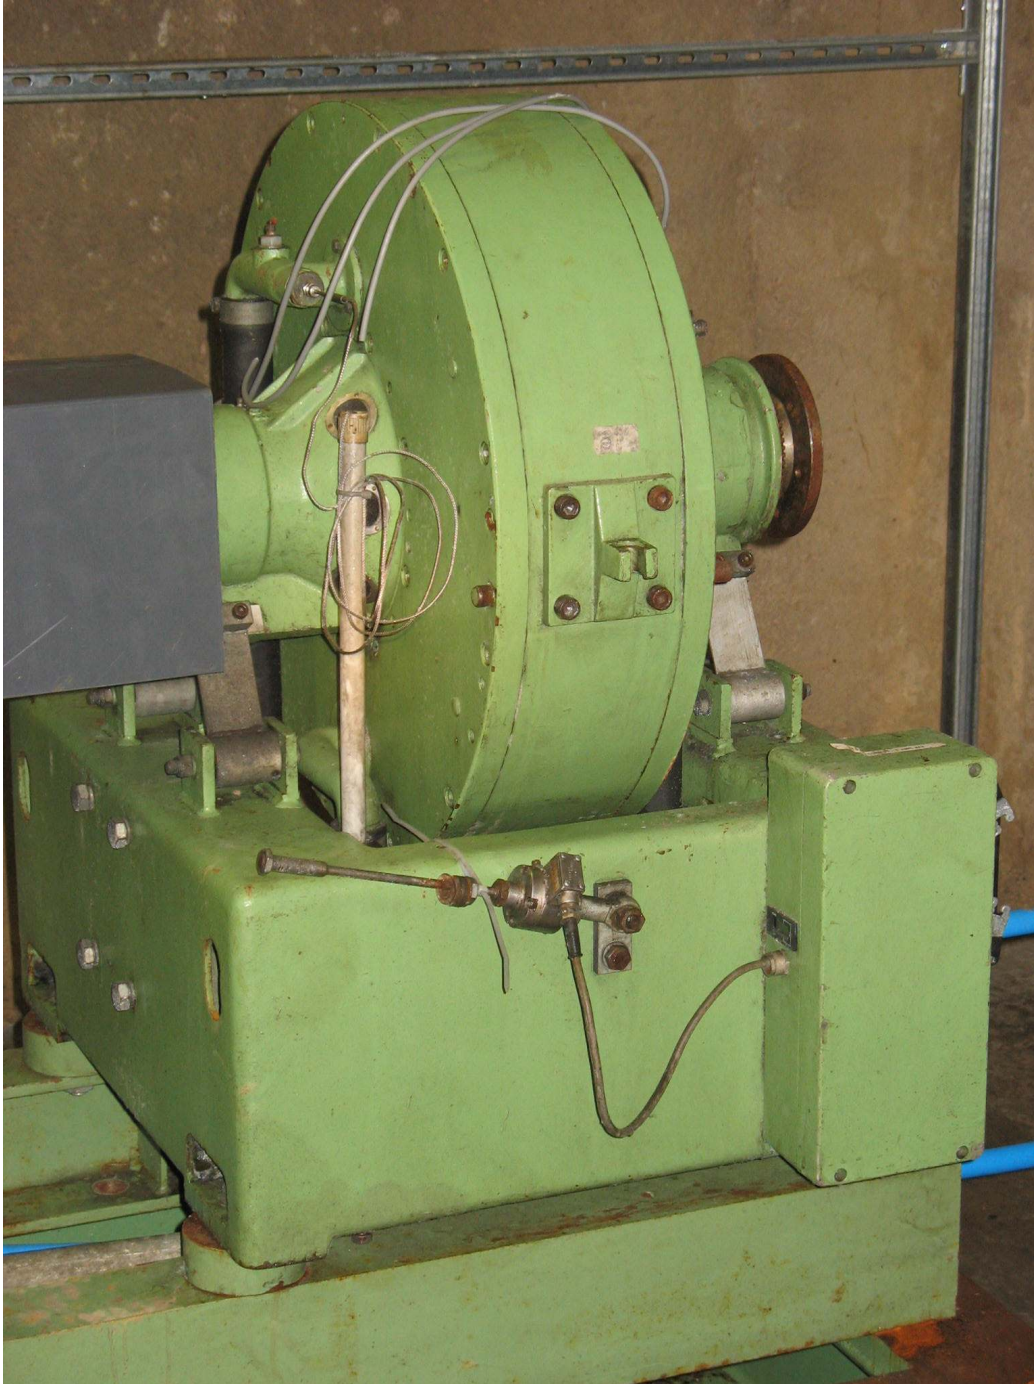
Figure 3: Dynamometer detail (N.B. Load cell unattached)

The German manufactured Schenk W230 had ample capacity across the range and also allowed for an increase in capacity, if required, in the future. The W230 can be crudely interpreted as having a maximum mechanical power of 230kW.

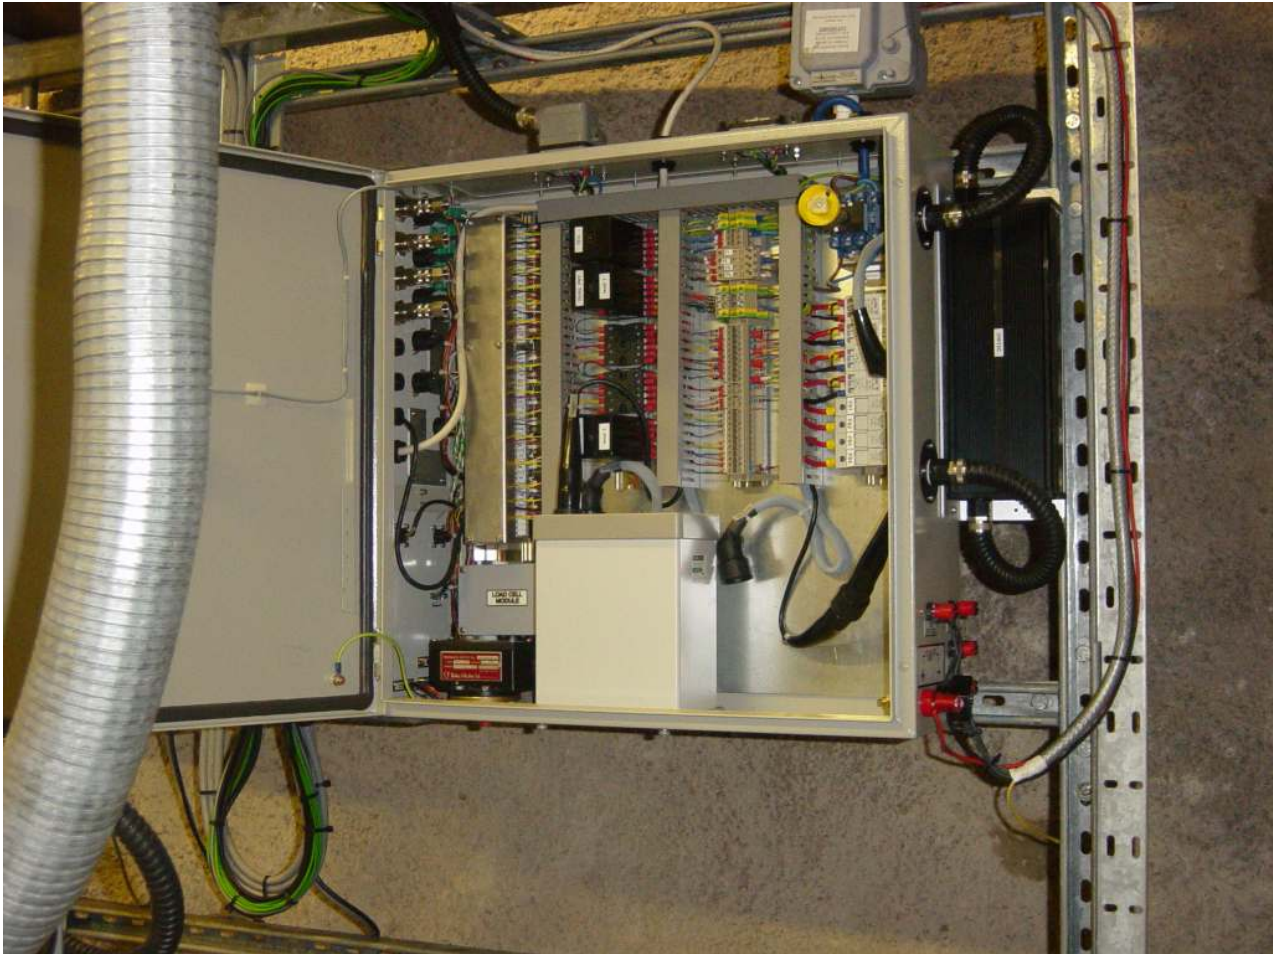
Figure 4: Data logging and control hardware

The data logging and control hardware is built into a 19" sub-rack. The backplane is fitted with a three row 64 way power supply connector and twelve two row 64 way sockets each of which is associated with a card slot identified as 2 through 13. On the rear of the backplane 10 of the 64 ways are linked to rearward facing 10 way connectors. All signals from the external system are connected to the cards via these 10 way connectors. In a CadetLite system the 13 backplane slots are used as follows:

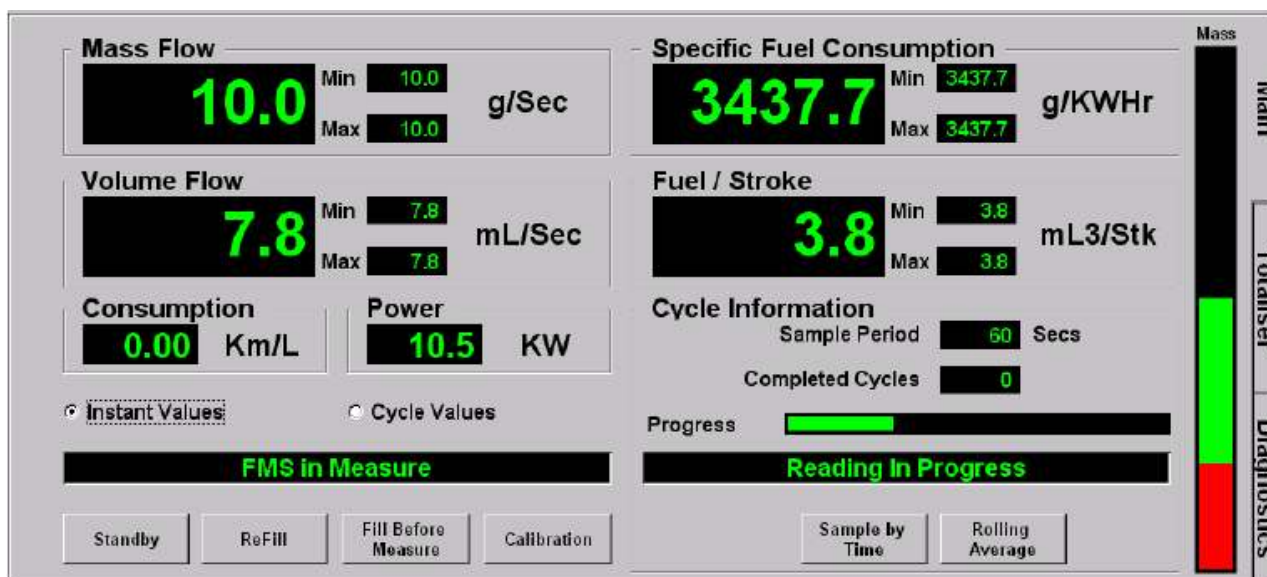
Figure 5: Fuel measurement system main display panel

The FMS system employed is relatively simple in concept and operation. The system functions by dosing approximately 1 kg of fuel into a vessel that is in the fuel delivery line between the header tank and the engine. Return fuel from the engine is also delivered to this weighing vessel. When the predefined fill level is achieved the fuel delivery from the header tank to this vessel is suspended. The vessel sits upon a load cell and the mass of the vessel is logged at predefined time intervals to derive the fuel consumption in terms of mass. When a predefined lower level of fuel is achieved, data logging is suspended and the vessel is re-filled. The operation of the FMS is controlled by the dynamometer software and has hardware settings that intervene when appropriate.

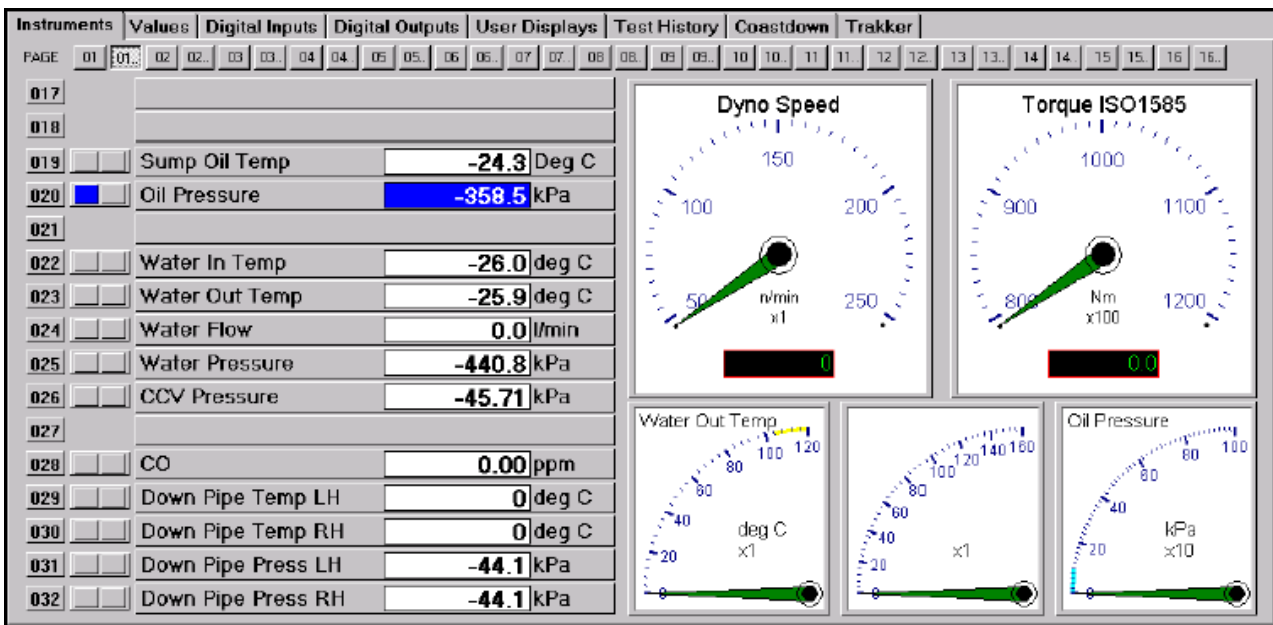
Figure 6: Example of main instruments display panel of the Cadet Lite system

Cadet Lite provides some standard calculations commonly used in the engine test. They can be configured anywhere on the main display layout using the Test Editor. The calculations provided are listed below. Pseudo variables are normally used for calculations, User variables are normally used for configuration but do also contain some calculations.

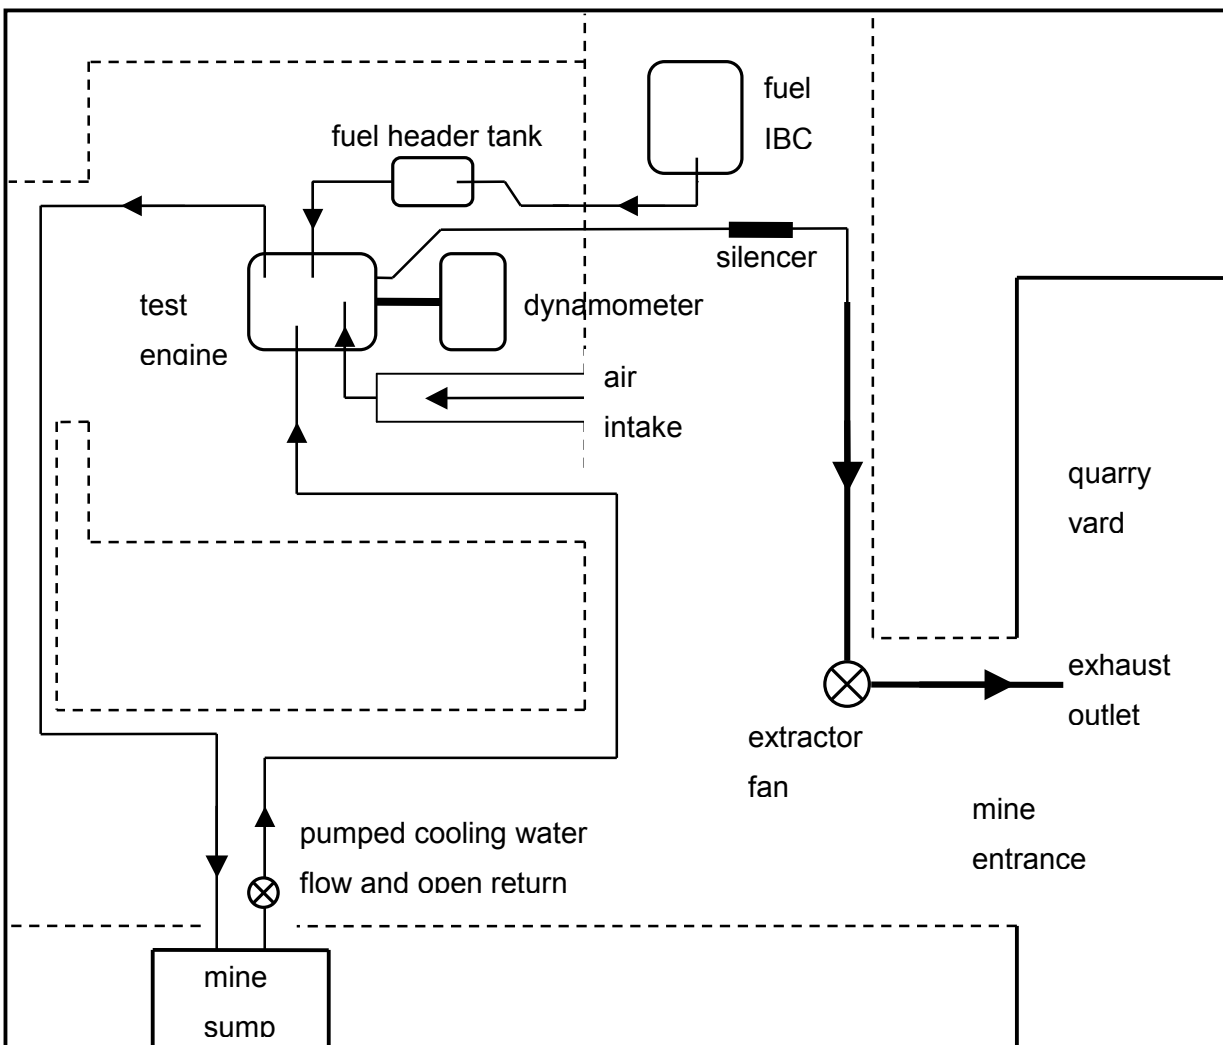
Figure 7: Schematic diagram of test infrastructure within the mine.

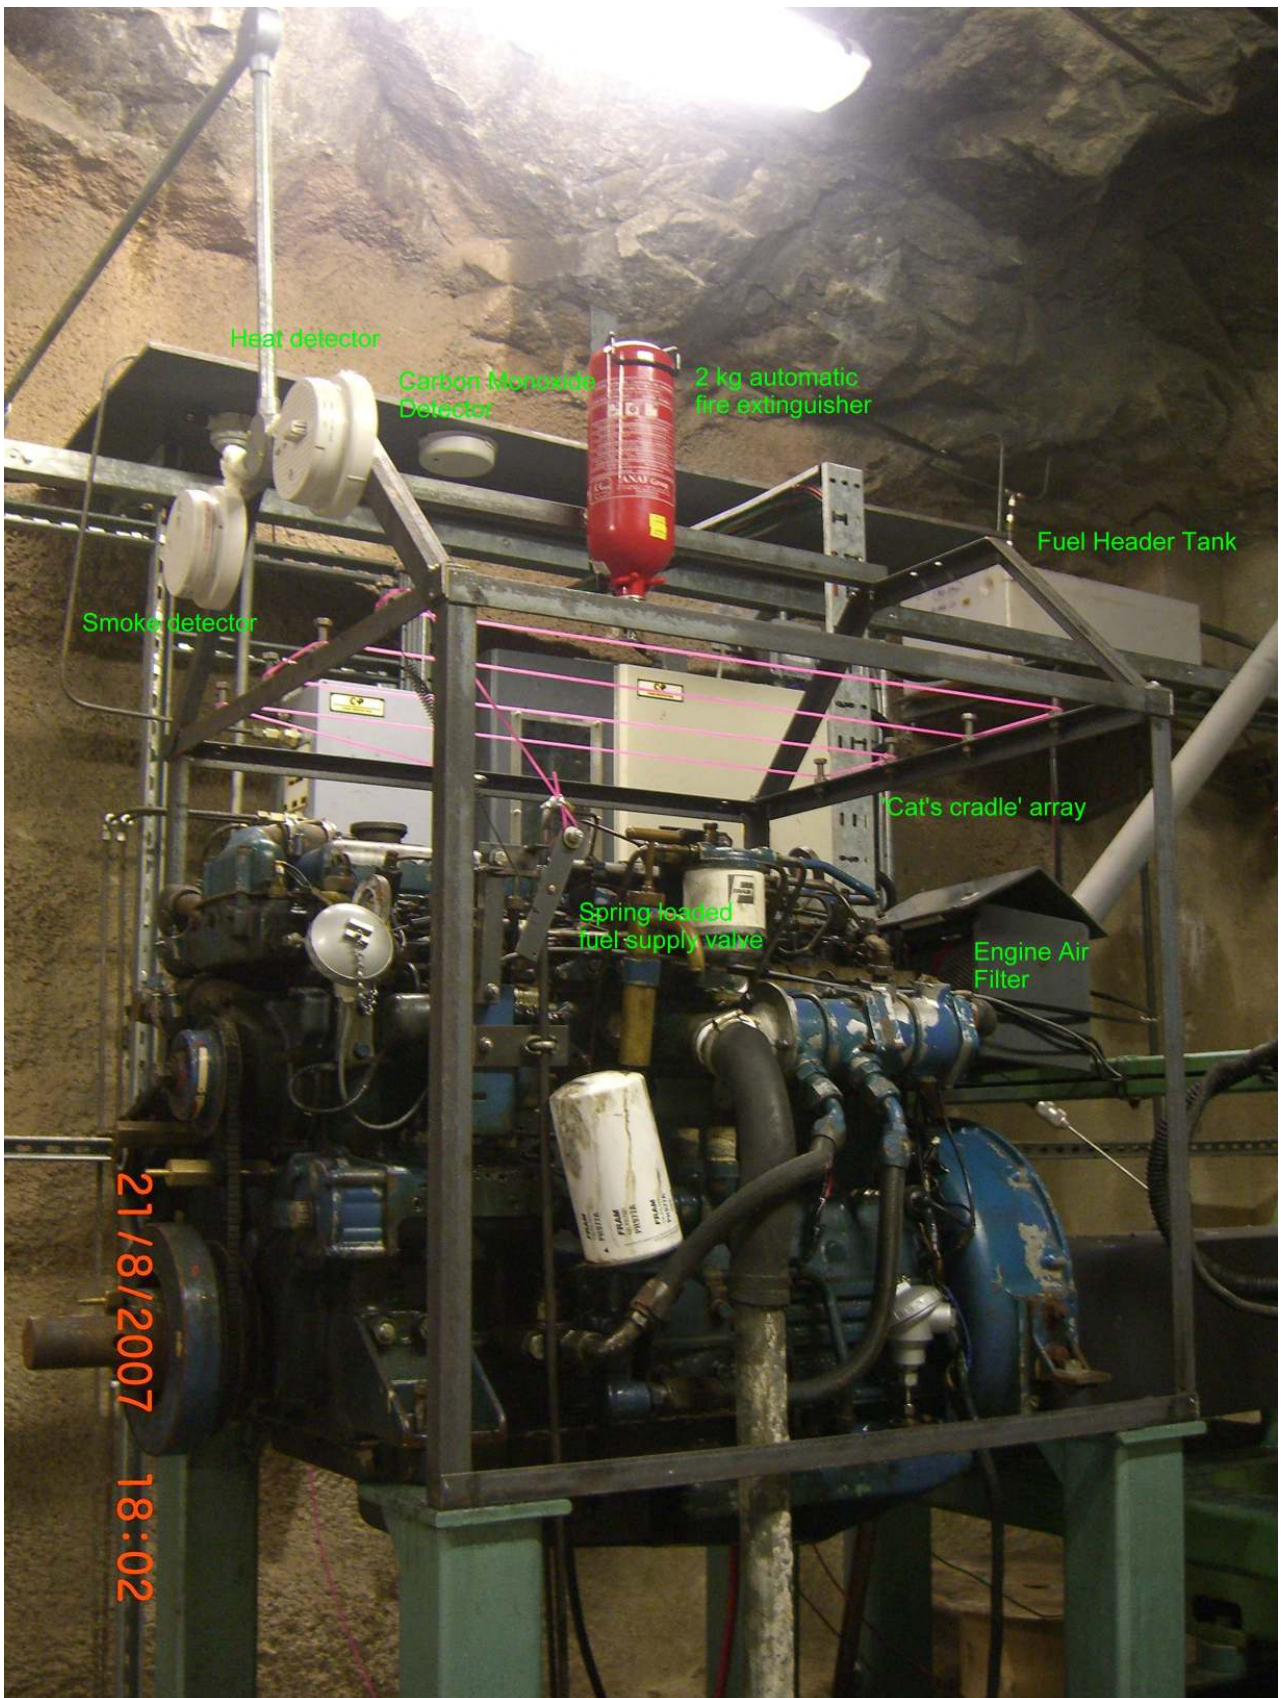
Figure 8: Test engine showing fire protection measures installed to support unattended operations for prolonged testing.

The two essential ingredients for fire are the fuel (here diesel) and oxygen. A 2kg powder fire extinguisher was suspended 300mm above the engine with a heat sensitive bulb. If the temperature exceeds 59° C the extinguisher will activate, stifling the fire and depriving it of oxygen. To remove the source of fuel, two valves were installed on the fuel feed and return lines which are sprung closed. A nylon mesh is arranged in a network 100mm above the engine and fastened to each valve, holding each valve open. Under normal conditions the valves are held open and fuel is able flow to and from the engine. In the event of a fire, the string is quickly burnt through and the valves spring closed stopping the source of fuel to the fire. These two measures will act to successfully extinguish a fire by removing the fuel source and depriving the fire of oxygen.

For 24 hour operation a warning system has been installed to alert the operator if a fire has occurred in the night and that it is not safe to enter due to the possible presence of hazardous gasses. The system consists of a smoke sensor and a heat sensor above the engine linked to another smoke sensor in the approach to the test cell. Therefore if smoke is detected or the temperature exceeds 60° C all sensors will actuate audible alarms. The sensors are mains powered but have battery back ups if the power supply is affected.

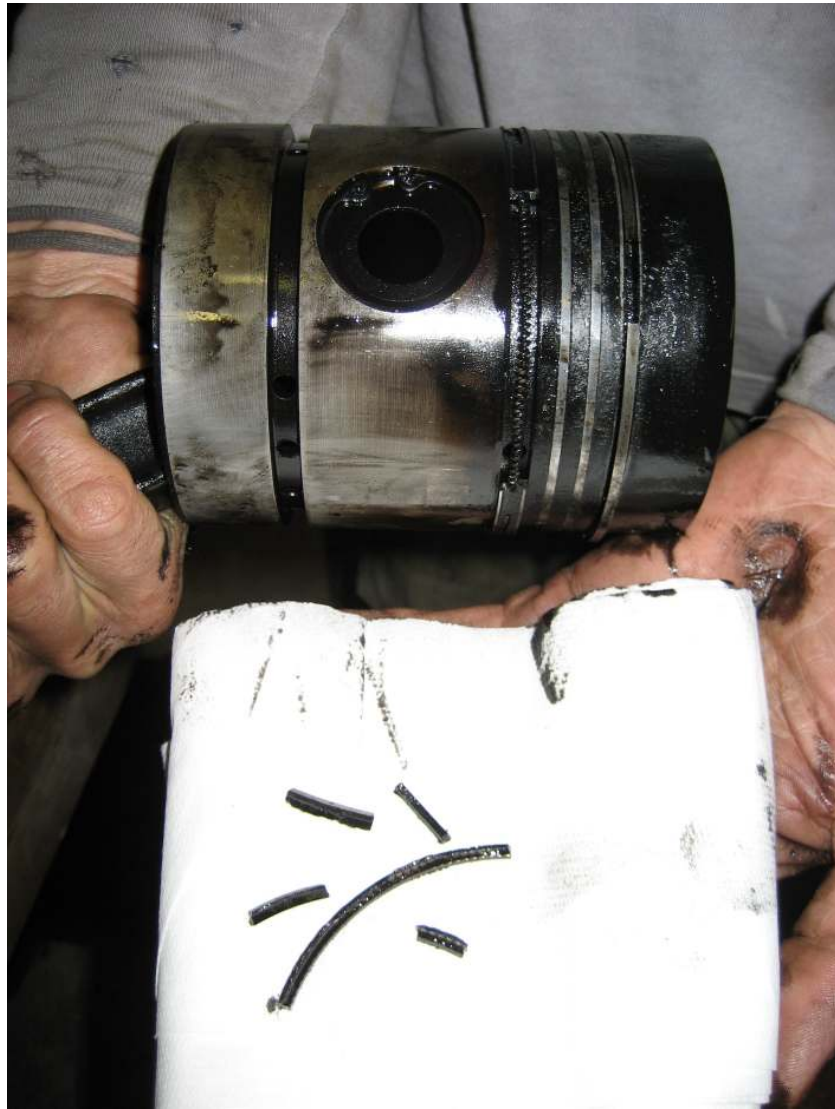
Figure 9: Broken and seized piston rings

When sufficient baseline power tests had been conducted and the project was about to move on to make fuel tests the engine suffered a major failure. This failure manifested itself as high pressure within the crankcase that expelled the engine oil from the manual oil pump provided to aid oil changing. Compression from the cylinders was gaining access to the crankcase by leaking past the piston ring seals. The engine was stripped down and it was found that the cylinder liners were badly worn in all cases and that two pistons had broken compression rings with a further piston having compression rings that were seized within their grooves (*see figure 02*).

The failure of the engine in this manner was considered to be due to a combination of the following factors:

1. The engine was an old and well worn unit at the time of commissioning (refer to previous section *Engine characterisation*). This was deliberate in order to replicate the units in use within the 10 metre class of fishing boat.
2. The baseline test being used until the 19th September was very harsh and far exceeded the duty cycle that engines of this age would be subjected to in boats. This test, Baseline 002 had been replaced by Baseline 003 on this date as it was feared that the severity of the test was placing the engine in jeopardy.

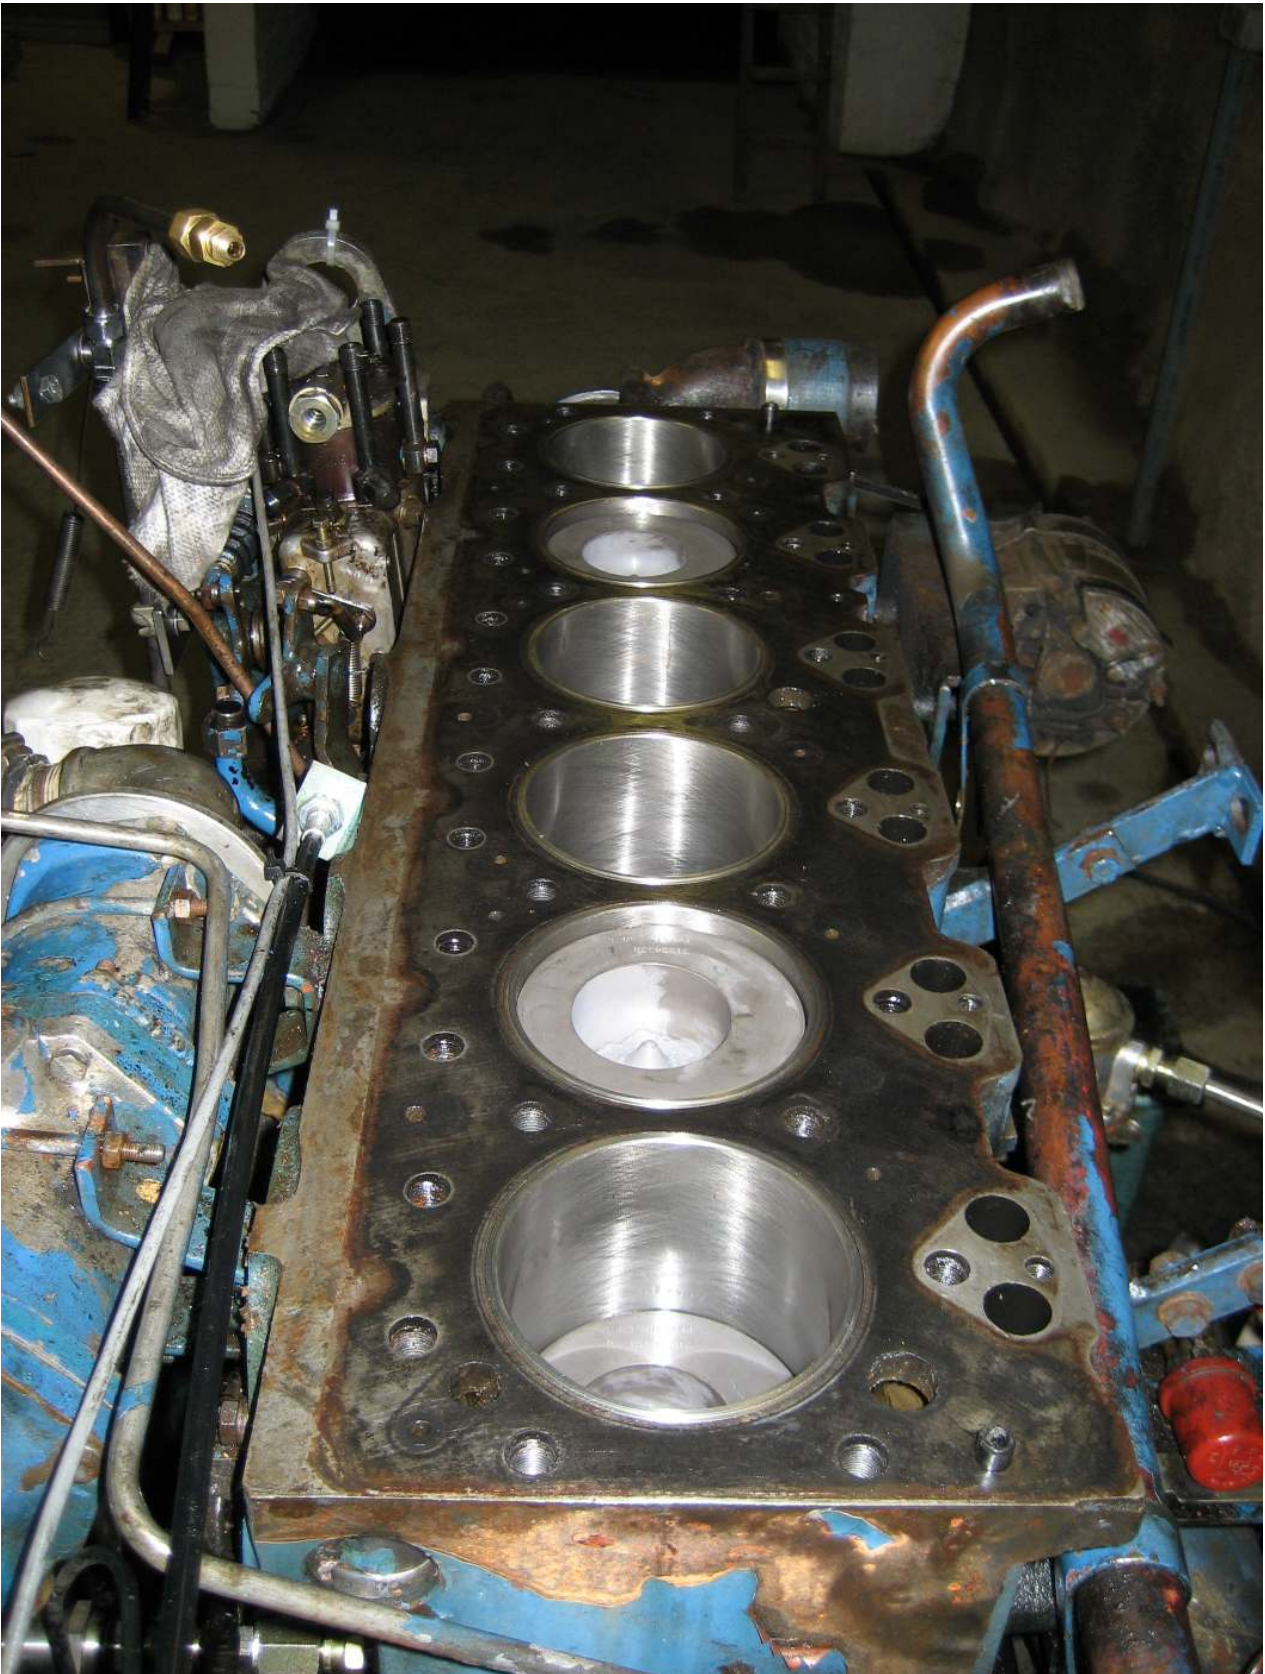
Figure 10: New cylinder liners and pistons

Six new cylinder liners were fitted together with new pistons and piston rings (*see figure 03*). The opportunity was also taken to replace the connecting rod big end bearings but these appeared to be sound in any case. The engine rebuild then necessitated a period of running in which is required to allow the close fitting components to wear themselves to a working fit without overheating due to the added friction created by new and tight surfaces. Advice received from the marine engineer affiliated to the project suggested 20 hours of running commencing with approximately 25% output power ramping up to around 80% at the end of the period. These 20 hours of running in were performed over 7 days whilst the FMS fill valve problem was being investigated. At the end of the running in period the engine oil was changed together with the filter and the fuel filter. The valve clearances were checked and required only minor re-adjustment suggesting that the cylinder head had settled only very slightly.

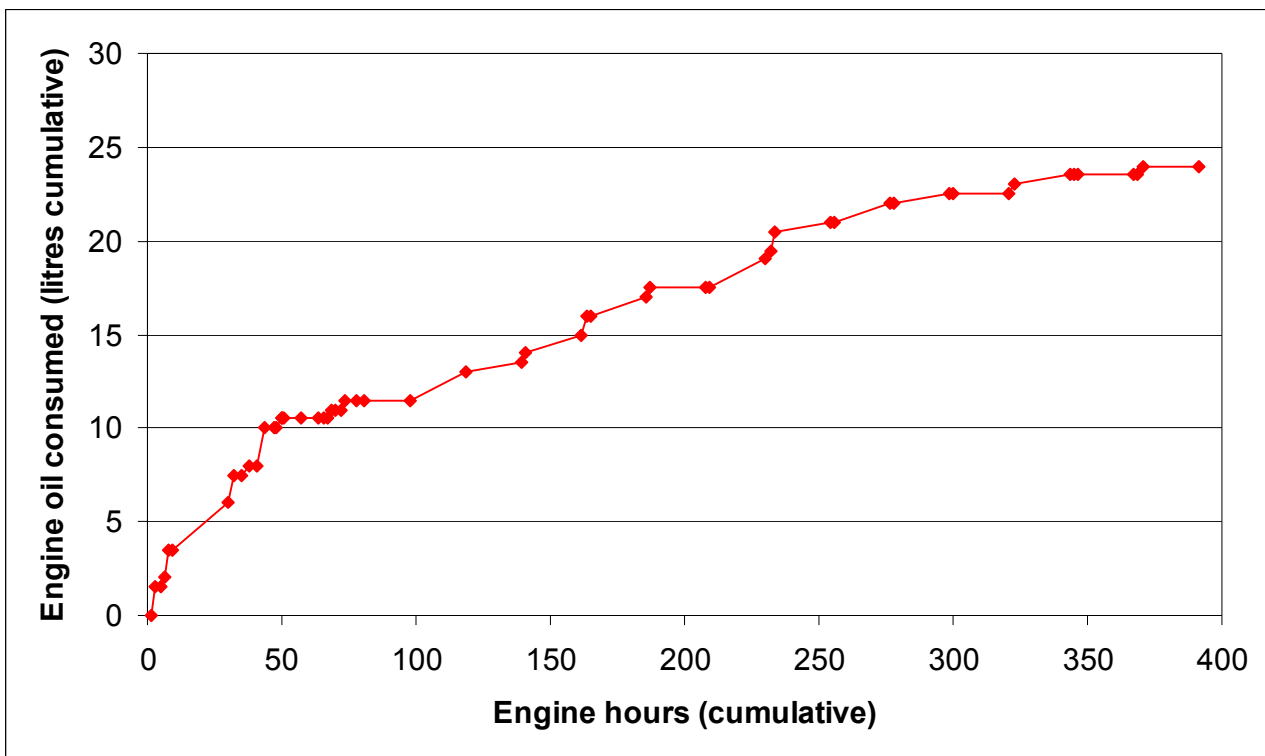
Figure 11: Graphical representation of oil consumption.

Figure 04 below shows this oil consumption in graphical form and whilst there is no representation of the loading of the engine, merely running hours, the plot clearly demonstrates the reduction in consumption at around 45 hours corresponding to the engine rebuild. The plot also appears to show a gradual reduction of oil consumption since the rebuild which suggests a continuing improvement in engine condition due to bedding in.
