**Quality Audit of the
Port of North Shields
- August 1997**

Confidential Report No. CR130

Consultancy Report No. 130

Authors: M. Myers
M. Emberton
M. Boulter
E. Nicholls
M. Platt
October 1997

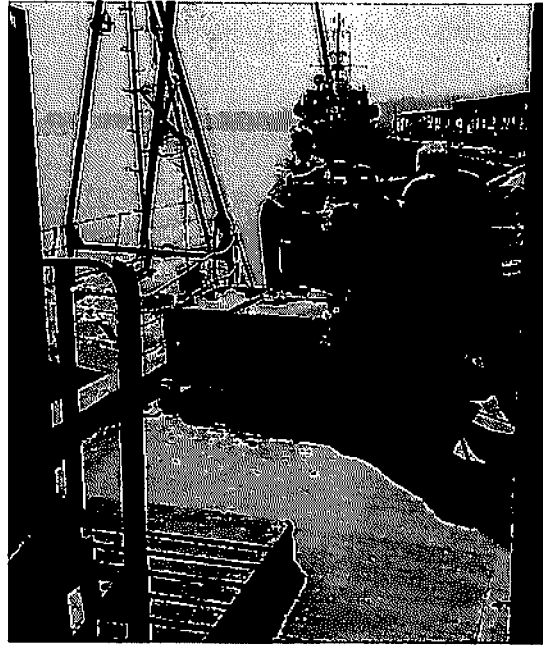
Figure 2 - The quay apron is blocked by a single vessel landing

The original piled structure has been recently renovated and capped with a new reinforced concrete apron. The new apron is of excellent construction, well lit and allows landings directly into the market. Although the quay is narrow and can become congested, access is available from both ends of the market. (Figure 2). Larger vessels land using their own gear. Smaller vessels are provided with a small davit at the upstream end of the quay.

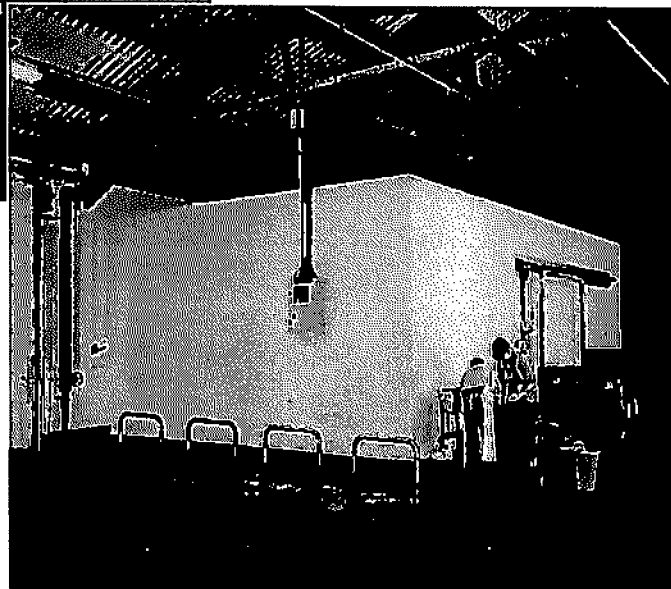
Figure 4 - The chill store

floor is excellent (Figure 4). Temperatures within the chill are monitored and recorded automatically. The grading tables are made from stainless steel to a good standard. Scales are provided when needed by vessel

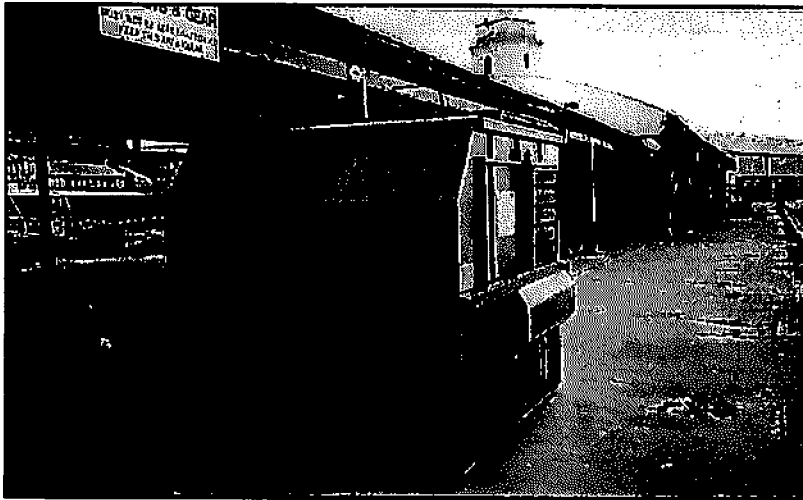
Figure 5 - A quayside skip is provided for rubbish

Figure 5 shows the skip provided by the Company for general waste. Waste oil disposal is the responsibility of individual vessels.

- 7.8 A formal Waste Plan should be devised and introduced.
- 7.9 Fly tipping at the rear of the market must be stopped (see (1) 5.3).
- 7.10 Seafish strongly supports the upgrading of the area to the rear of the fish market to improve hygiene and the public image of the fish industry.

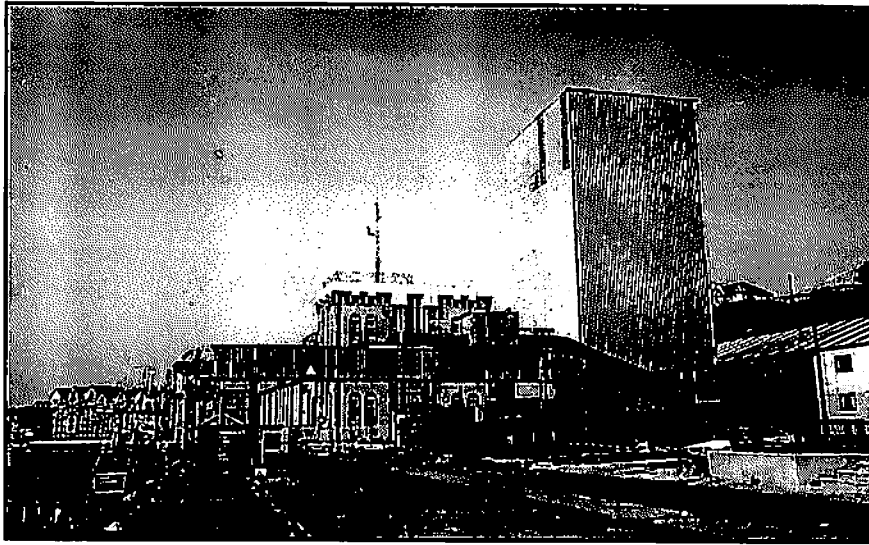
Figure 6 - The ice plant

An ample supply of flake ice is available from Tynemouth Ice Ltd. The plant (Figure 6) can produce 150 tonnes/day and can store up to 80 tonnes.

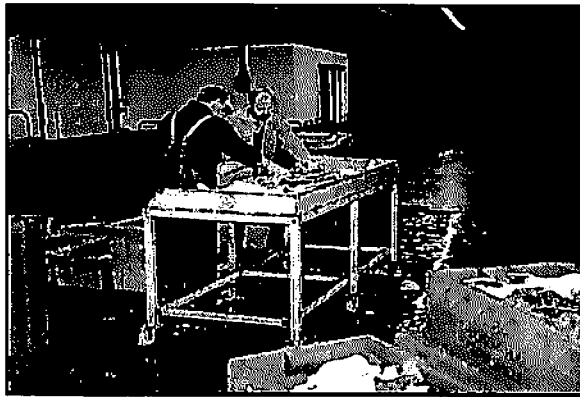
Figure 7 - Flatfish being graded and repacked

the chill store. However, it was noticed that fish were removed from the chill and laid out at 0400 hrs, more than three hours ahead of the auction. This was unnecessary and fish could stay in the chill until shortly before 0700 hours. Flatfish were tipped, graded, repacked and weighed prior to the sale (Figure 7). Inspection of the repacked fish showed that they had not been adequately re-iced (Figure 8).

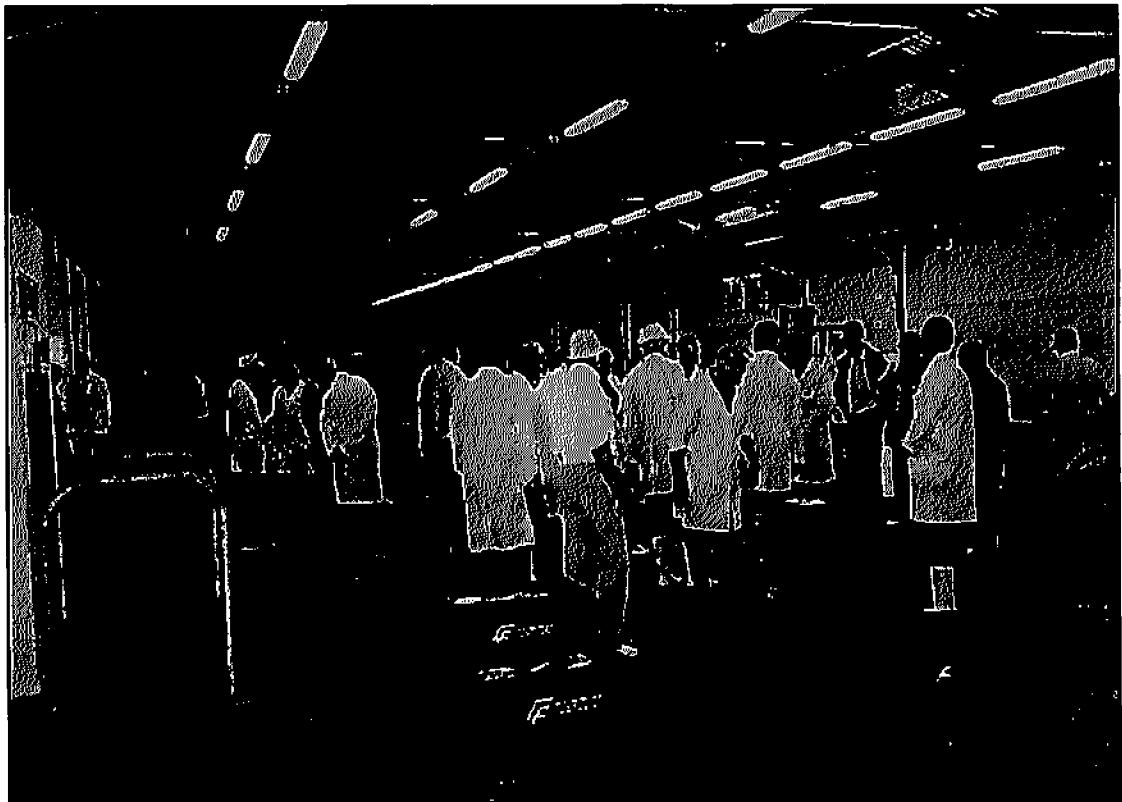
Figure 10 - The auction sale in progress

The auction sale (Figure 10) commenced at 0730 hours. All of the boxes were laid out for sale in a sensible way with adequate walkways left between tiers to discourage walking on the boxes. The fish display was well lit. On the days of the audit the sale was quick and the boxes were promptly removed from the market.
