**The Results of a Water and
Effluent Study carried out at
G. W. Latus Limited in
September 1997**

Consultancy Report No. CR131

December 1997

The Sea Fish Industry Authority

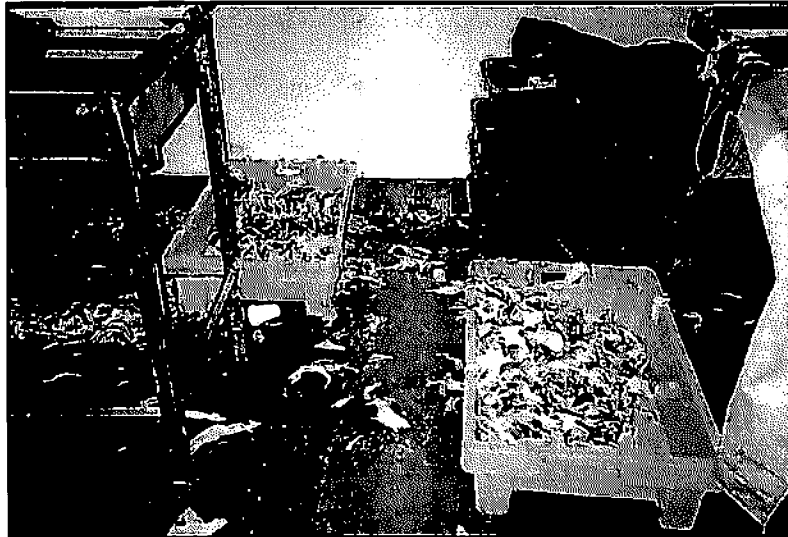
Figure No. 3 - Filleting waste on the floor

During hand filleting, the frames and lugs are thrown or flicked into the fishmeal bin or a fish box. A significant amount of waste misses the containers and ends up on the floor (Figure No. 3). Smaller pieces of fish are flicked into the filleting tub. At the end of filleting most of the pieces of fish on the floor are shovelled up. The remaining waste is hosed down the drain.

Composite effluent samples were taken from the drain in the filleting area and spot effluent samples were taken from the Baader filleting machine. The effluent from the drain had a COD of 1270 mg/l and TSS of 248 mg/l. The effluent sample from the Baader filleting machine had a COD of 5346 mg/l and a TSS of 4231 mg/l.

To prevent filleting waste ending up on the floor, benches could be modified to include a simple offal tray (Figure No. 4). Small pieces of fish could be flicked into the offal tray which would reduce the effluent strength in the filleting bench. Education is also required to ensure filleters accurately throw offal into appropriate containers to prevent it ending up on the floor.

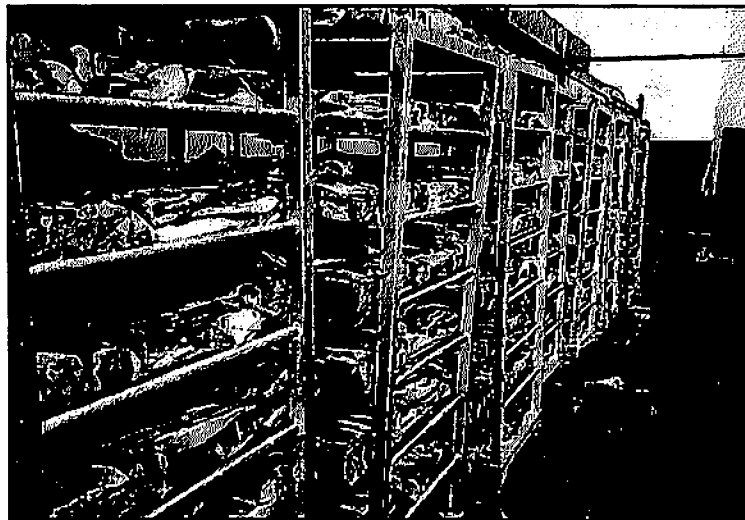
Figure No. 5 - Fish placed outside the factory

Frozen blocks of fish are defrosted in stages. Firstly, they are placed on racks outside the factory, uncovered at ambient temperatures (Figure No. 5). At the end of processing for the day, the racks are brought inside and placed into the defrosting room, which has an overhead water spray system. Water is then sprayed over the racks of fish throughout the night. As the fish thaw, they fall away from the blocks onto the floor (Figure No. 6).

It is not acceptable to defrost unprotected fish in the open air, or directly on the floor. This exposes the fish to possible contamination from a number of sources. Both defrosting fish on a rack and in stacked fish boxes is not effective as the water does not come into contact with all the fish. The current method of defrosting wastes a large volume of water.

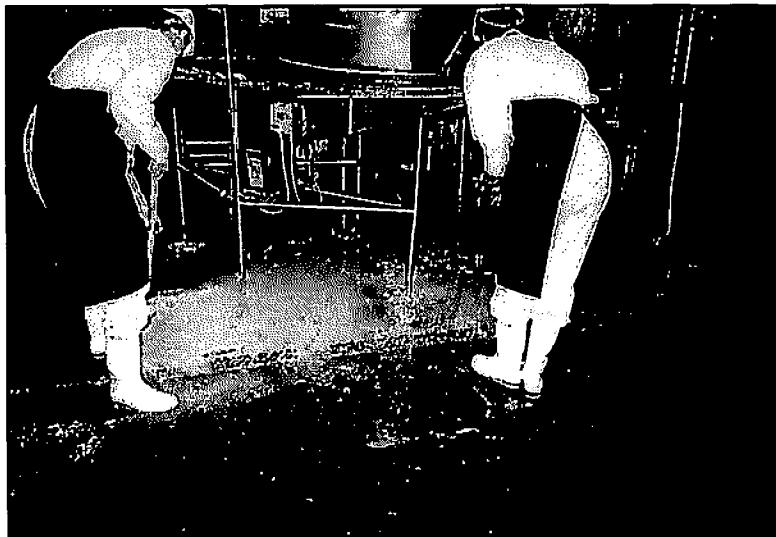
Figure No. 8 - Waste being washed down the drain

The floor in the enrobing area is cleaned down as necessary during the day. At the end of processing, any batter, oil and scraps which are on the floor are washed into the drain. The drain covers are usually lifted up by personnel to make this task easier (Figure 8).

All solid material should be prevented from finding its way on to the floor and into the drains. The drainage channel covers should be replaced with 6mm stainless steel punch plate or smaller aperture wedge wire, to prevent large solids entering the drain. Covers should incorporate a simple locking device to prevent lifting by unauthorised personnel.
