**Quality Audit of the
Port of Rye**

Consultancy Report No. CR127

September 1997

Seafish Technology

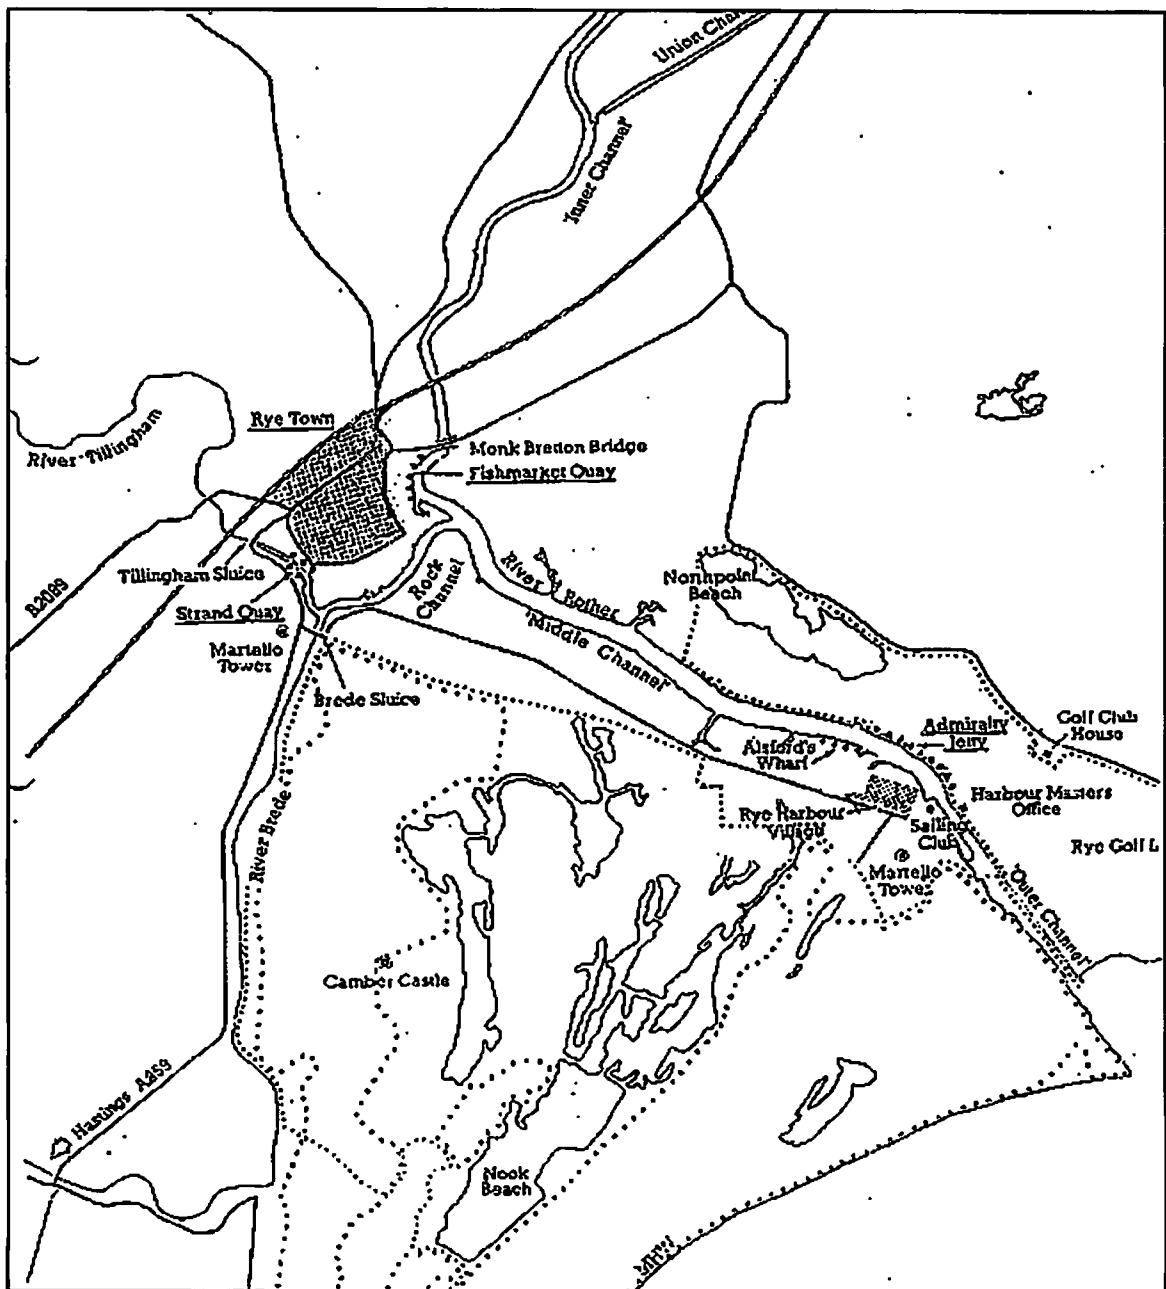
Figure 2 - Rye approaches and fishmarket quay

The principal site for fish landings and fish-related activities is a narrow strip of land between the River Rother and the flood defence wall to the east of the Town Salts, some 3 kilometres from the sea (as shown in Figure Nos. 2 and 3). The area is subject to frequent flooding that gives rise to significant concerns for safety and hygiene. Use is also made of the mud flats in the area of Rye Harbour village and the Admiralty Jetty by a number of small fishing craft, mostly, but not all, part-timers.

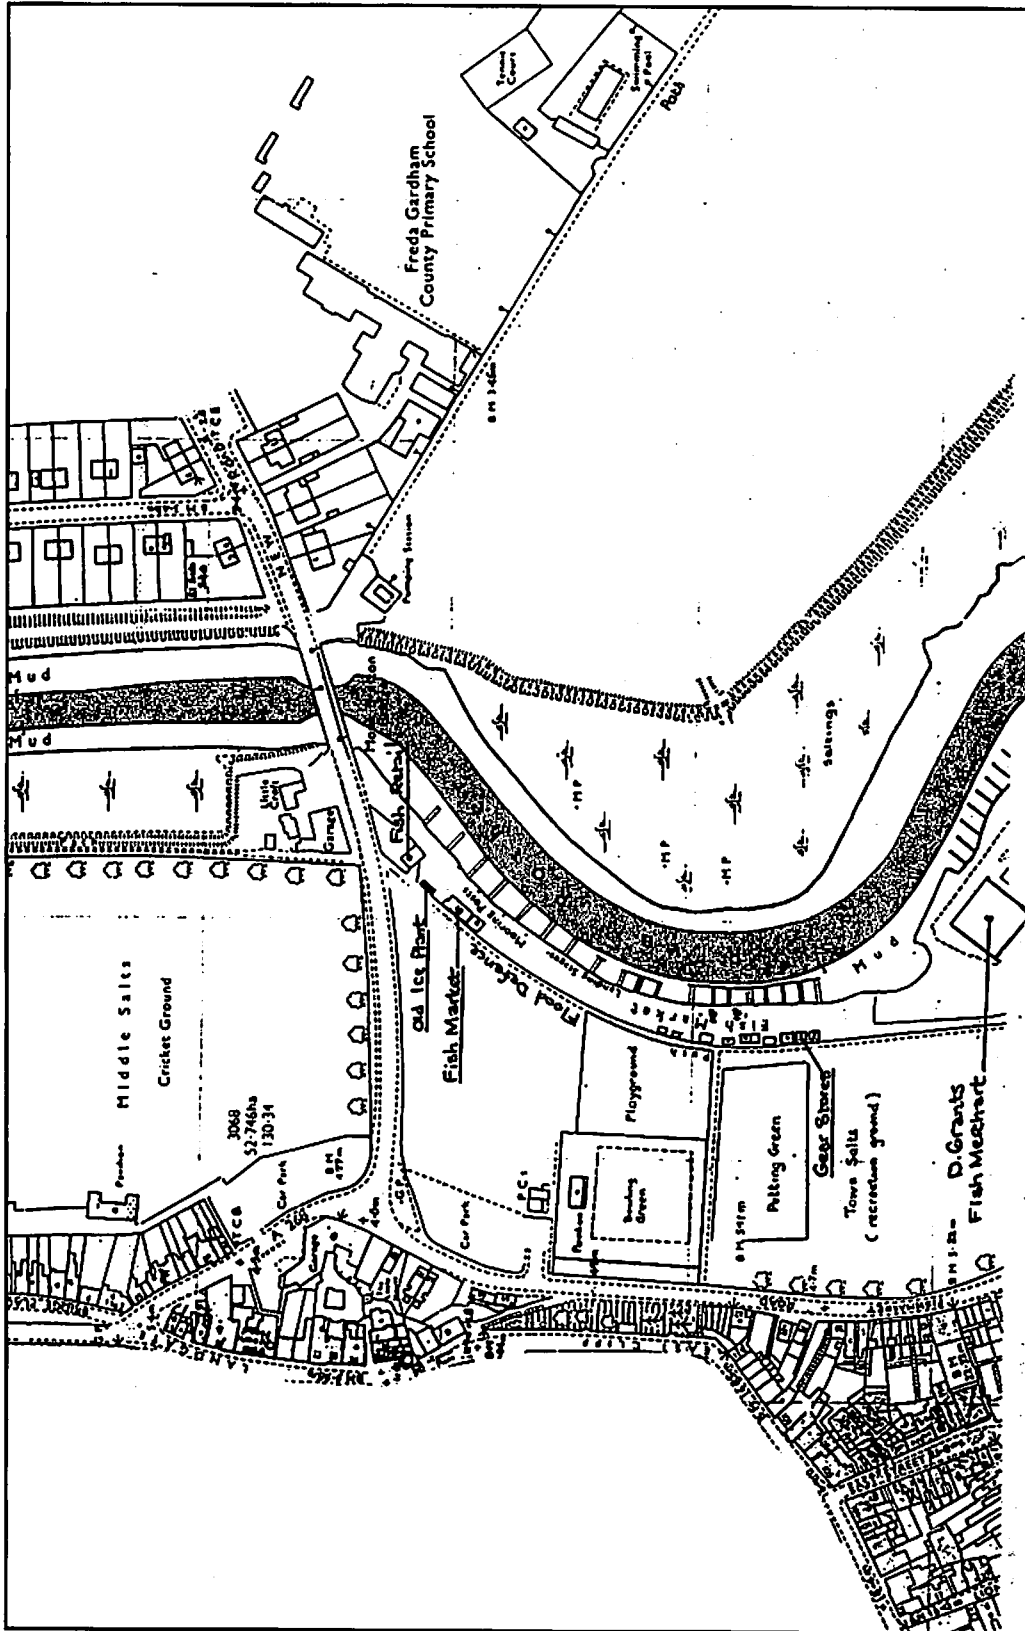
Figure 3 - Landing stages and marketing infrastructure

The market lacks any staff facilities, including toilets, and is generally in poor condition. The nearest toilets are public facilities on the Town Salts adjacent to the Bowling Green (Figure No. 3). It has no internal drainage and water from washing down is hosed/brushed towards a hole in the wall to an external gully that runs along the rear of the building. The market floor is raised approximately 0.3 m above the surrounding quay but is still subject to flooding. The market cannot be said to comply with the standards required by hygiene/food safety legislation. However, the owner and salesman, Mr. B. Drew, has plans to upgrade and extend it, and is seeking grant support.

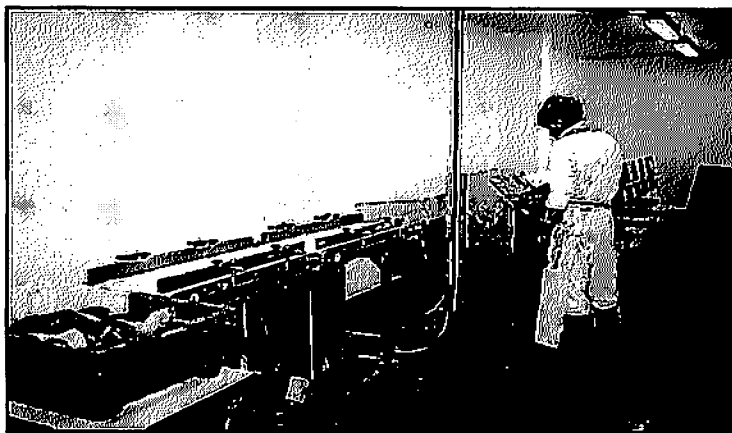
Figure 8 - Grading equipment in the premises of D. Grant

D. Grant provides electronic check weigh platform scales and a Scanvaegt automatic and computerised grading and weight totalising system. See Figure No 8.

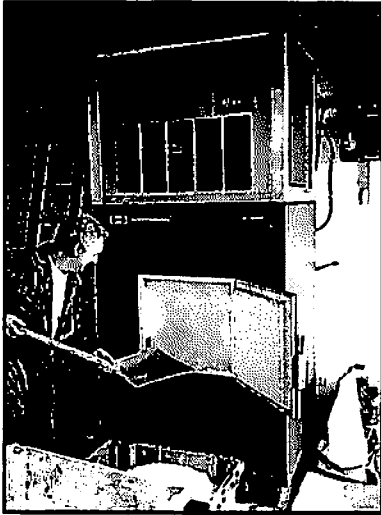
Figure 12 - Ice plant in market

Ice is available on the market for icing fish on landing, etc. but is not used by the fleet at sea. The 'Scotsman' machine (Figure No. 12) can produce approximately $\frac{3}{4}$ tonne/24hr. A previous plant operated by the Fishermen's Co-operative (Figure No. 10) is defunct and derelict. D. Grant also has a machine capable of 5 tonnes/24 hr. but it is restricted to factory use.
