**Quality Audit
of the
Port of Brixham**

Seafish Report No. CR 176

February 2000

Confidential Report No. CR176

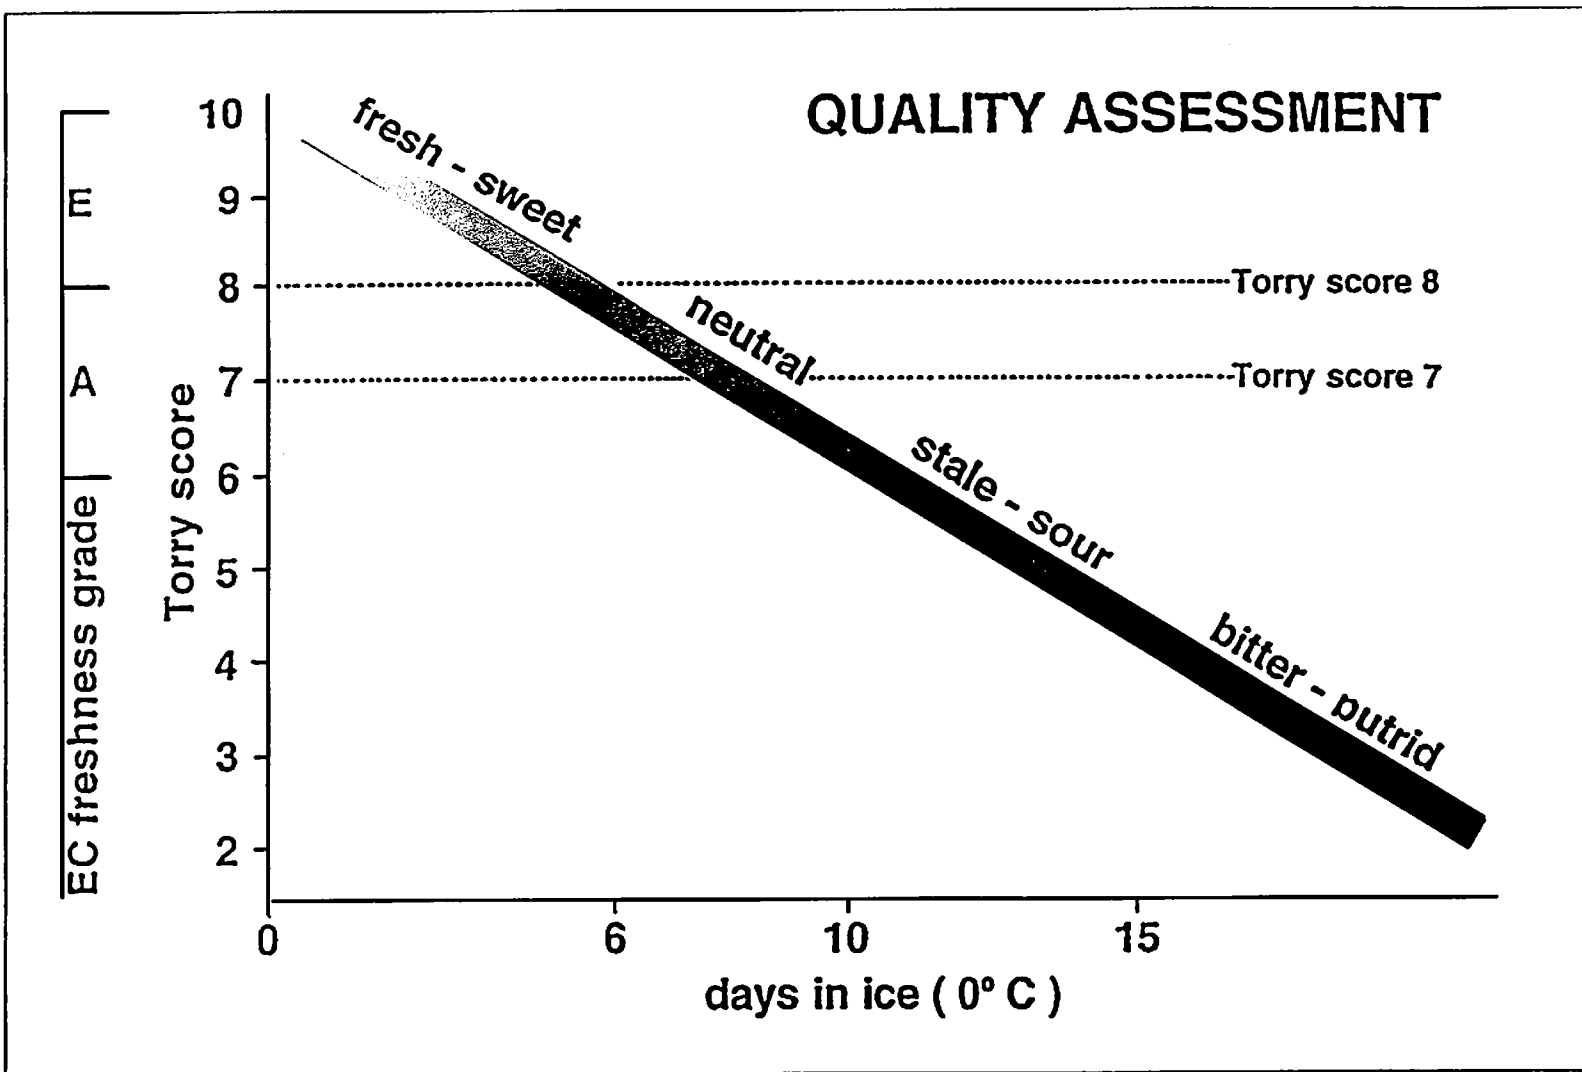
Figure No. 13 - Freshness quality assessment

The Seafish Guidelines for Fish Processors recommend that the fish they purchase should preferably be of Torry Score 8 or above (EU freshness Grade E), in order that their products have a good chance of retaining sweet, desirable flavours when they reach the consumer and the fish should be no lower than Torry Score 7, so that their products should not have undesirable sour or bitter flavours by the time they reach the consumer.

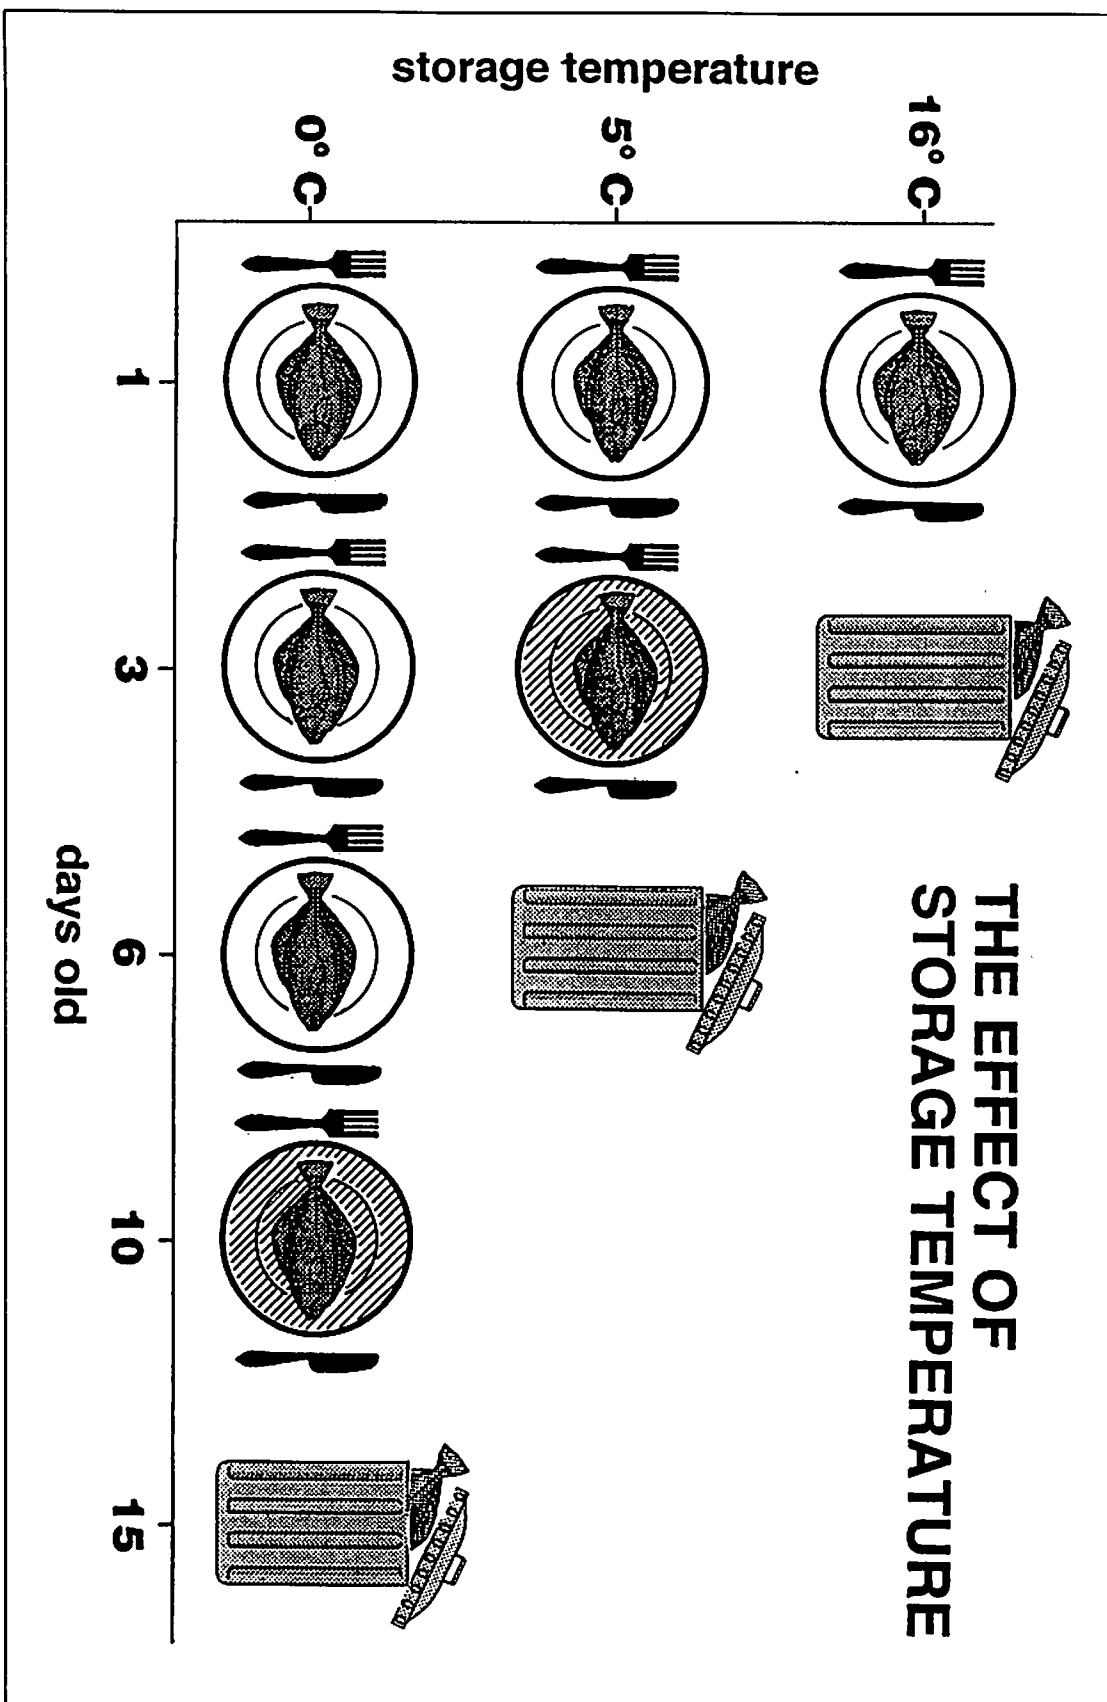
Figure No. 14 - The effect of storage temperature

Note that temperature control is by far the most significant factor affecting the rate of deterioration of fish and that at temperatures above that of melting ice, spoilage is greatly accelerated, see Figure No. 13 overleaf.

Typically white fish remains acceptable for about 10-11 days after capture if well iced, but this can be reduced to a matter of a few days if left unprotected at summertime ambient temperatures.
