**Lochinver
Port Quality Audit**

Confidential Report No. CR157

February 1999

M. Myers
M. Emberton
February 1999

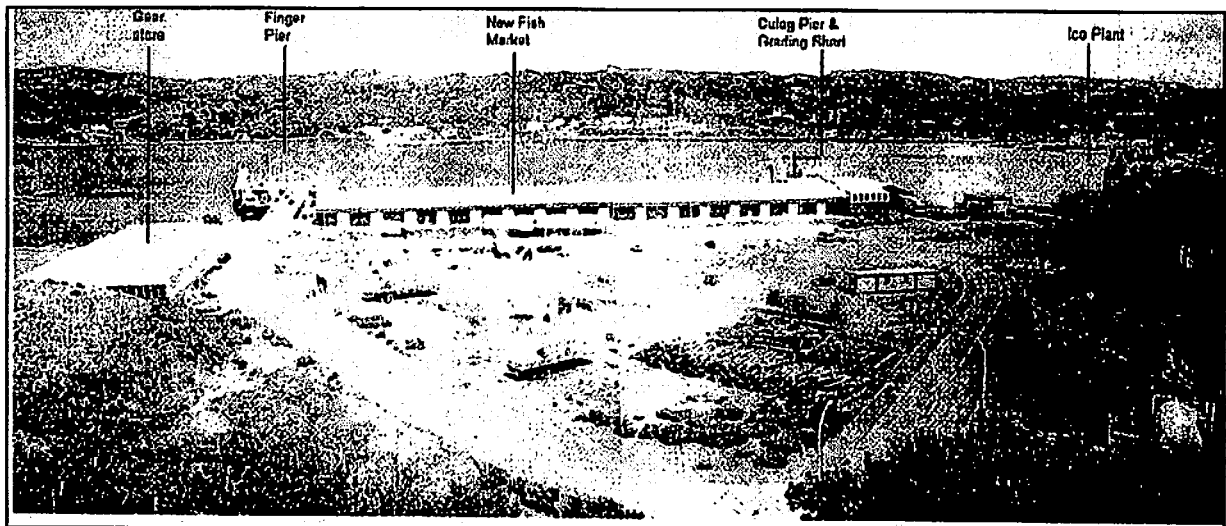
With financial assistance from the ERDF and Caithness and Sutherland Enterprise work was completed in 1992 at a cost of £6.7 million. 110,000 tonnes of rock were blasted from the surrounding hills to build a new breakwater and create a level area of land for infrastructure development. A new and larger fish market was constructed on a 200m landing quay and a new 240m finger jetty provided berthage for bunkering and lay-by. The development also provided new gear stores, net mending shed, fuel storage and delivery system and improved road access. The new development is shown in Figure 2.

Figure 2 - The new harbour development
