**Plymouth  
Port Quality Audit**

**Confidential Report No. CR 148**

September 1998

This report presents the findings of a Quality Audit of the new fishing complex at Sutton Harbour, Plymouth. The audit examined the quality of fish supplied to the market, standards of physical infrastructure, operating practices and management controls.

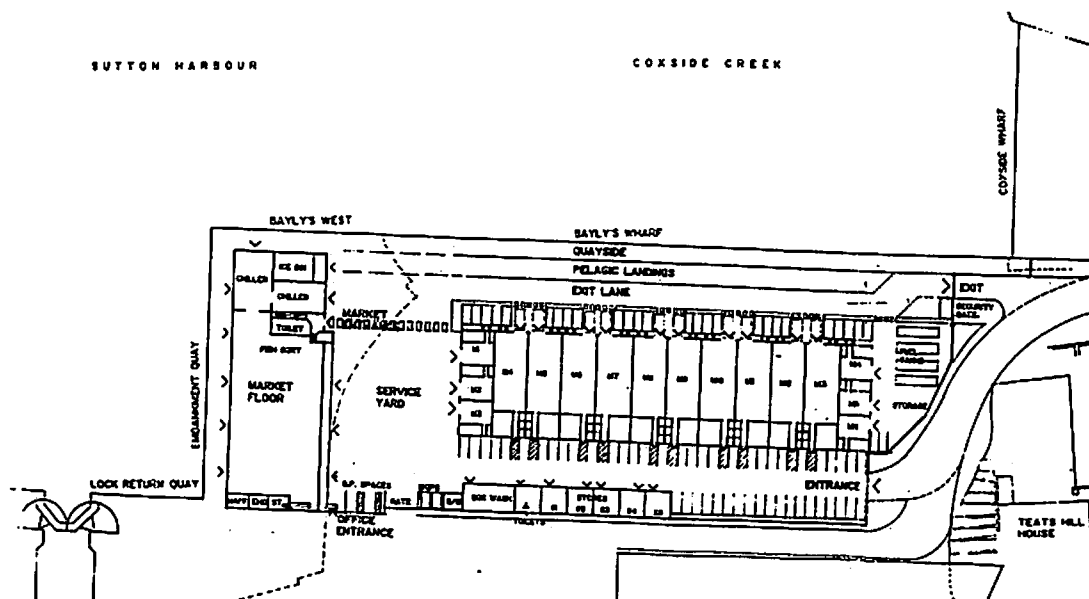
Figure 1 – Map of new fishing complex (some minor changes have been made since these original plans)

As a result it was decided to relocate the market into new premises on reclaimed land at Bayly's Wharf (Fig No.1 ). Constructed as part of a wider £42 m development scheme for the Sutton Harbour area, the fishing complex cost £3.5 m. The site was developed by the owners, Sutton Harbour Company plc, who established a subsidiary, Plymouth Fisheries Ltd to manage the complex.

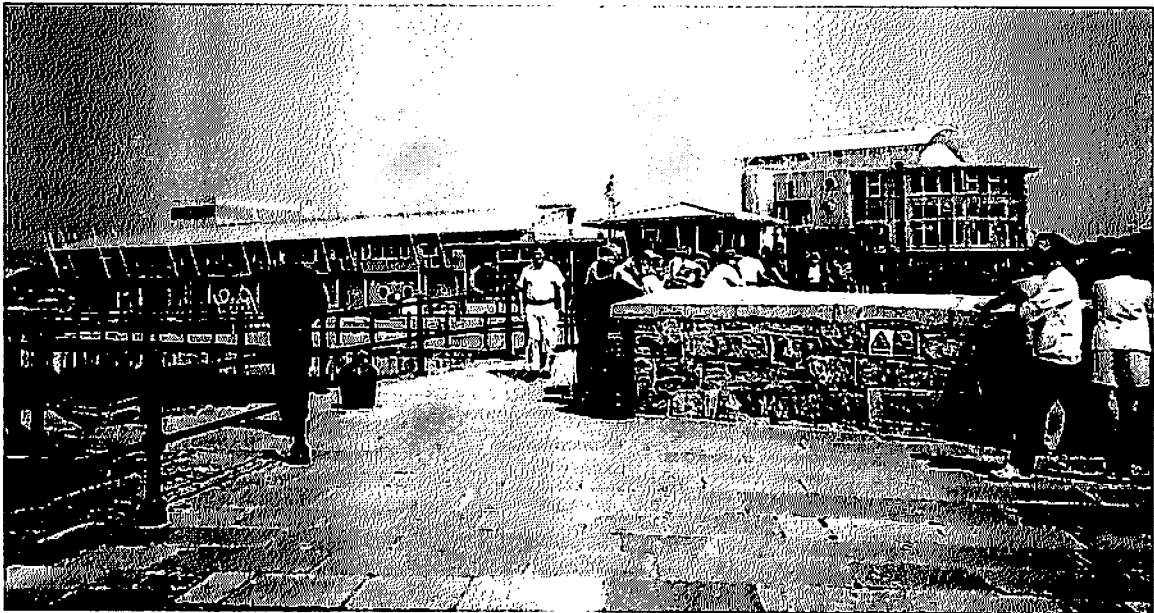
**Figure 2 – The fishing complex is 'cheek by jowl' with the leisure industry**

The fishing complex is now very busy and trade is flourishing for all of the resident businesses. However, adjacent land originally earmarked to accommodate fish industry expansion has been let instead to the leisure industry. As a result, the fishing complex is now very short of space (even the vacant ground between the market and the lock pit has to be kept clear for the sake of the view from a cafe)(Fig.2).

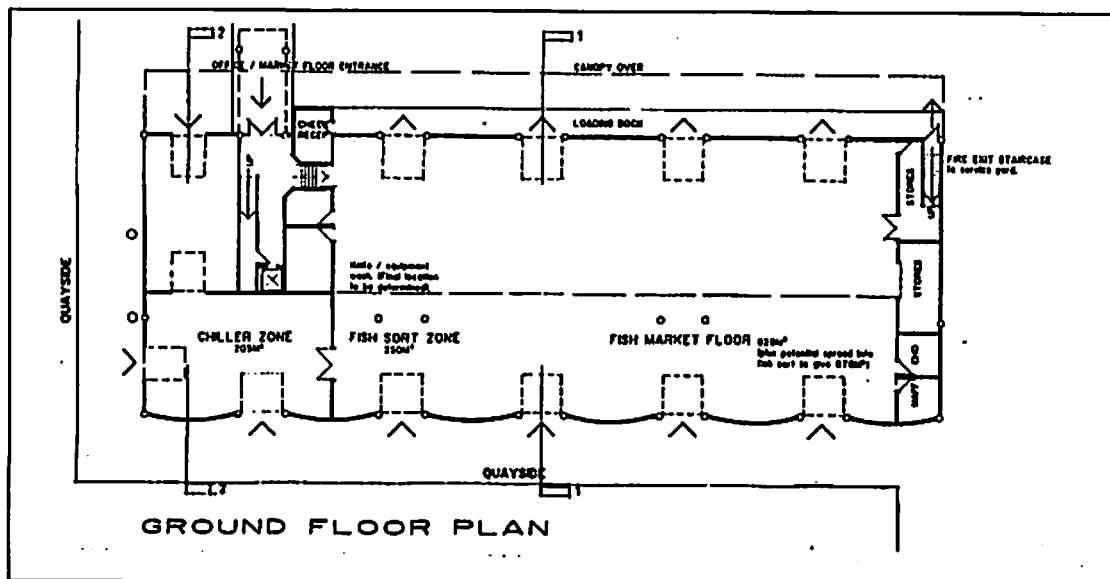
Figure 5 – Plan of ground floor (there were some subsequent modifications to the chiller layout at the construction stage)

The new market hall, when compared to its Victorian predecessor is spacious and is one of the most visually attractive markets in the UK (Figure No. 5 ). It is of hygienic design and construction and meets the requirements of EU Regulation 91/493. The ground floor consists mainly of a market floor, a chill store and a visitors reception area. The market floor has a design capacity of 1100 x 4 stone (800 x 7 stone) boxes laid out unstacked. The first floor houses offices and the ice plant.

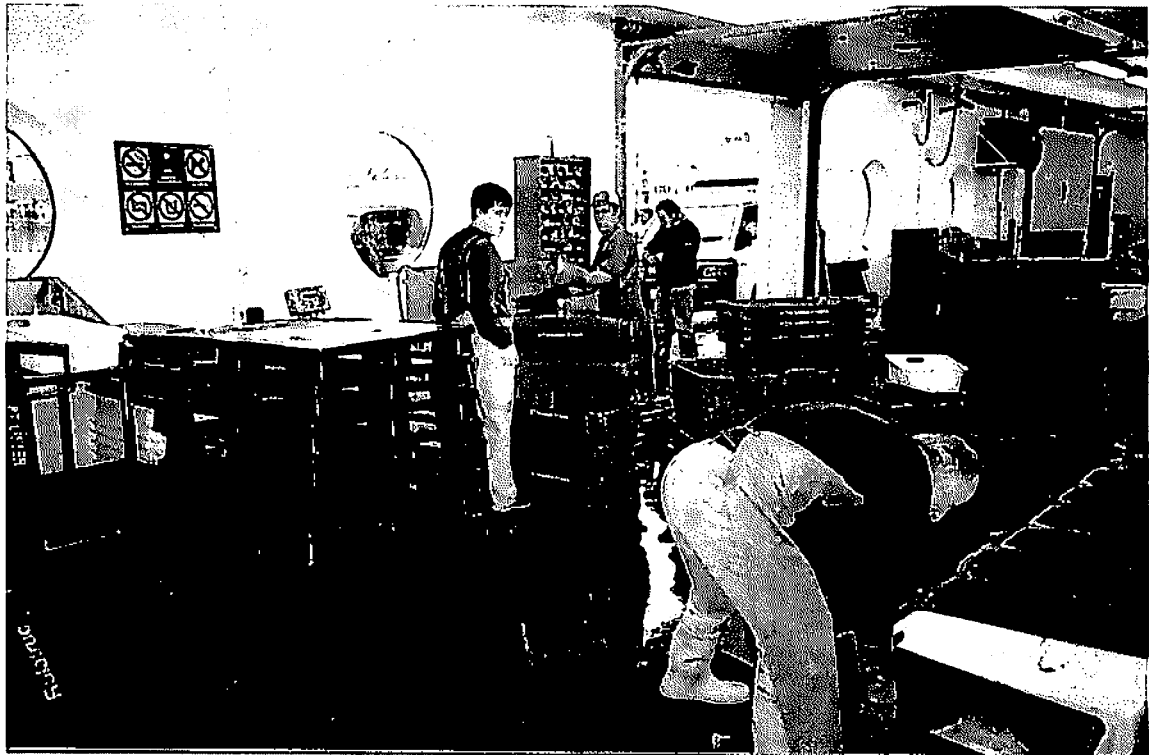
**Figure 7 - Manual grading under way**

Smaller quantities of fish from day boats were sorted manually using traditional stainless steel grading tables (Fig. 7). Large quantities of single species such as sole or bass were sorted by an automated Scanvaegt grader. The Scanvaegt has proved to be essential for dealing with large quantities of fish quickly. After grading by either method, all fish were re-boxed into Plymouth Fisheries boxes and labelled by vessel and weight. The fish were then top iced. A direct ice supply from the silo had originally been planned for the new market, but this convenient feature was unfortunately never built. Instead, ice has to be brought by bin and pallet truck from the quayside delivery chute. After icing the fish are stored in the chill until laying out for sale.

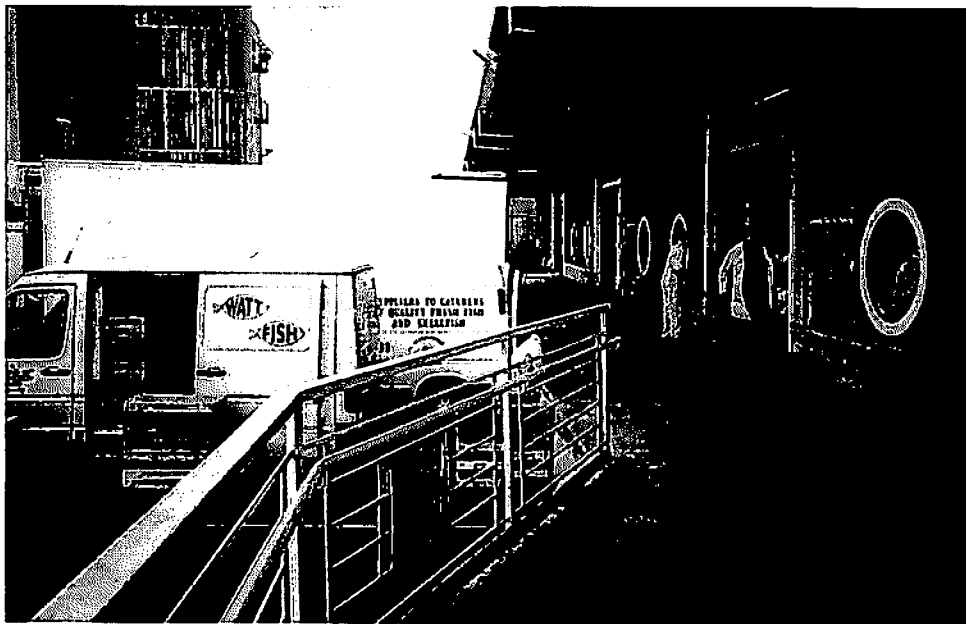
**Figure 12 – Fish transport waiting at loading bay**

Removal of fish was permitted as soon as it was sold. Fish were moved by PTA staff to dedicated buyers' stances at the despatch side of the market where their respective purchases are gathered together before onward transport. As Plymouth Fisheries' boxes were not allowed off the site, most of the fish had to be re-boxed and iced prior to transit. Although at the time of the audit there was sufficient space, this re-boxing would take up valuable floor space and time if the market was busier. When ready, fish were taken outside to lorries by buyers or transport staff using pallet trucks. The vehicles used for fish transport were almost all up to proper specification, being covered and chilled (Fig. 12). Market door discipline at this time was particularly poor.

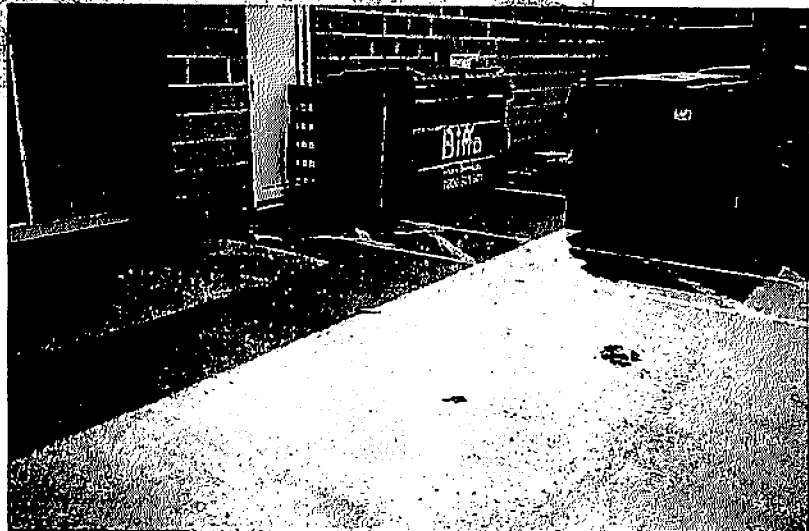
**Figure 16 – Forklift damage to doorway**

The ramp at the entrance to the shed is too steep to allow easy access by pallet truck. Forklifts have been used at times as an alternative to pallet trucks but the door way has suffered damage as a result (Figs. 15 and 16).

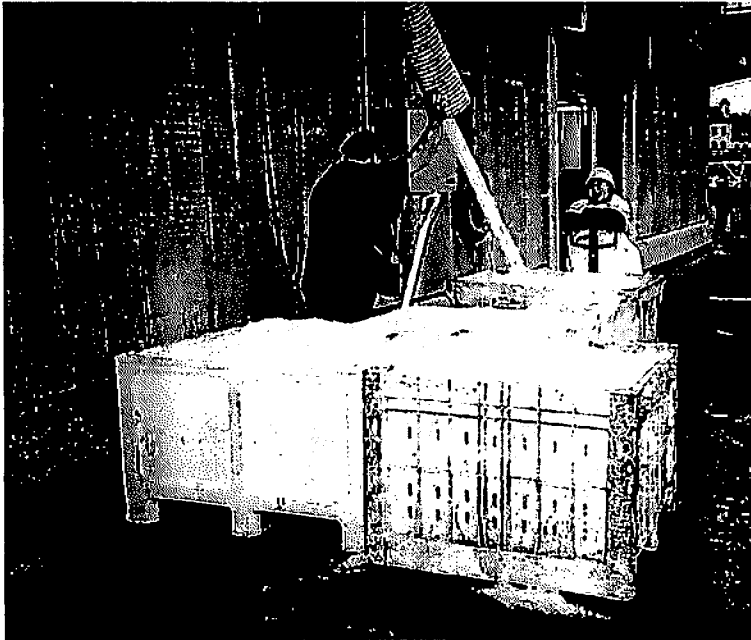
**Figure 18 – Ice is delivered into bins for use within the market**

The ice supply is operated by Plymouth Fisheries. Ice is supplied from an 80 tonne Stancold silo situated within the market building. Production from the Genoglaze ice machine is 38 tonnes in 24 hours. A chain driven scraper transfers ice from the top of the store into an auger system that then delivers the ice via an external chute directly into vessels or bins (Fig 18).

As the system always rakes from the top of the silo (where the fresh ice is deposited by the ice machine) older ice tends to compact at the bottom of the silo and becomes useless. This has to be removed occasionally and requires (in a single silo system like this) a temporary halt to production. Unfortunately, it is difficult to forecast the requirement of the fleet (particularly the larger visiting vessels) and the need to close the plant at times is inconvenient.

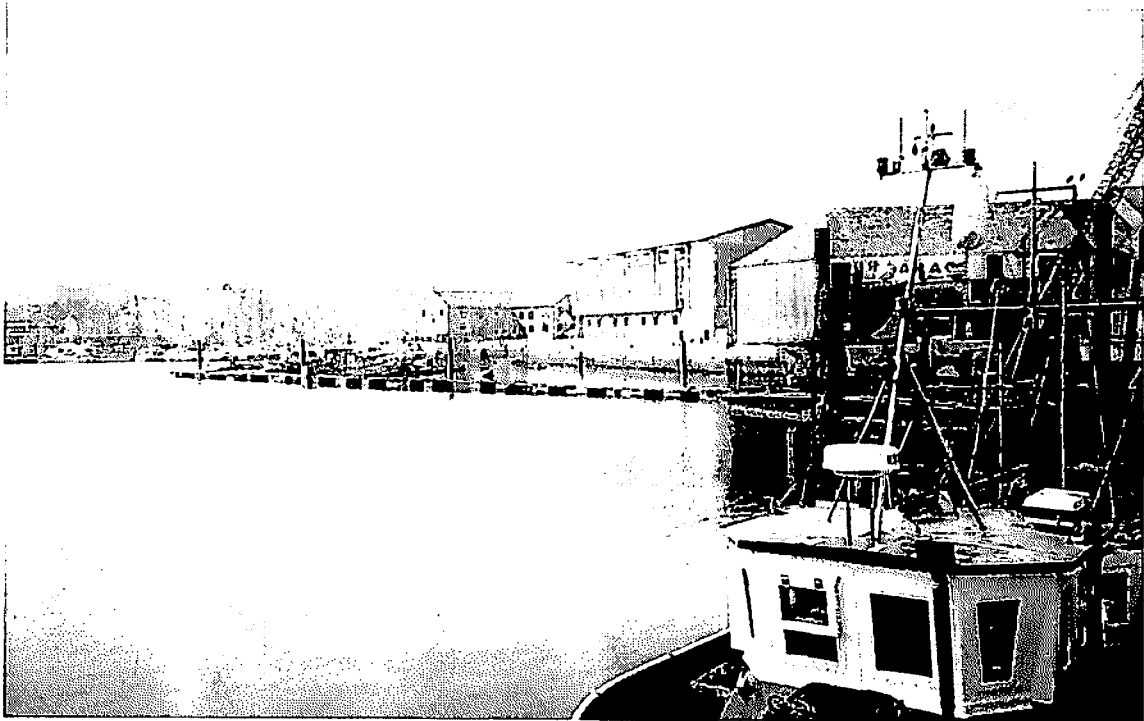
**Figure 20 – Pontoon berths for day boats are under construction**

Berthing is allocated and controlled by Plymouth Fisheries. Since the new fishing complex has opened, the day boat fleet has increased in size and the port is visited by more large beamers. Consequently, current berthing provision is becoming inadequate. As a result, plans are in hand to provide new pontoon berths for the day boat fleet (Fig. 20). This is expected to free up 16 berths for beamers.

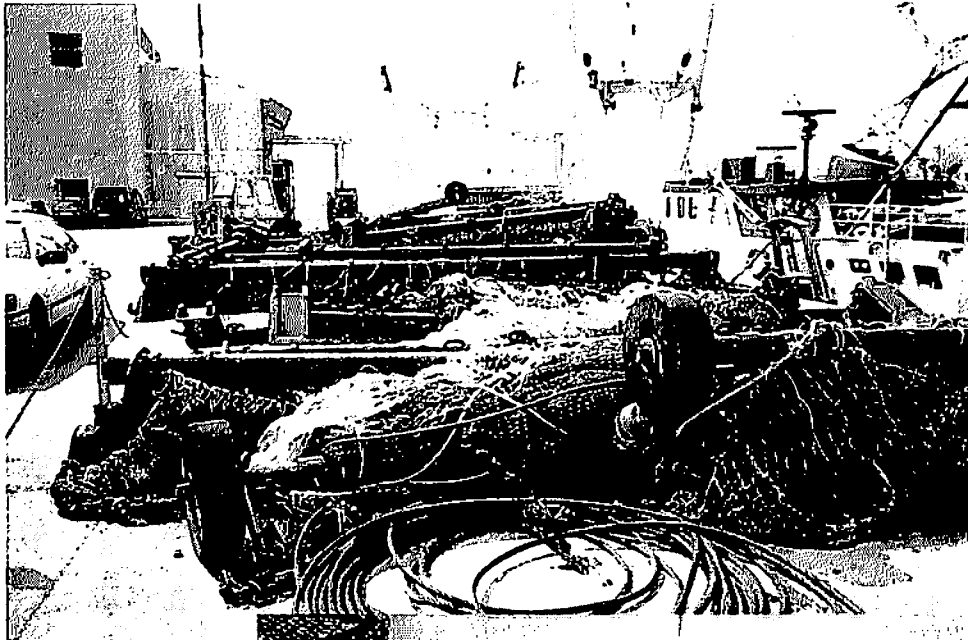
**Figure 21 – The increasing beamer trade requires space to store gear**

The expanding fleet has brought increased demand for gear storage and mending facilities. Unfortunately the dedicated gear stores originally planned were never built, and there is no longer room on site to provide them. At present there is a communal gear cage at the entrance to the complex, but this is inadequate. The increased beamer trade has brought a corresponding increase in heavy gear left on quays (Fig 21). This obstructs quayside access by vessels and service vehicles and has become a major problem. There are bins of static nets cluttering the site (Fig. 22). The fishmarket itself is currently being used as a depot for gear and supplies awaiting collection by vessels (Fig 23).

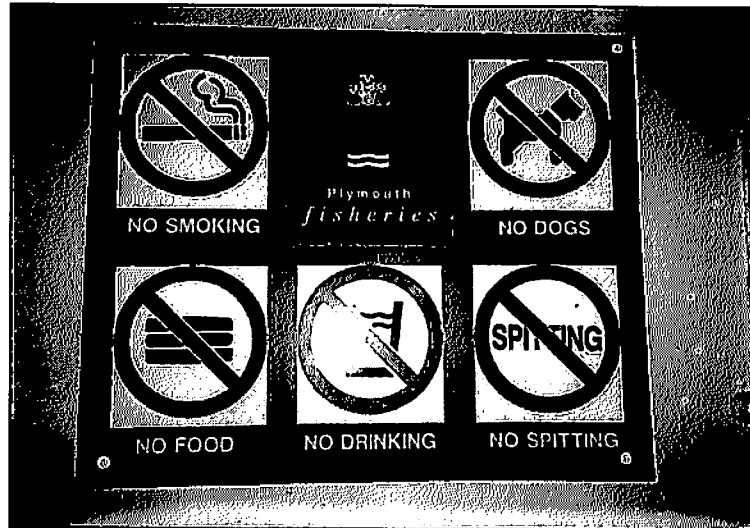
**Figure 26 – Prohibition notice on market floor**

There is no formal list of fish market hygiene and behaviour regulations. There is a sign within the market hall which clearly prohibits smoking, eating, drinking, spitting and dogs on the market (Fig. 26). Despite recent efforts to enforce prohibition of smoking and drinking, these problems continue.
